michigan's demonstration erosion control program

update evaluation report - august, 1975

The University of Michigan

Coastal Zone Laboratory

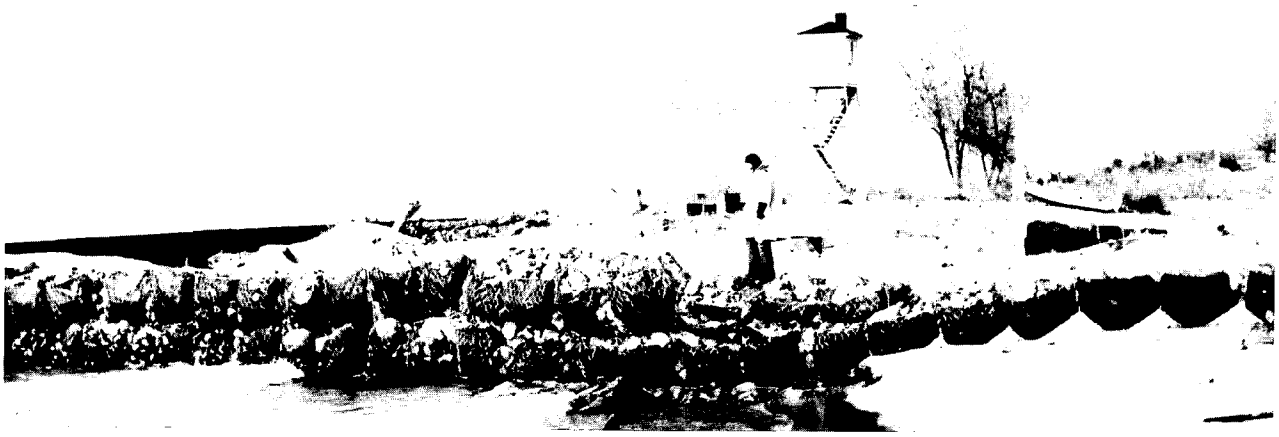
Condition. Photo #3 shows the condition of the site with the gabions in place, but prior to the backfilling which occurred in the fall of 1974. Photos #4 and #5 show the condition of the site in the spring of 1975 after the winter's storms.

Photo #3 October 19, 1974
The structure prior to completion of the gabion return wall.

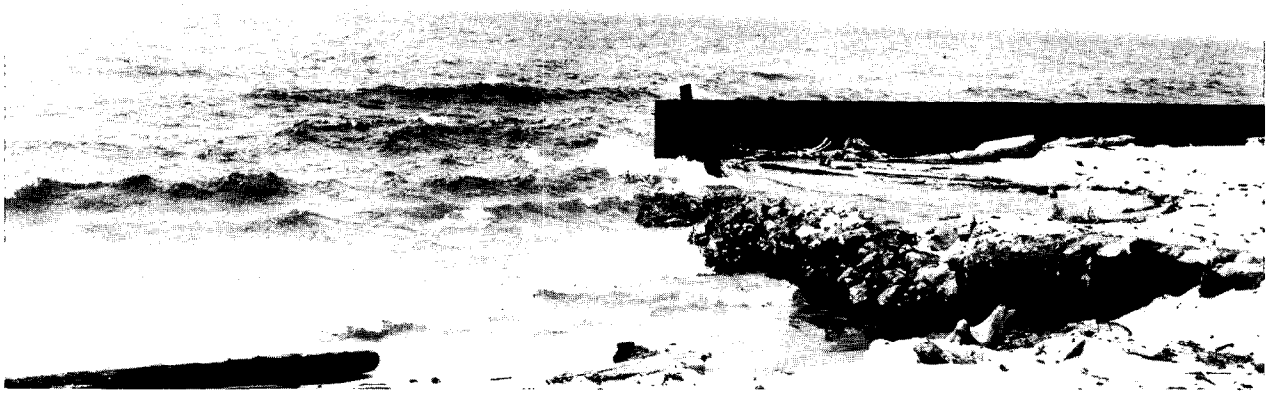
The gabion return wall in the south has failed. The backfill material has been washed out from behind the wall. The gabion cut-off walls have been flanked, and some further bluff recession appears to have taken place.

Analysis. The south groin was poorly constructed and failed, while the center groin, also poorly constructed, was too short to be functional. As a result, severe overtopping by waves has washed out about half of the backfill. Removal of the backfill also revealed that the tie-backs had not been completed properly. On June 5, 1975 the water in front of the steel wall was 8 feet deep, but the wall had not failed.

Photo #4 May 19, 1975
Condition of the gabion return wall after several months of service.

Photo #5 May 19, 1975
Damage to gabion return wall by winter storms. Gabion cut off walls were flanked and backfill washed out from behind wall. Improper tie-back usage is evident.

Maintenance. A number of repairs must be made at this site to enable these structures to prevent further damage. The center cut-off wall needs to be extended further back into the existing bluff, while the gabion return wall in the south needs to be replaced in its entirety. The tie-backs installed next to the existing seawall need to be secured to pilings, and the backfill material needs to be replaced.

Design Modifications. The ideal type of groin for this site would be one made of wood or steel. If the groins are replaced by gabions, they should probably be placed on gabion mat foundations with additional emphasis on water-proofing of the groins. The violence and volume of the overtopping appear to be so great that the gabion groins may never be able to contain the sand backfill. The only way this overtopping can be reduced is by building a rubble toe onto the outside of the wall. An alternative to replacing the backfill would be to protect the area behind the wall by combining rocks of mixed size with larger stones weighing at least 50 pounds to form a 24 inch buffer zone which would decrease the intensity of wave attack directly on the backfill material.

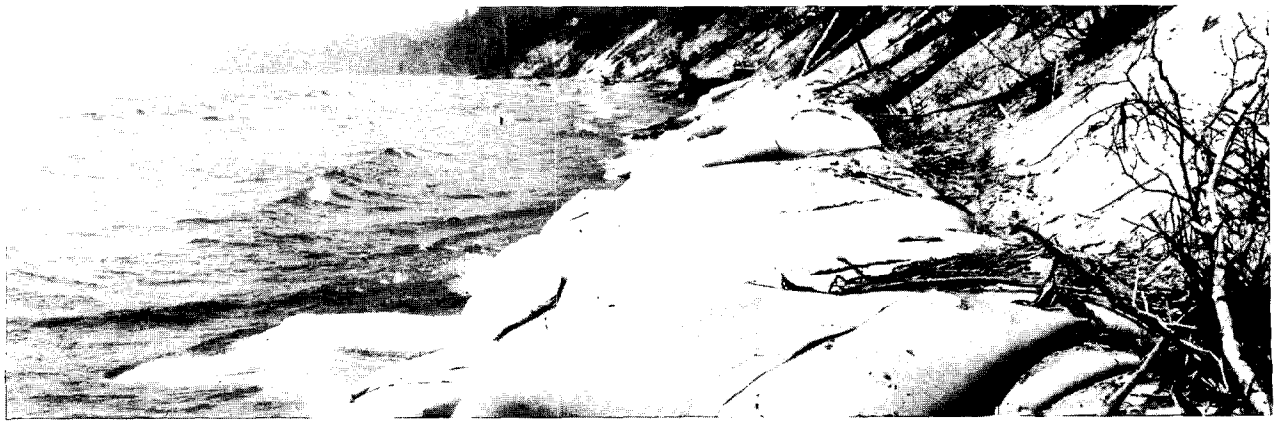
Condition. Diagrams #4, #5 and #6 and Photos #7 through #10 show the condition of the structures at this site. The rate of settlement in both structures has fallen off to a practically negligible level, and the slumping bank has stopped pushing the tubes forward from behind. Both protective devices, including the various sand bag stacking arrangements, have nearly retained their original effectiveness. Few if any additional sand bags have been vandalized during the second year.

Photo #9 October 5, 1974
Vandalism and damage to sandbags from floating debris is evident here.

Photo #10 May 18, 1975
Winter storms caused some sand bags to shift and others to be lost.

Maintenance. The top Longard tube has been shimmed with wooden wedges to increase its stability. Some additional shims may be required to help hold the top tube in place. A number of missing sand bags should be replaced.

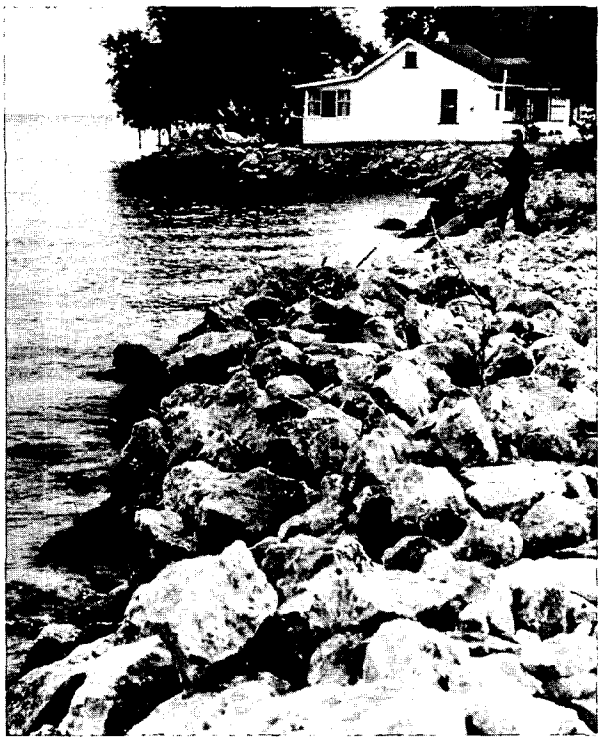
Photo #11 July 30, 1974
This photograph was taken shortly after completion of the project.

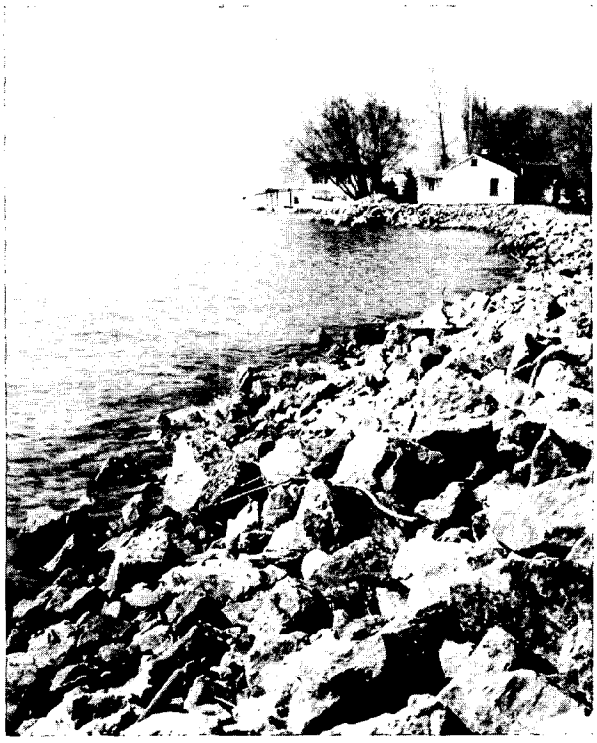
Condition. Diagrams #7 and #8 and Photos #11 and #12 show the condition of the site. No further erosion or recession of the bluff has occurred to date. Some of the rock has begun to slump and slide toward the lake, although this movement has been minimal to date. It should be noted that further storm activity may cause additional shifting.

Photo #12 May 17, 1975
After the first storm season, minor rock shifts are noted.

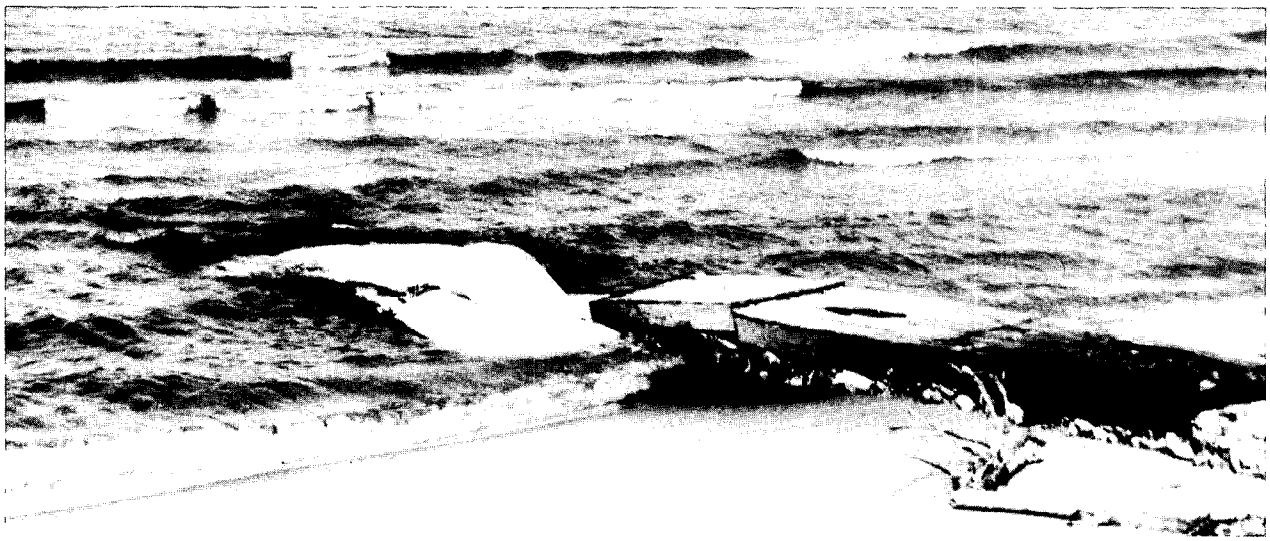
Photo #18 October 20, 1974
The sand bag-gabion arrangement is shown here. Some bags have lost sand and have shifted.

Photo #19 May 19, 1975
The shoreline has remained relatively stable at this location. Periodic sand replacement has been required.

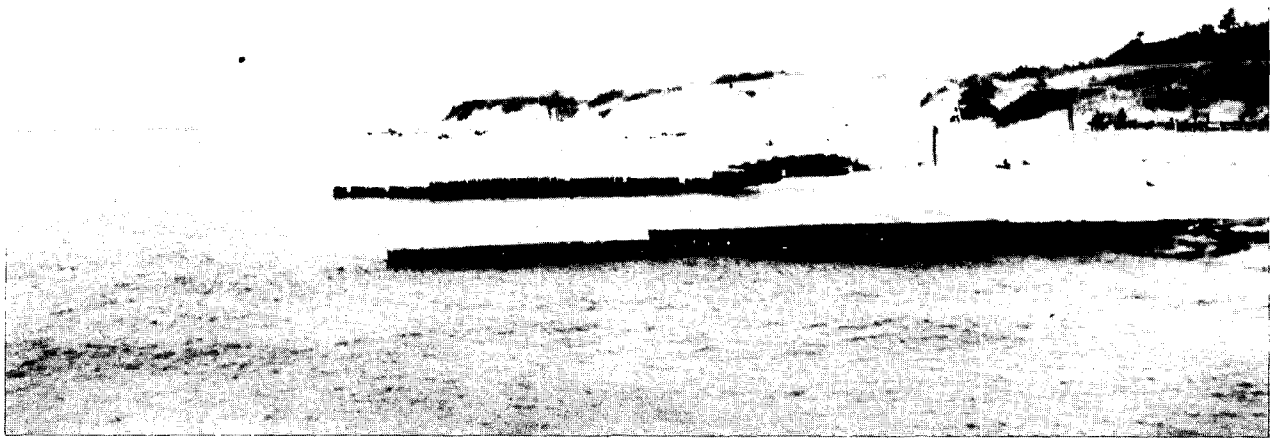
Photo #20 October 20, 1974
The groins at this site have required continual maintenance. A third groin (shown in background), which was built last and is not a part of the project, has fallen over.

Photo #21 May 19, 1975
A view of the groins looking south.

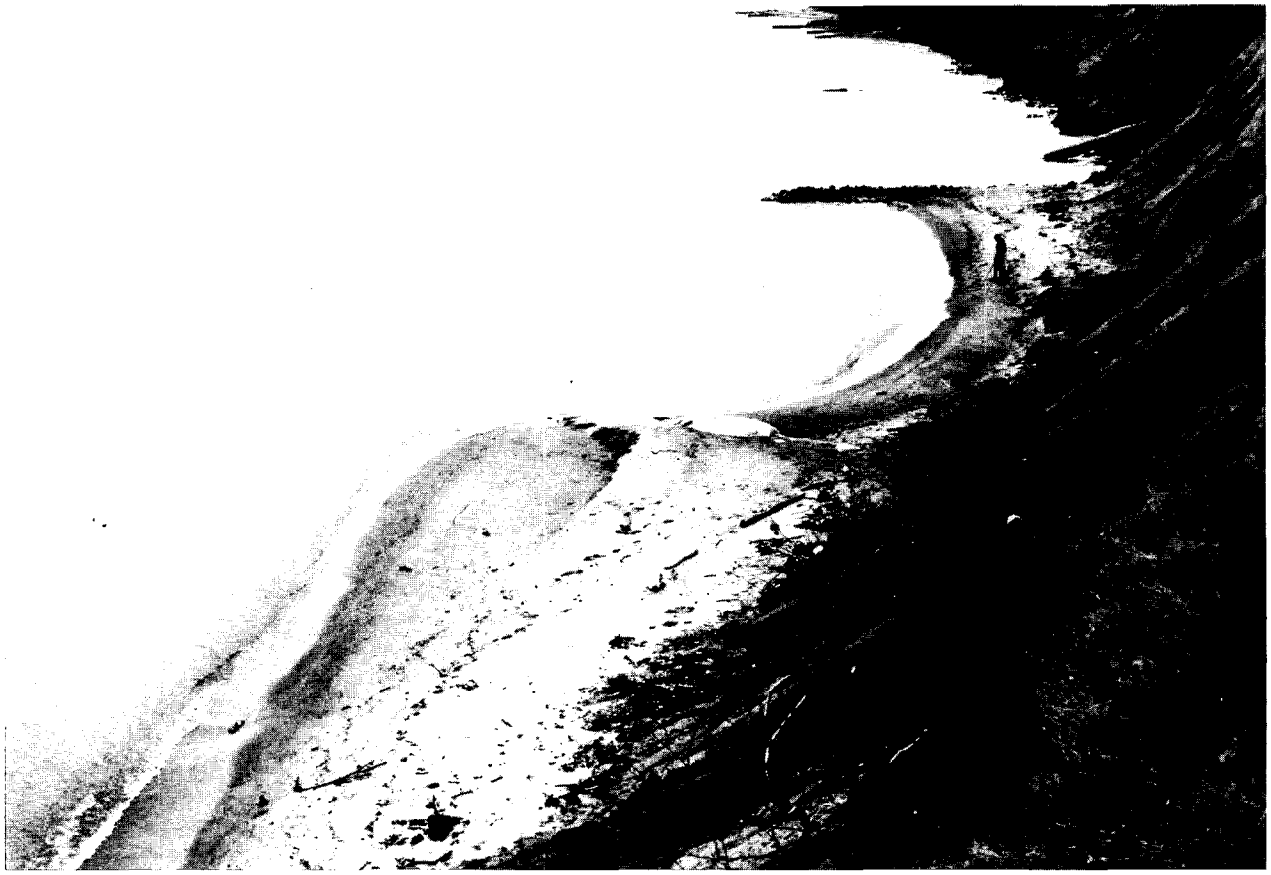
Photo #24 November 17, 1974
The groin at this site has lost a number of bags, but is still trapping sand and helping to build a beach.

Photo #25 April 27, 1975
Both the sand bag (which has lost many bags) and the rock mastic groin are shown here.

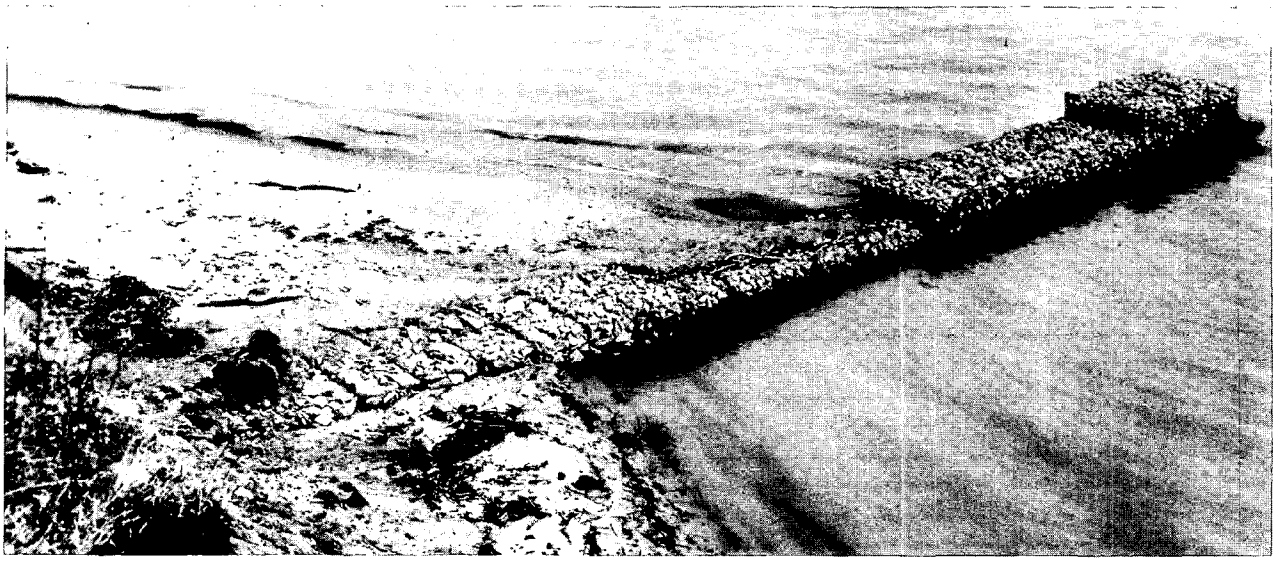
Photo #27 April 27, 1975
This gabion groin is already building a beach. Note the sand bag installation and the rock mastic groin in the background.

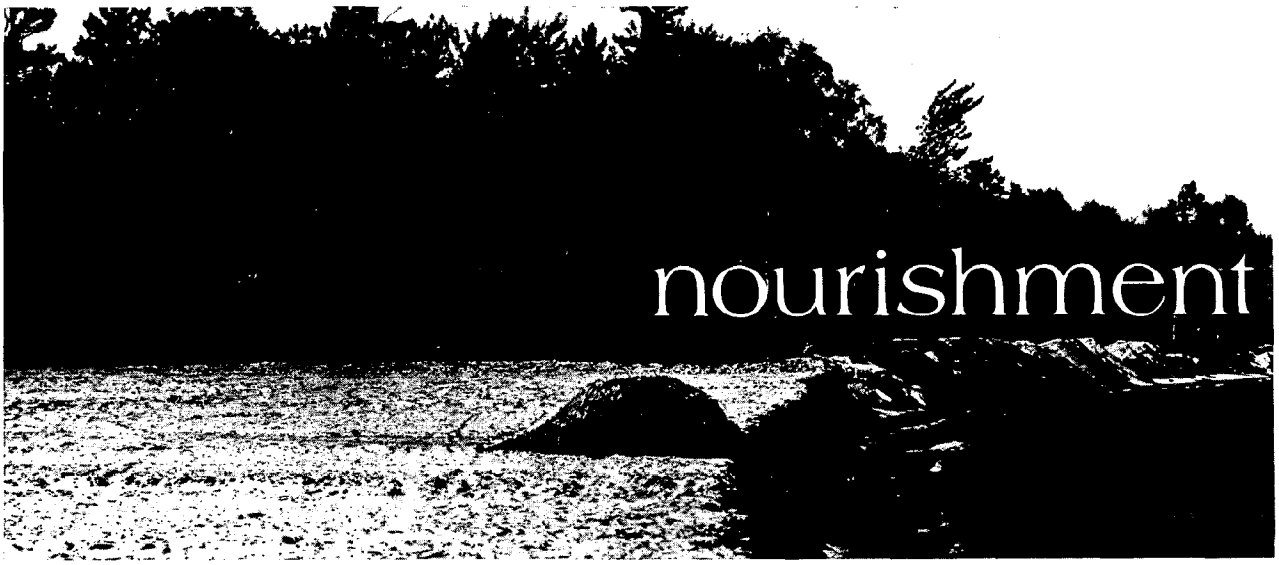
Photo #35 May 6, 1975
Sand has covered all but small portions of the tube. The structure is no longer needed and is not functioning as a shore protection device.
