CONSTRUCTING A FLOATING TIRE BREAKWATER
— THE LORAIN, OHIO EXPERIENCE —

— March, 1982 —

City of Lorain

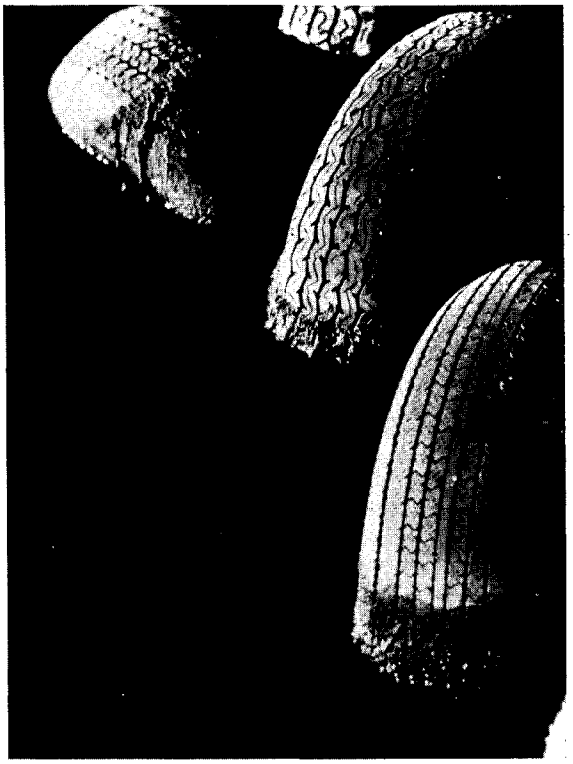
Figure 64

Accumulation of sediment inside the tires has been non-existent. Previous study of the area showed very little movement of bottom sediment. For this reason, no holes were punched in the tires to allow sediment to filter out. Current opinion is that these holes are not effective unless they are large enough to prevent plugging by sea life (i.e. 4-inch square or larger).
