MASTER & MANAGEMENT PLAN
WAGON HILL FARM
DURHAM, NEW HAMPSHIRE

STRAFFORD REGIONAL PLANNING COMMISSION
& THE TOWN OF DURHAM, NEW HAMPSHIRE

THE CAVENDISH PARTNERSHIP INC.
BANWELL WHITE ARNOLD HEMBERGER & PARTNERS INC.
BOURNE CONSULTING ENGINEERING

AUGUST 21, 1995

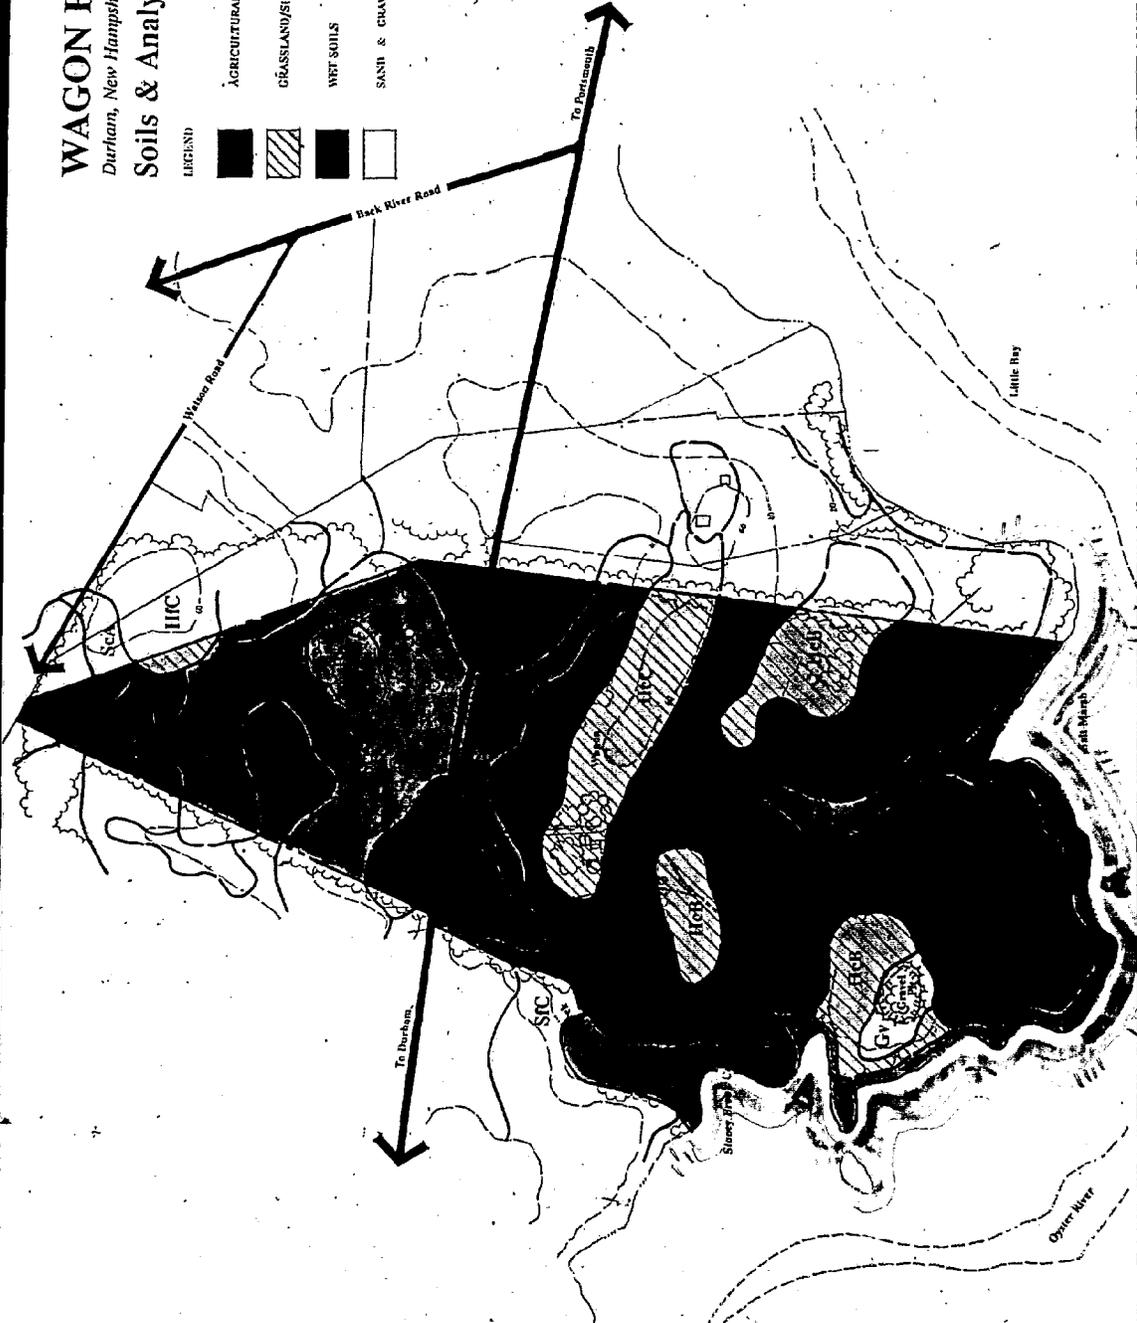
Soil Conservation Service Classification

Re - Helderford silty clay loam
 BAB - Batavia silt loam, 4 to 24% slope
 Gr - Gravel and borrow pit
 HtB - Hollis-Charlton fine sandy loam, 3 to 8% slopes
 HtC - Hollis-Charlton fine sandy loam, 8 to 15% slopes
 HtC - Hollis-Charlton fine sandy loam, 8 to 15% slopes
 SA - Scarth silt loam, 0 to 3% slopes
 SIC - Seefeld silt loam, 3 to 12% slopes
 Ts - Tidal marsh

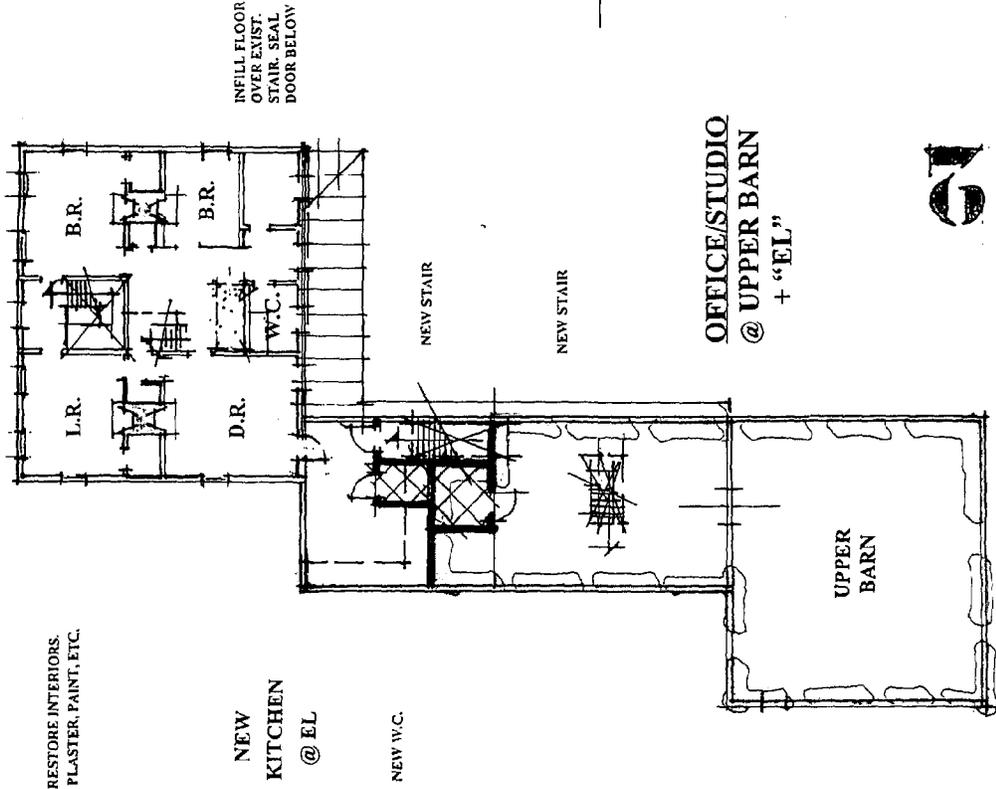
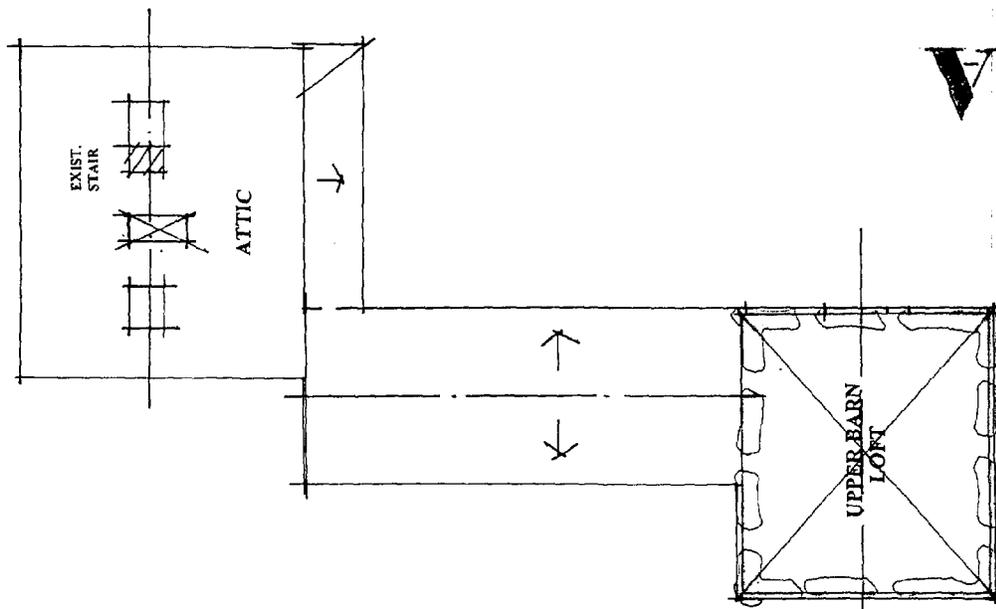
BICKFORD-CHESLEY HOUSE (CIRCA 1806)
RENOVATIONS

TENANT ENTRY
@ FRONT DOOR

APARTMENT @ 2ND
FLOOR

REPAIR EXT. WALLS (TYP.)

2. Farm house and "ell" repair and maintenance to bring the building up to local building codes. Approximate cost - \$120,000.
3. Resurfacing the trails is the one of the easier components to implement in this concept. Utilizing volunteer labor and donated or recycled materials this could be a low cost improvement. A certain amount of earthwork preparation may be required but the bulk of the work would be spreading mulch on the designated trail system. An interpretive signage system could be designed by a UNH student as part of a thesis.
Cost - Variable.

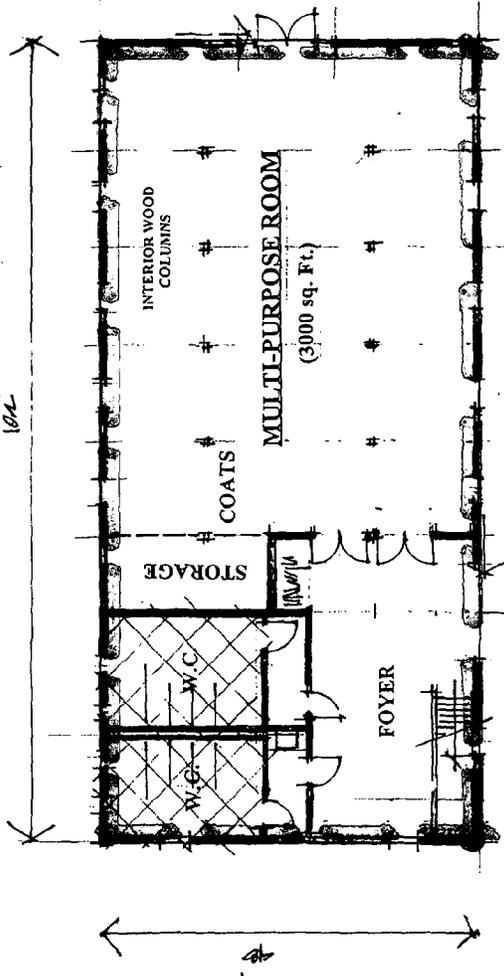
GROUND FLOOR PLAN

- WOOD FRAMED STRUCTURE
- ON SLAB-ON-GRADE
- WOOD WINDOWS
- NATIVE PINE BOARDS

CONFERENCE BARN
RECONSTRUCTION
SEATING FOR (400?) PERSON

1. The reconstruction of the horse barn is necessary if these facilities are to withstand normal weather conditions. (Snow Loading, Wind, Rain). If the horse barn becomes a public space the present structure is not stable and would require significant reconstruction or renovation. The most cost effective solution would be to replace the barn. The replacement cost including public restrooms and undeveloped storage space above would be approximately \$250,000.

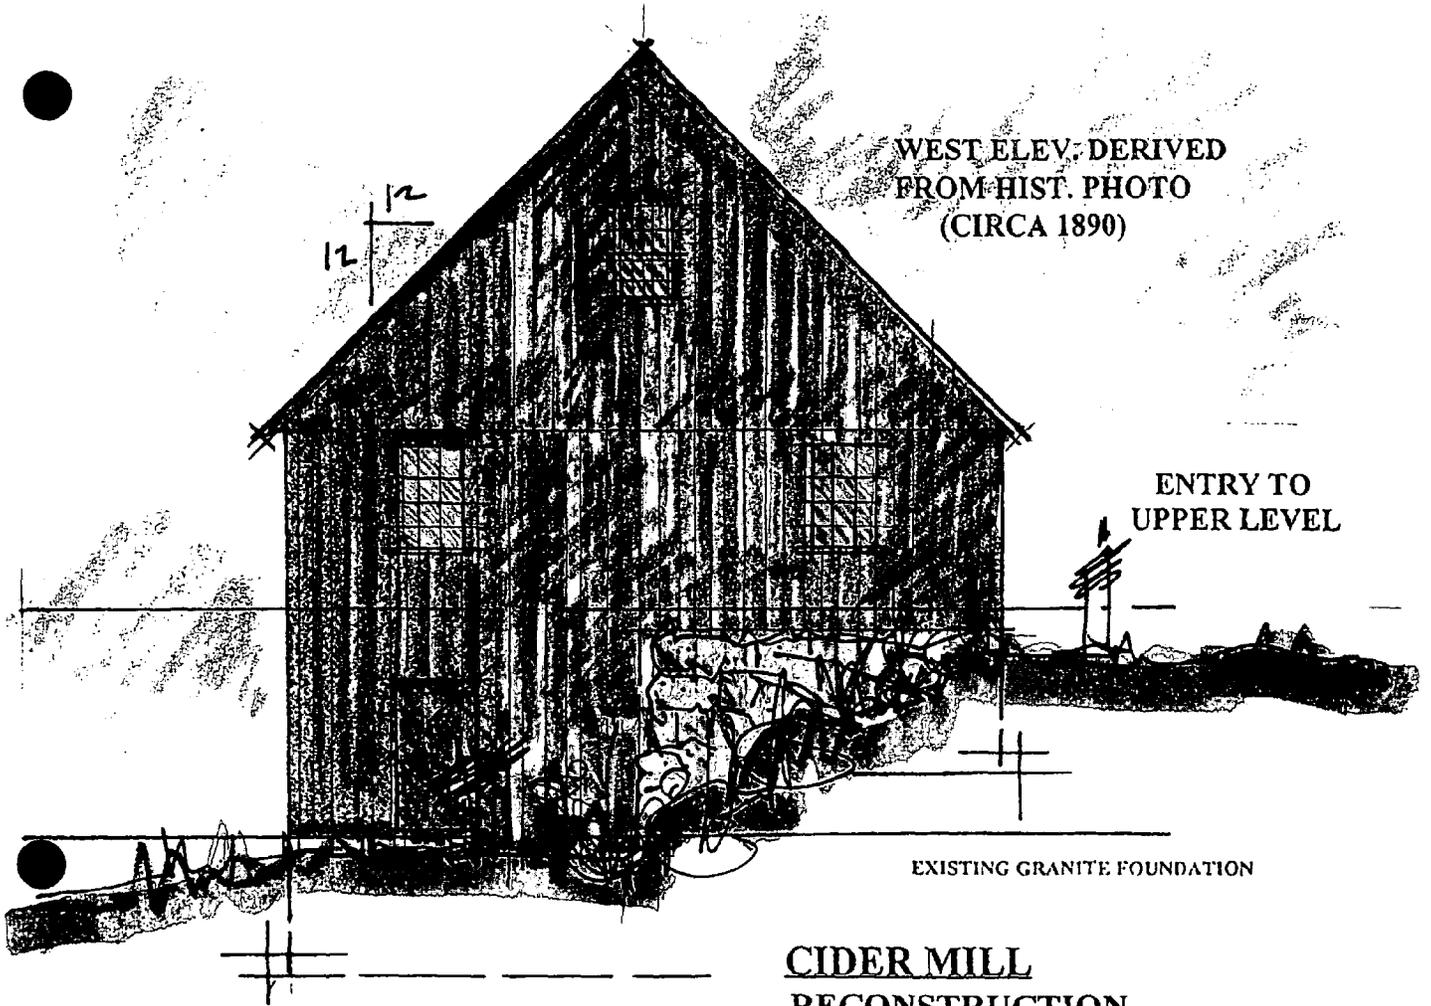
**CIDER MILL
RECONSTRUCTION**

WEST ELEV. DERIVED
FROM HIST. PHOTO
(CIRCA 1890)

EXISTING GRANITE FOUNDATION

1/8"=1'-0"

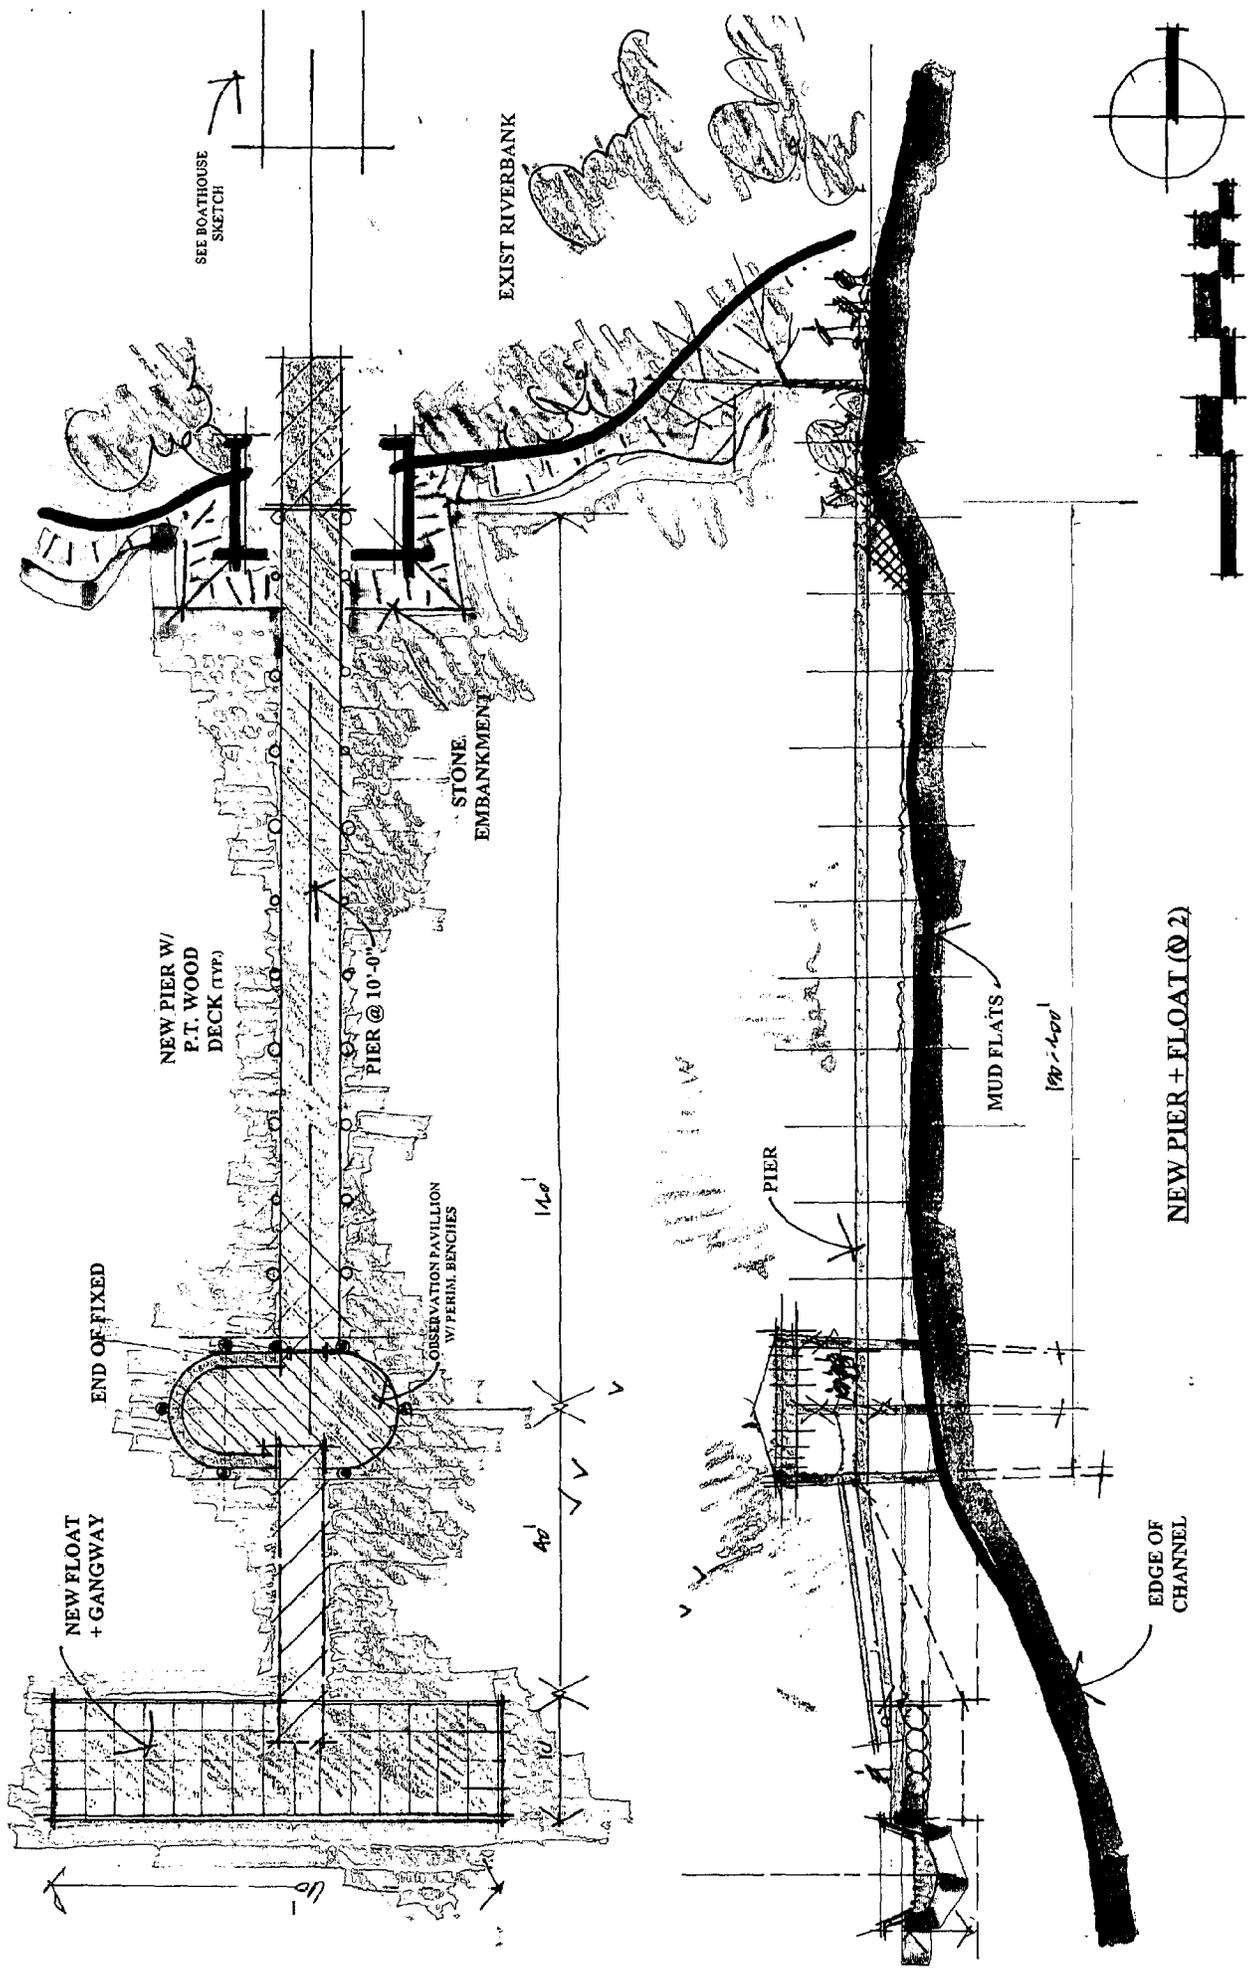
SEE BOATHOUSE SKETCH

EXIST RIVERBANK

NEW PIER + FLOAT (NO. 2)

CHANGING
ROOMS +
SHOWERS

15. The boat house and/or bathroom facility at the wharf should be looked at closely. The problems of running water, sewer lines, and electricity on a pier can be long-term maintenance issues. The utility lines would be susceptible to freezing or damage from wave and ice conditions under the pier structure. The boathouse may be more suited to an upland location with sufficient room immediately in front for users to work on boats and allow easy transfer of boats in and out of the boathouse. In addition, with the presence of wetland vegetation on the outer portions of the wharf area it is unlikely that construction over that area would be allowed. Cost - \$81,000.00

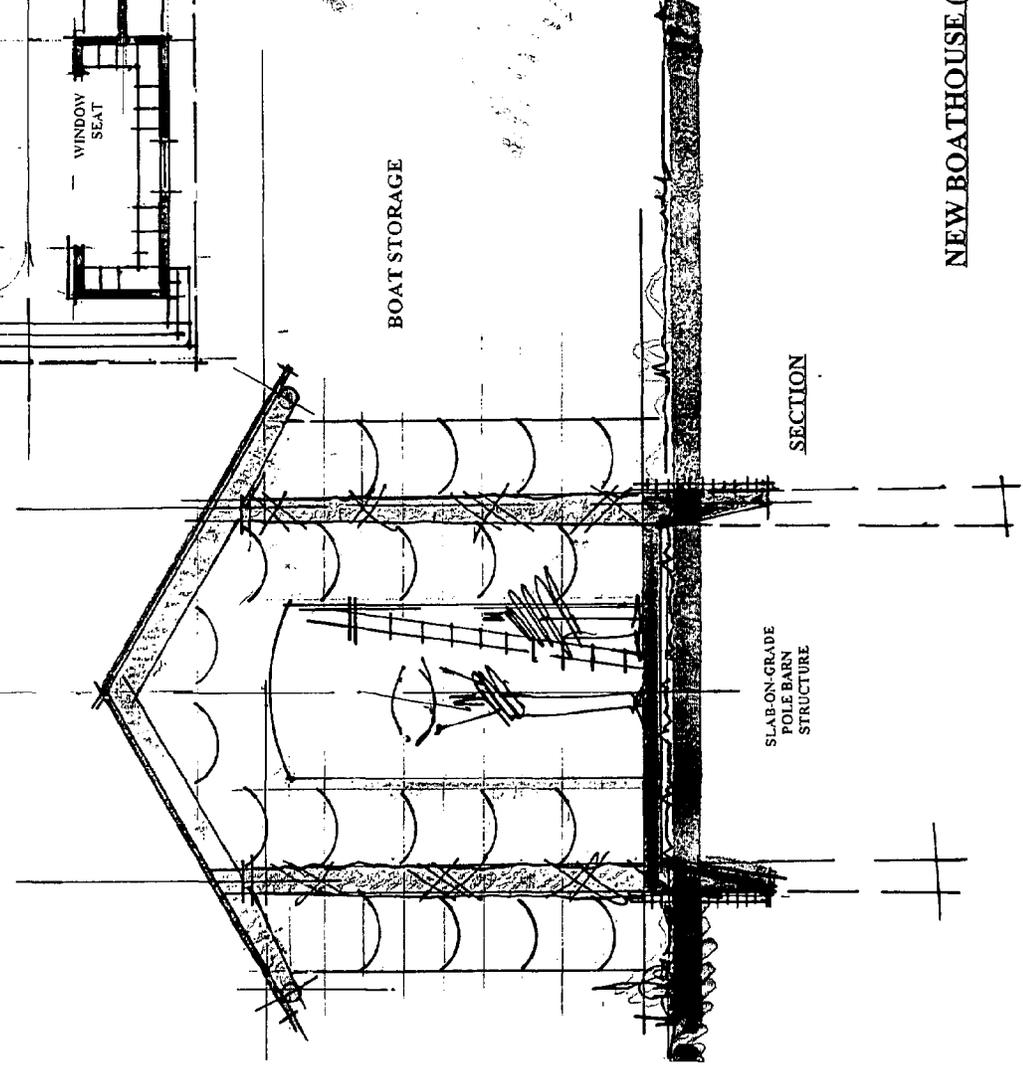
SECTION

METAL ROOF
SHIP LAP
PINE BOARD
SIDING

SLAB-ON-GRADE
POLE BARN
STRUCTURE

NEW BOATHOUSE (Q 3)
