**Development and Erosion
History of Bayocean Spit
Tillamook, Oregon**

Thomas A. Terich
and
Paul D. Komar

Reference 73-16
September 1973

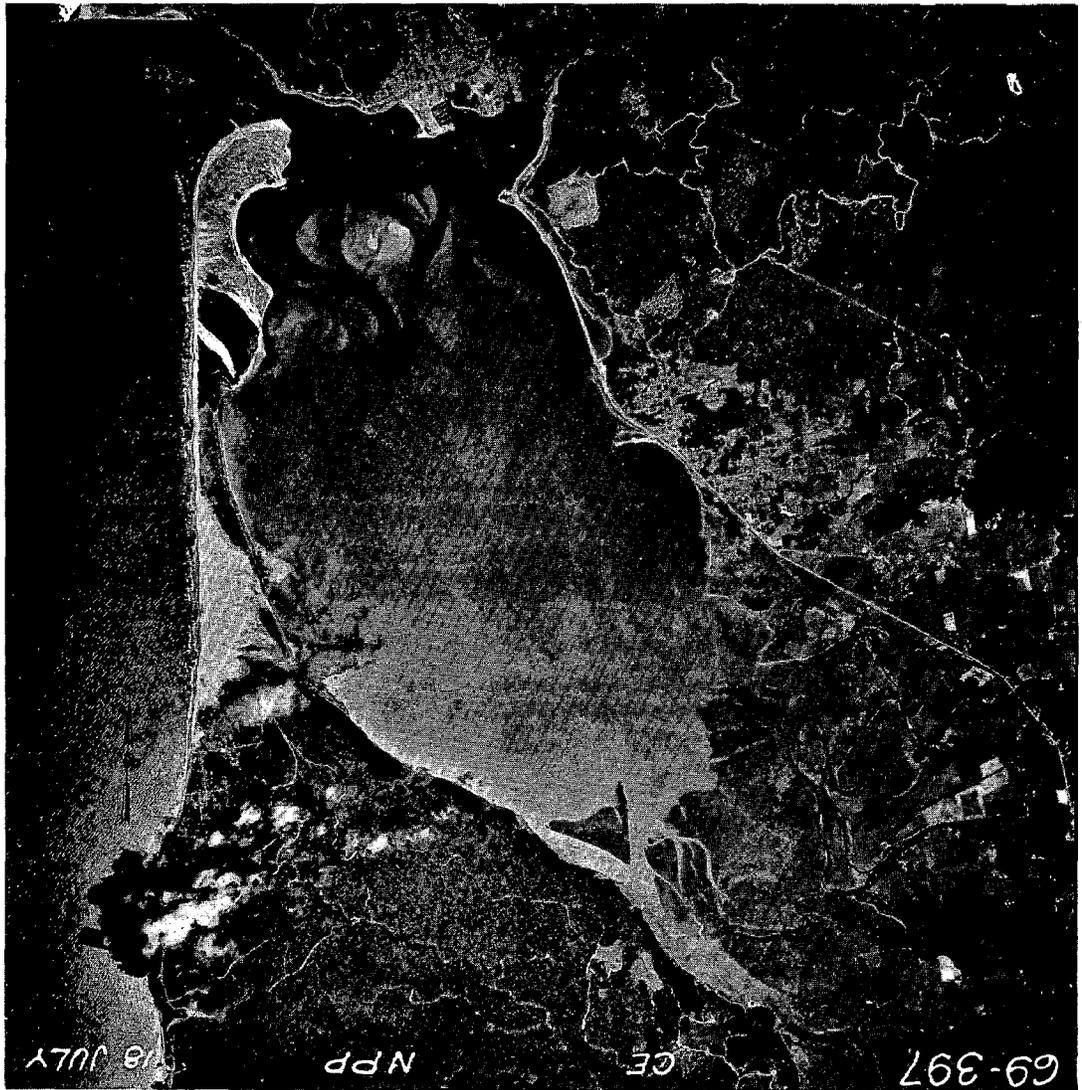
Figure 1. 1969 aerial view of Tillamook Bay and Bayocean spit.

Bayocean spit, on the northern Oregon coast separating the Pacific Ocean from Tillamook Bay (Figure 1), has had a long history of beach erosion. Early in the century, work was begun on a large beach resort on the spit. Financial problems caused the decline of the resort, and it was abandoned in 1952 as severe erosion and breaching of the spit threatened the few remaining residents. The erosion was believed to have been caused by the construction of a north jetty to the Tillamook Bay channel. The jetty is thought to have blocked the prevailing north to south littoral sand transport thus depriving Bayocean spit of sand.

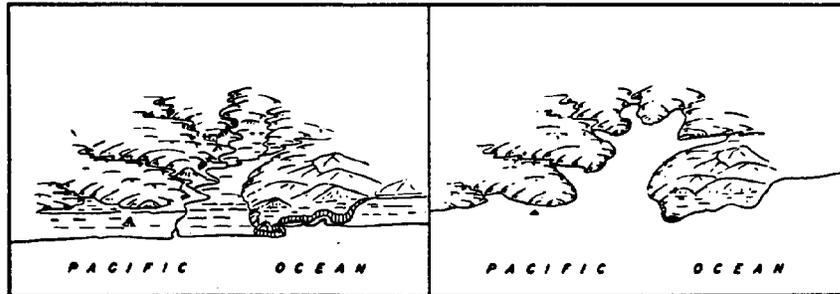
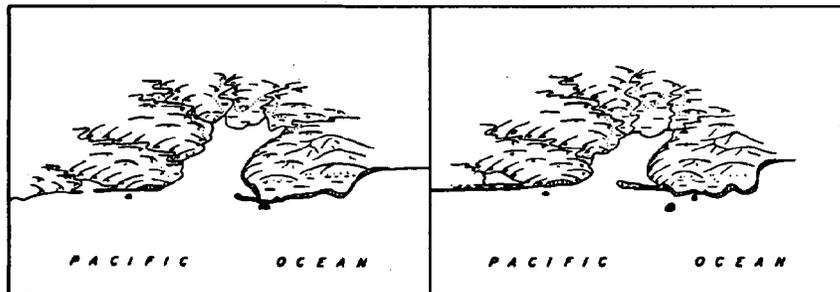
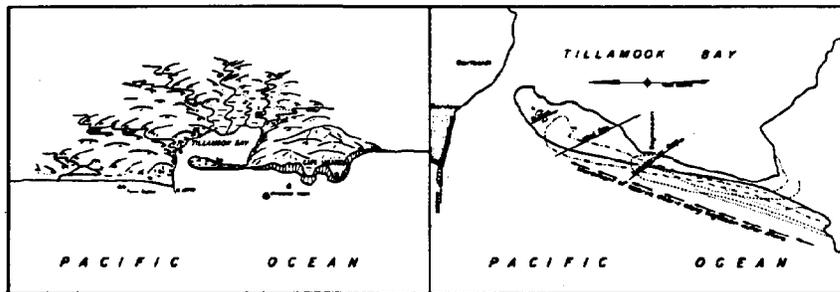
FIGURE 1
EARLY AND MIDDLE PLEISTOCENE INTERMITTENT DRAINAGE OF TILLAMOOK BAY REGION

FIGURE 2
LATE PLEISTOCENE OR EARLY RECENT DRAINAGE OF TILLAMOOK BAY AND TRIBUTARY RIVERS

FIGURE 3
EARLY STAGES IN THE DEVELOPMENT OF THE PRESENT EROSION "CYCLE"

FIGURE 4
PROGRESSIVE EROSION OF HEADLANDS AND DEVELOPMENT OF RIVER DELTAS

FIGURE 5
PRESENT STAGE OF DEVELOPMENT

FIGURE 6
PROGRESSIVE GROWTH AND DEVELOPMENT OF BAYOCEAN SPIT

Tillamook Bay and Bayocean spit are believed to have been formed from the eustatic rise of sea level and partial drowning of stream valleys. Figure 2 illustrates a geologist's conception of the development of the spit and bay. The late Pleistocene transgression of the sea drowned the lowland and extended up the tributary valleys. The sea's transgression is believed to have initiated a straightening of the shoreline as waves eroded back promontories and beach deposits closed off inlets. Evans (1942) stated that the growth of spits is always in the direction of beach drifting, and that the more material carried forward by the process the more rapidly the spit grows. It appears that Bayocean spit thus evolved and grew from the northward

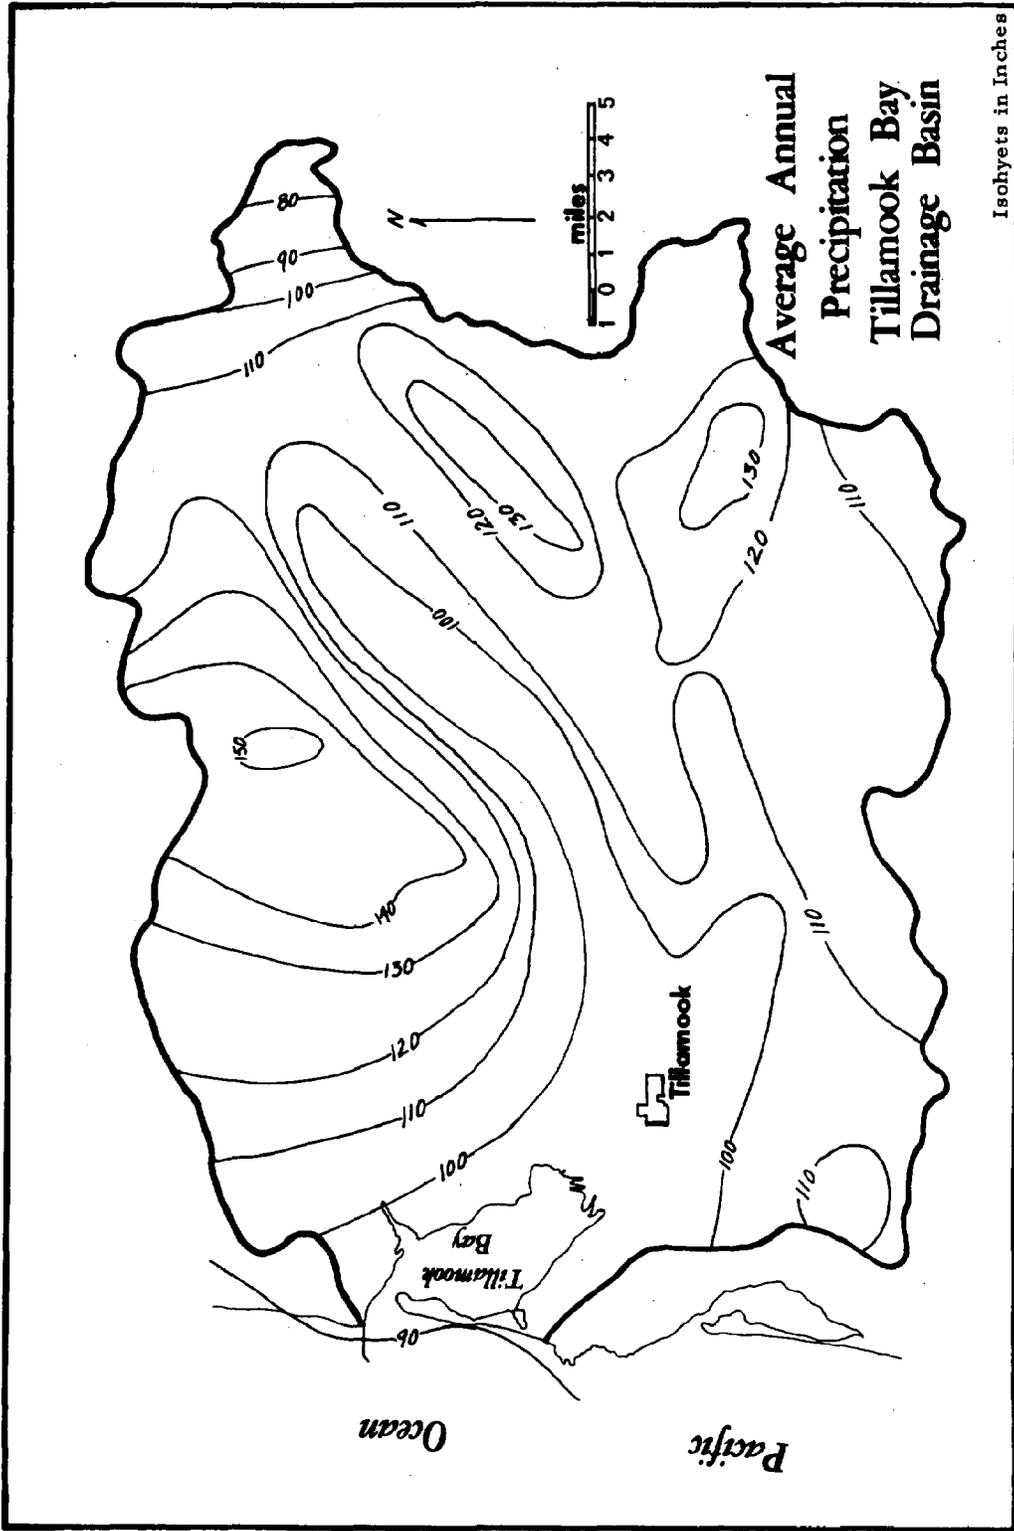
Figure 3. Average annual precipitation of Tillamook Bay drainage basin.

The increasing elevations in the Coast Range east of Tillamook effect an increase of annual precipitation. Some of the heaviest rainfall areas in the United States are found in the Coast Range. Figure 3 illustrates the abundant precipitation that annually occurs within the Tillamook Bay drainage basin. The copious winter precipitation provides high runoff and river discharges into Tillamook Bay (see Table 1). Conversely, the relatively dry summers are reflected in low river flows. Responses to the seasonal extremes in precipitation within the Tillamook Bay drainage basin are reflected in the average monthly discharges of the Trask and Wilson rivers (Figure 4).

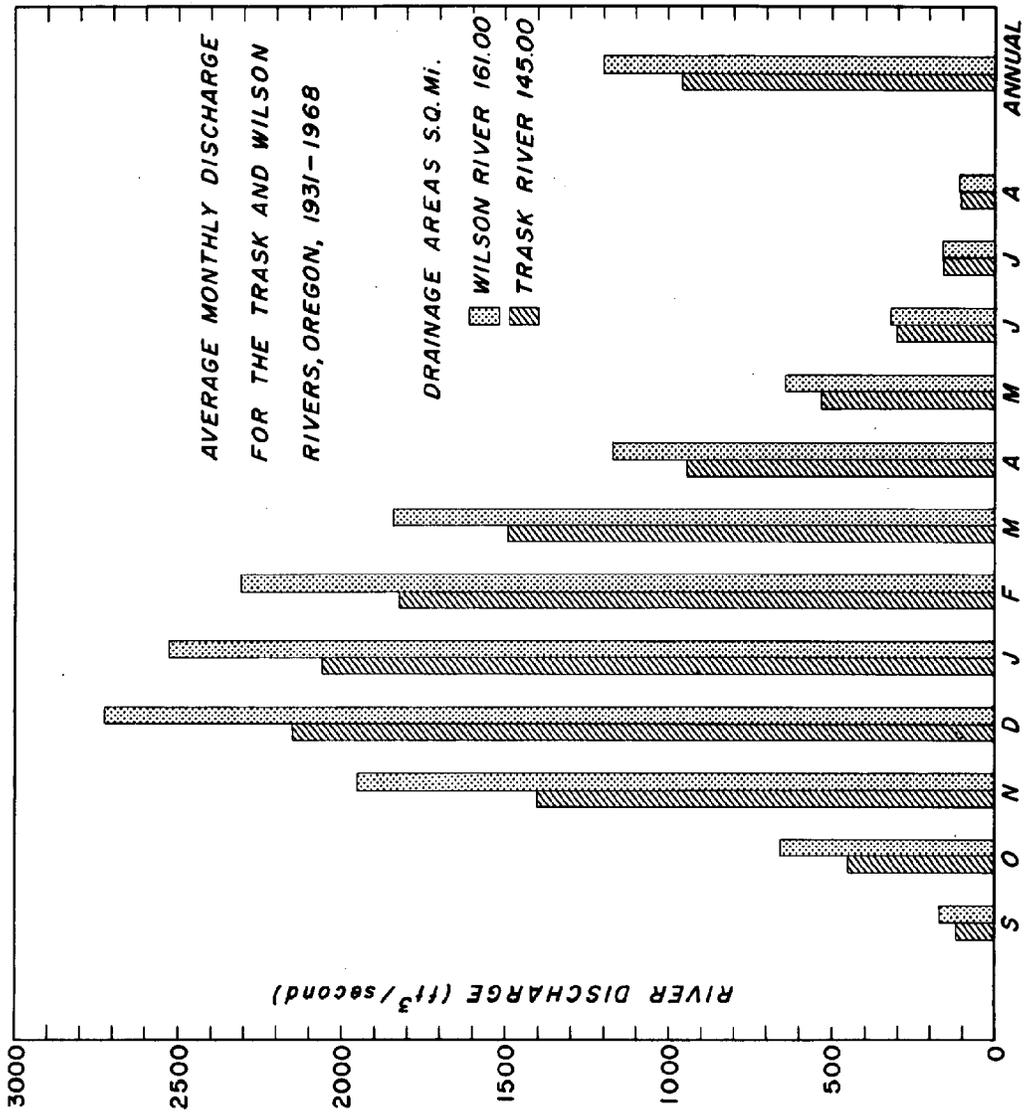
Figure 4. Average monthly discharge of the Trask and Wilson Rivers.

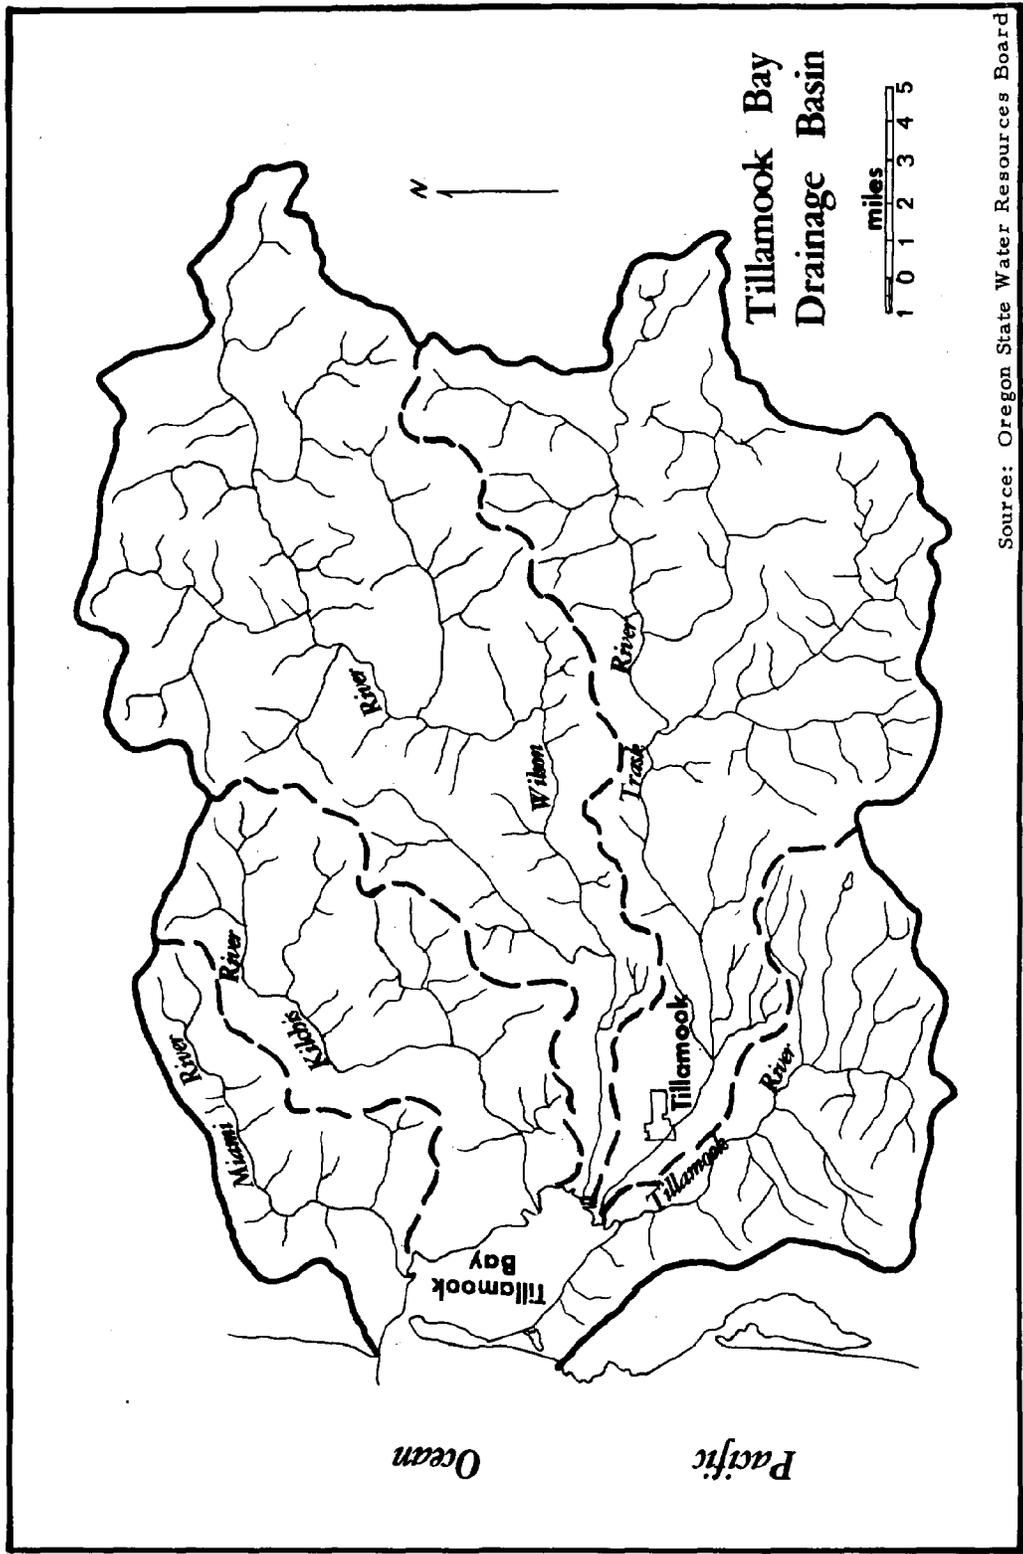
Figure 5. Tillamook Bay drainage basin.

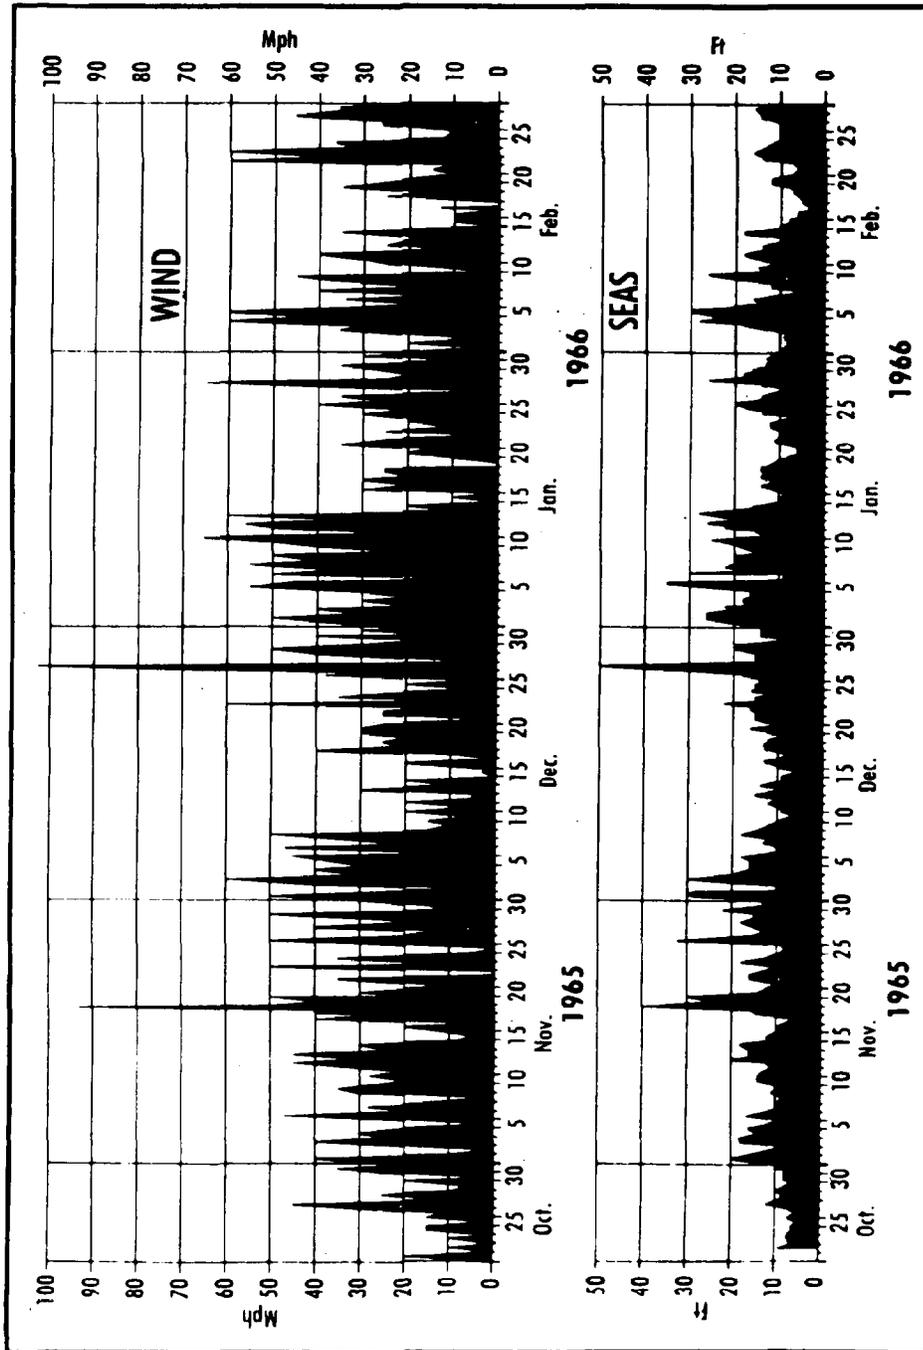
Figure 6. Wind and wave characteristics off the Oregon coast. After Rodgers, 1966.

- 1) The predominant direction from which local seas approached was SW-SSE during autumn and winter and N-NW during spring and summer.

- 2) The highest waves, regardless of angle of approach, always occurred in the winter.
- 3) Throughout the year, the highest waves came from the SW-SSE octant.

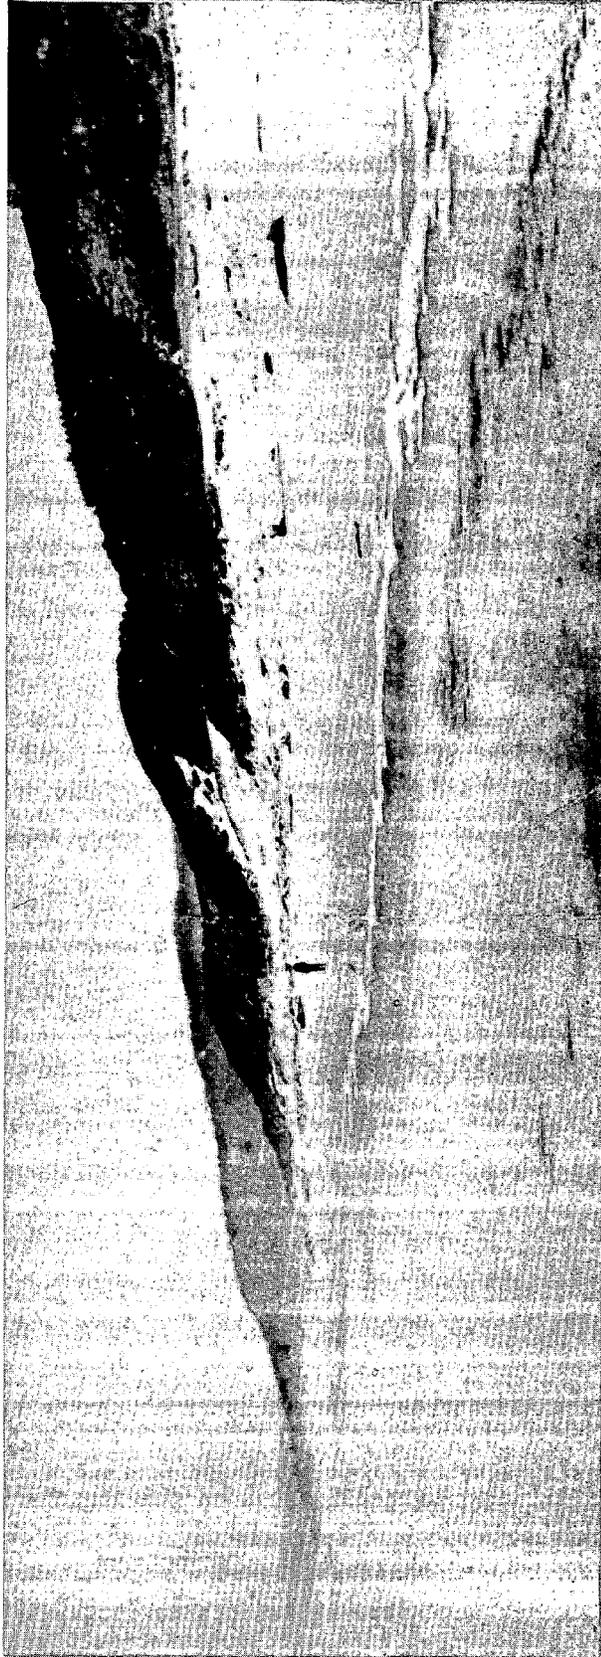
Figure 12. Wide sandy beach along Bayocean spit ca. 1910. Courtesy of Pioneer Museum, Tillamook.

The arrival of the railroad finally allowed the scheduling of an official opening of the resort for June 12, 1912 (Olsen, 1937). Photographs of the resort taken at its high point of development illustrate its attractiveness. Wide sandy beaches were backed by stable vegetation-covered foredunes (Figure 12). The large salt water natatorium was constructed mid-way on the spit, at the base of the foredunes (Figure 13). Upon the foredune and near the natatorium was the 40-room Bayocean Hotel (Figure 14). Other humble yet adequate temporary bungalow housing and tents were available to the visitor. Many large private vacation homes and permanent residences were scattered throughout the park (Figure 15). A pamphlet prepared about 1913 provided the following information about the resort (Bayocean Park Resort, 1913?):

contrasted to the pre-erosion vegetated seaward face of the foredunes about 1910 (Figure 12).

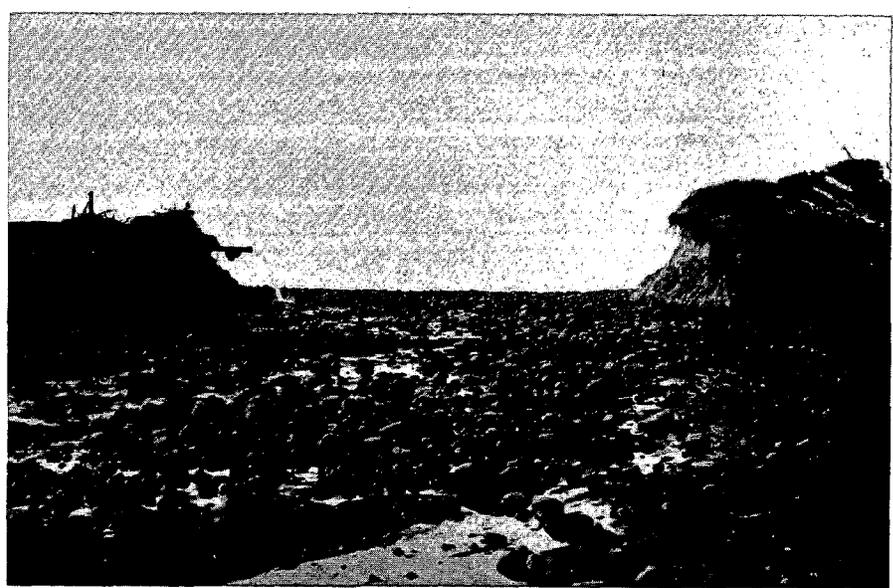
Figure 17. Wash at Jackson Gap, Bayocean spit, looking west showing broken water main, January 6, 1939. Courtesy of U.S. Corps of Engineers.

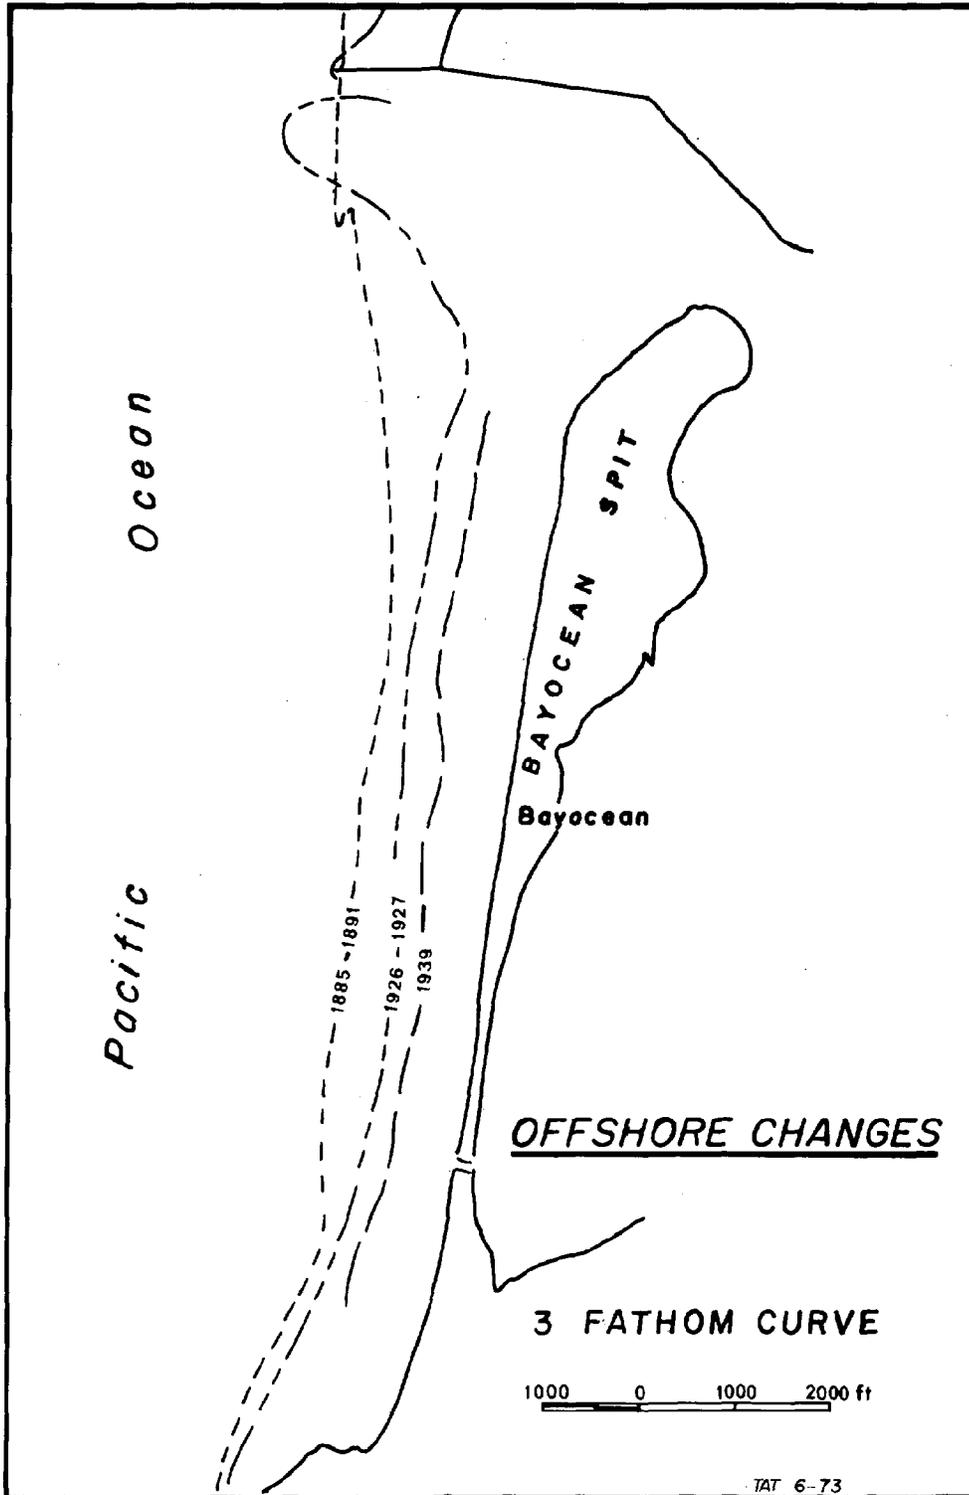
Figure 18. Depth changes offshore Bayocean spit 1885-1939.
U. S. Army Corps of Engineers.

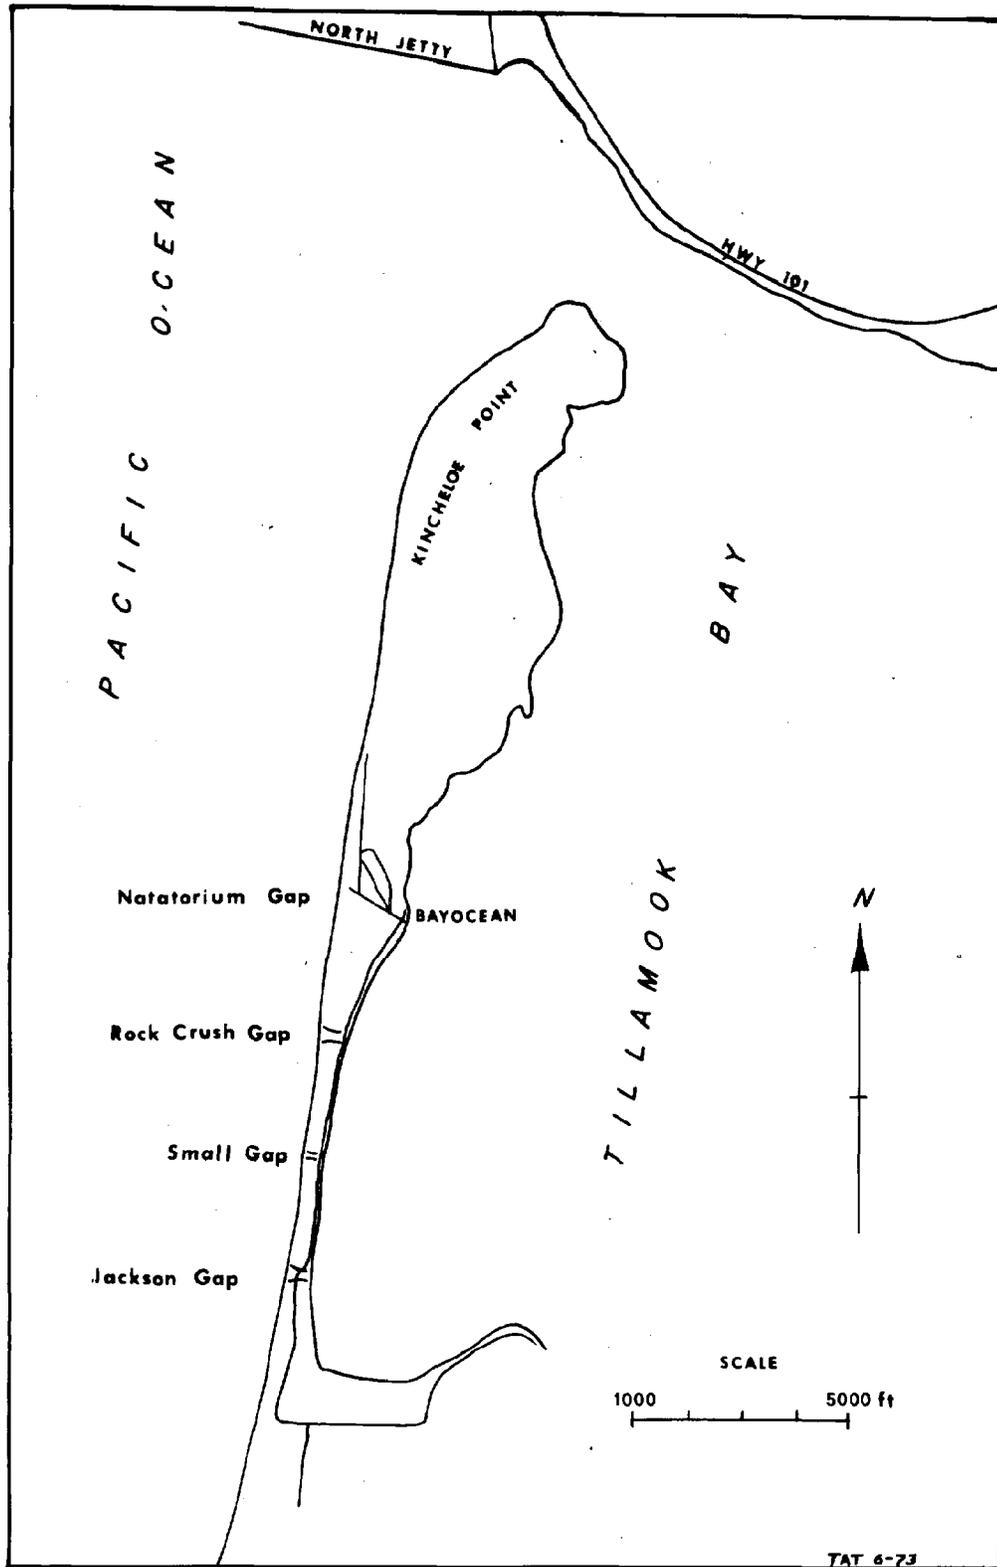
Figure 19. Washover gaps along Bayocean spit.

The gaps discussed in the newspaper account are found along the narrow southern neck of the spit (Figure 19). Two were awash with waves carrying debris and gravel into Tillamook Bay. The largest washover, Jackson Gap, was about 50 feet wide and 7 feet below the general ground level (Figure 17). Natatorium Gap had also been awash. The natatorium which stood on the seaward side of the gap had been totally destroyed (Figures 20 and 21). Considerable damage was done to the paved road along the foredune between Cape Meares and Bayocean Resort. The road's surface was littered with debris washed in by the high waves (Figures 22 and 23).

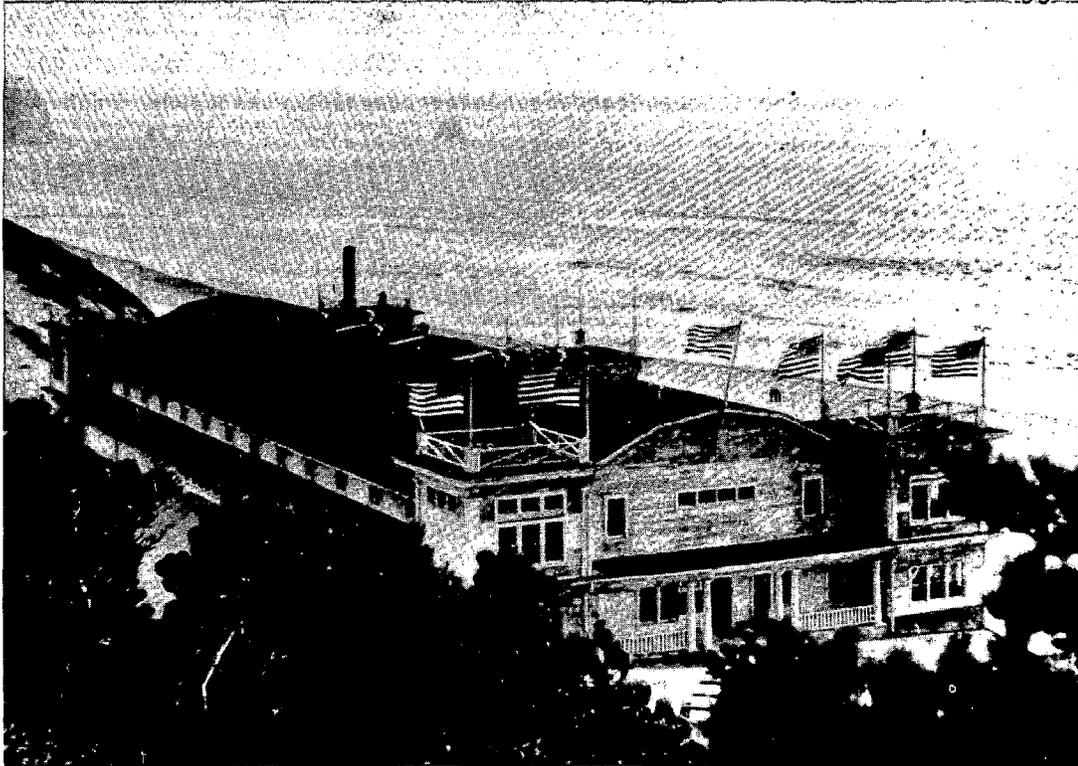
Figure 20. Looking south at Bayocean natatorium ca. 1915. Olsen, 1937.

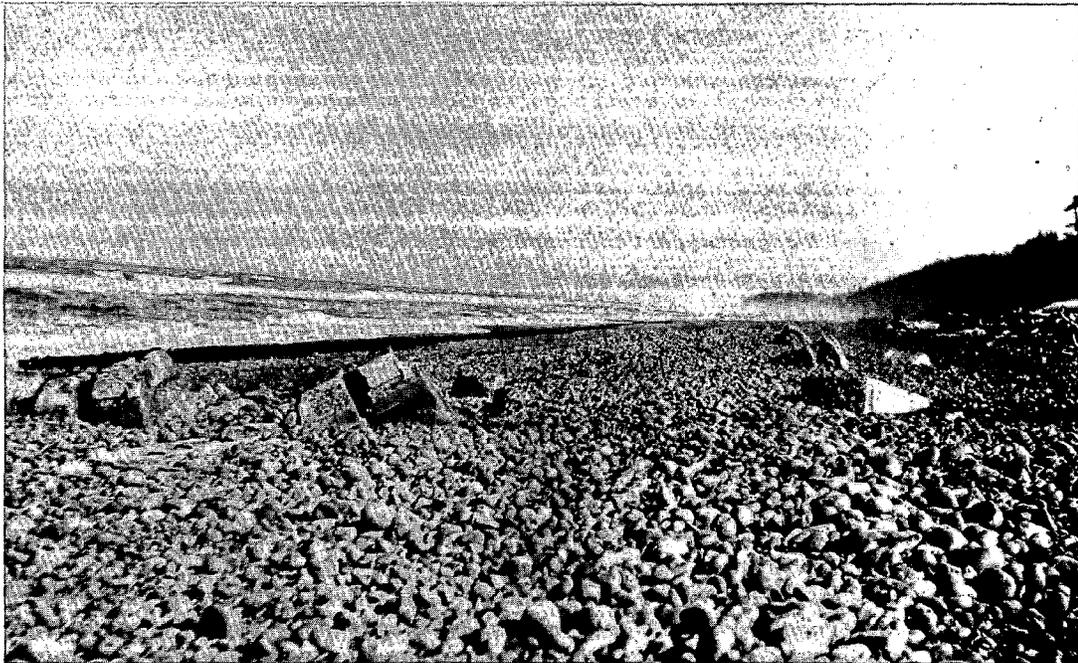
Figure 21. Looking north at remains of Bayocean natatorium ca. 1940. Pioneer Museum, Tillamook.

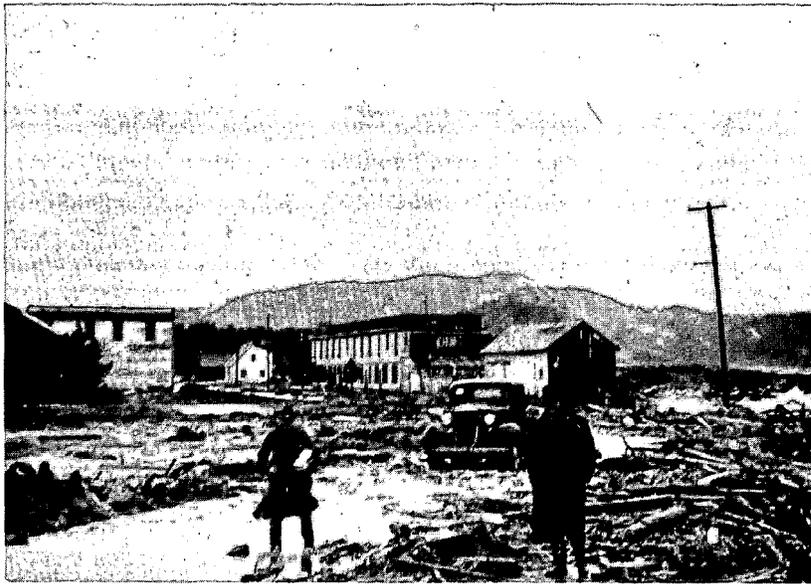
Figure 22. Drift and debris at Bayocean Park. January 4, 1939.
U. S. Army Corps of Engineers.

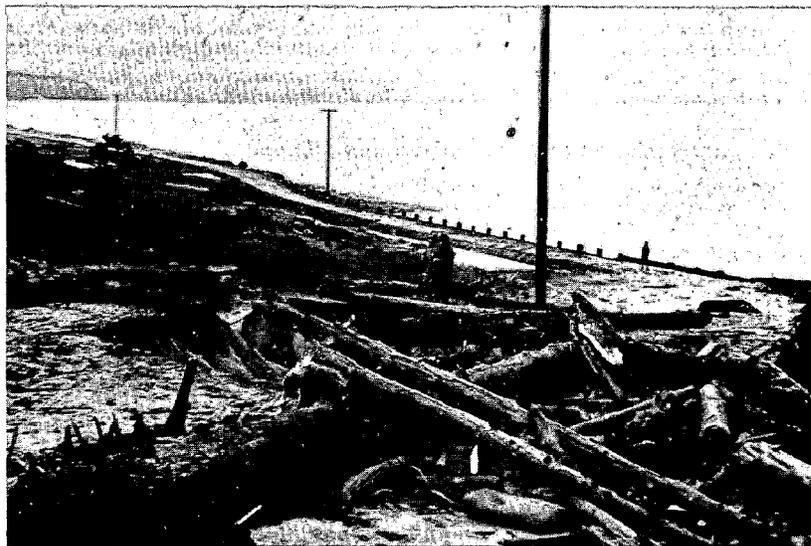
Figure 23. Drift and debris on the road to Bayocean Park. January 4, 1939. U. S. Army Corps of Engineers.

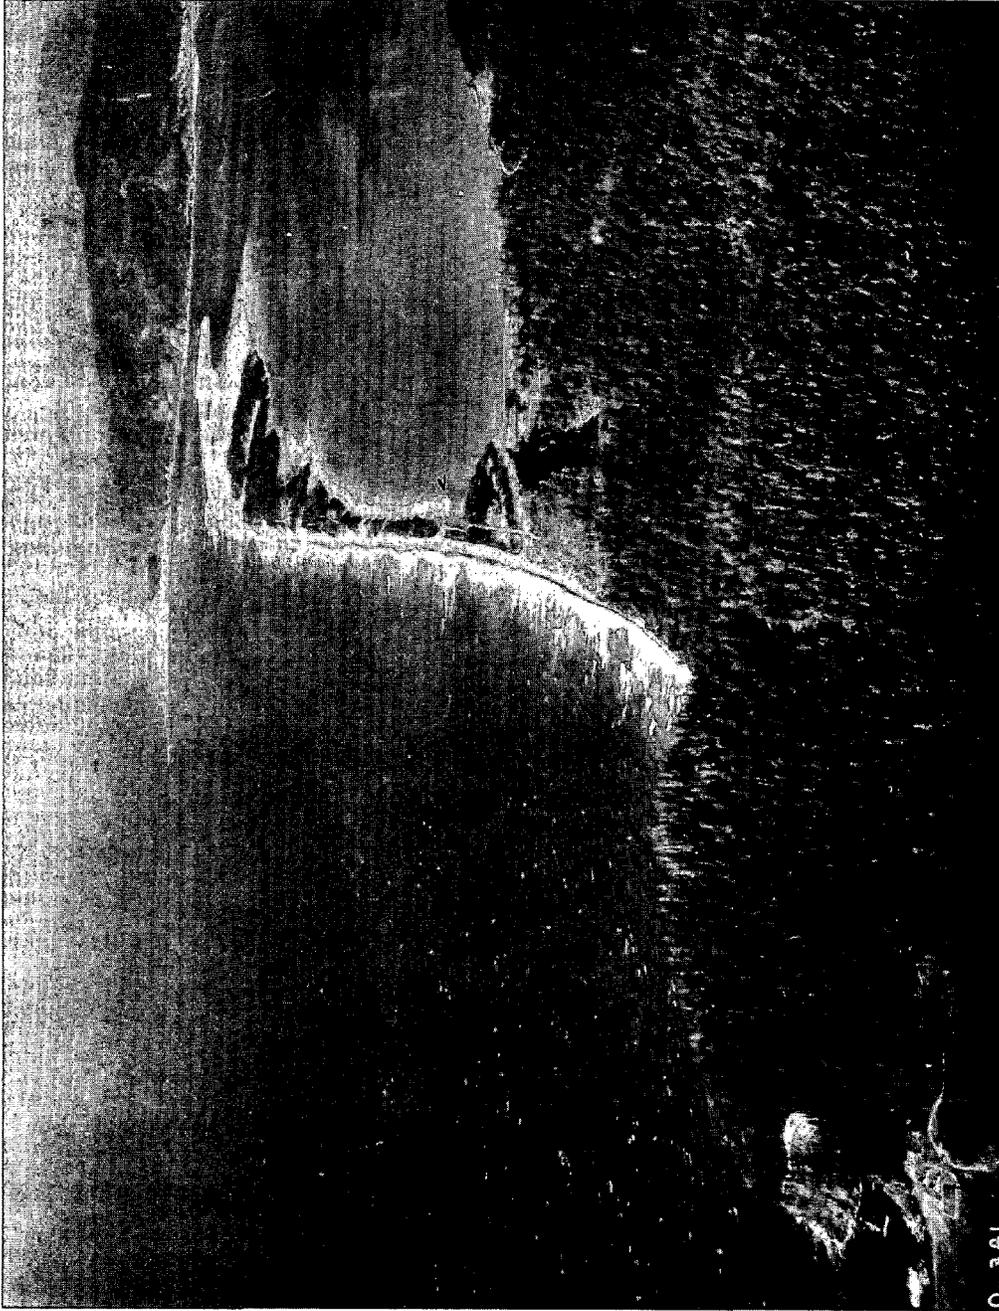
Figure 24. Aerial view of Bayocean spit, looking northerly from Cape Meares. Tide +6.6 feet. July 20, 1939. U.S. Army Corps of Engineers.

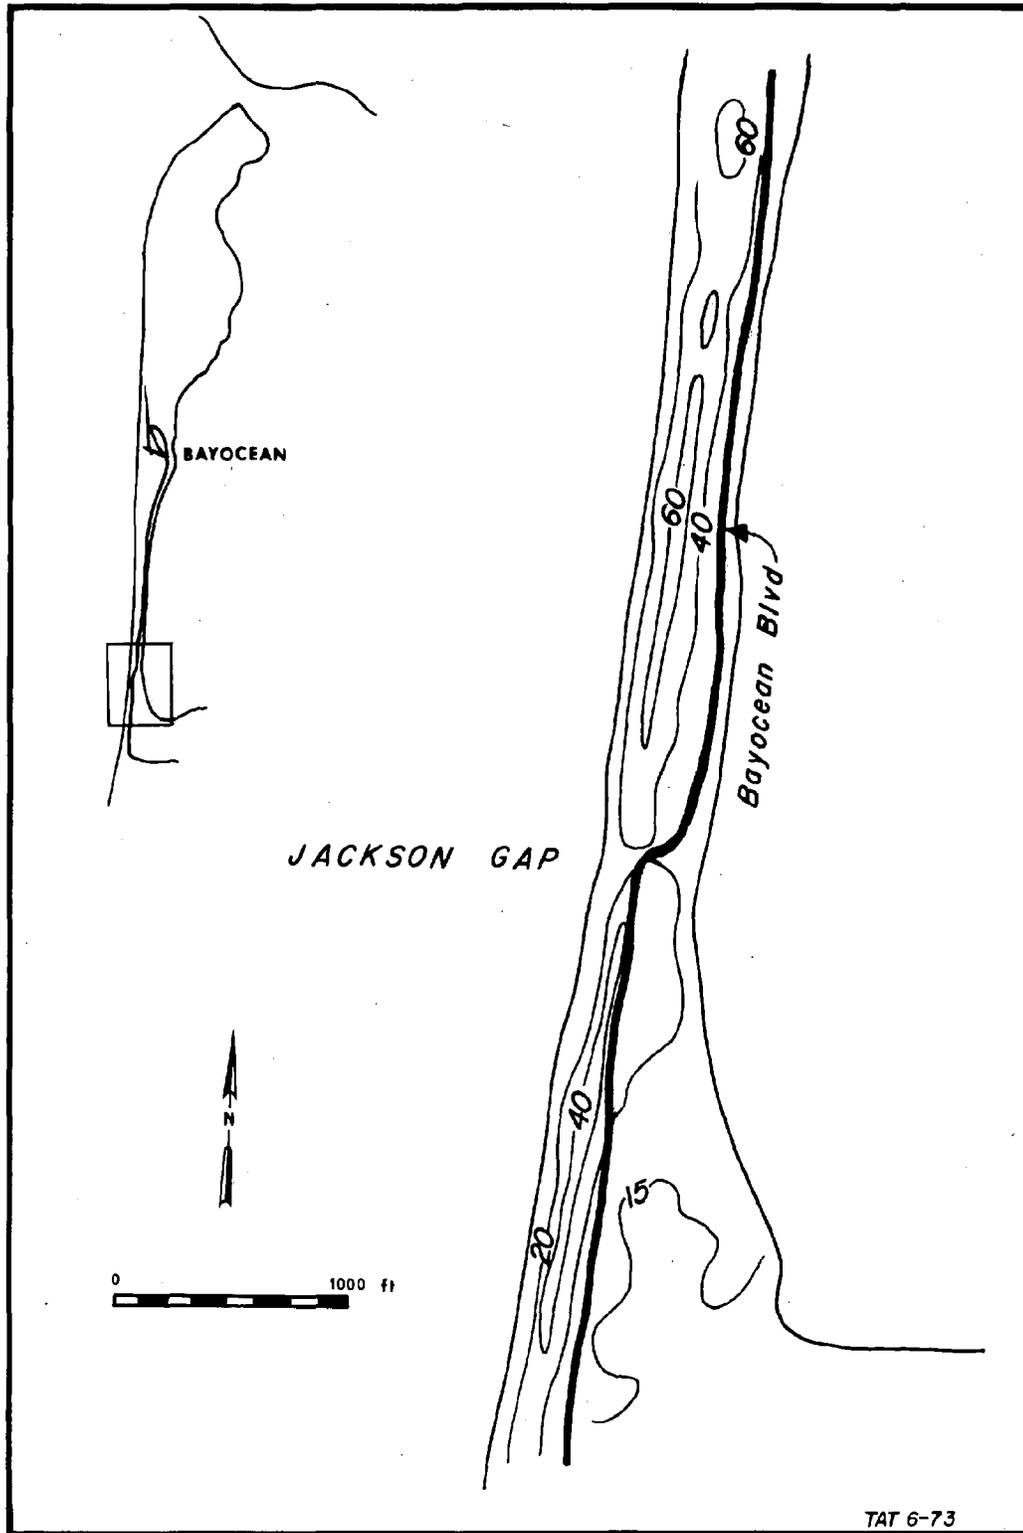
Figure 26. Bayocean Boulevard.

Bayocean Boulevard, the main access road to Bayocean Park, was cut along the narrow sand ridge (Figure 26). At Jackson Gap, the road descended and turned bayward within the gap. Beyond the gap, the road continued northward to the park. Use of the gap as a convenient turning point for the road may have increased its vulnerability to widening and deepening as the passage of vehicles would prevent vegetation growth and sand accumulation. The road should have avoided use of the gap. The road should have descended the ridge south of Jackson Gap and have been diked along its bayward margin. Sand stabilizing vegetation should have been planted within the gap to trap all beach-derived sand.

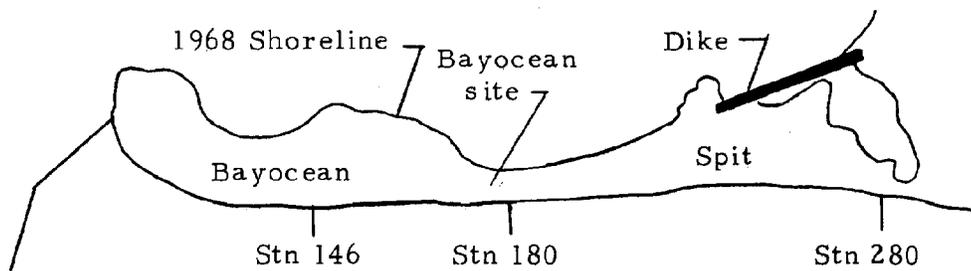
Figure 27. Bayocean beach cross-section changes 1939-1946. U.S. Army Corps of Engineers.

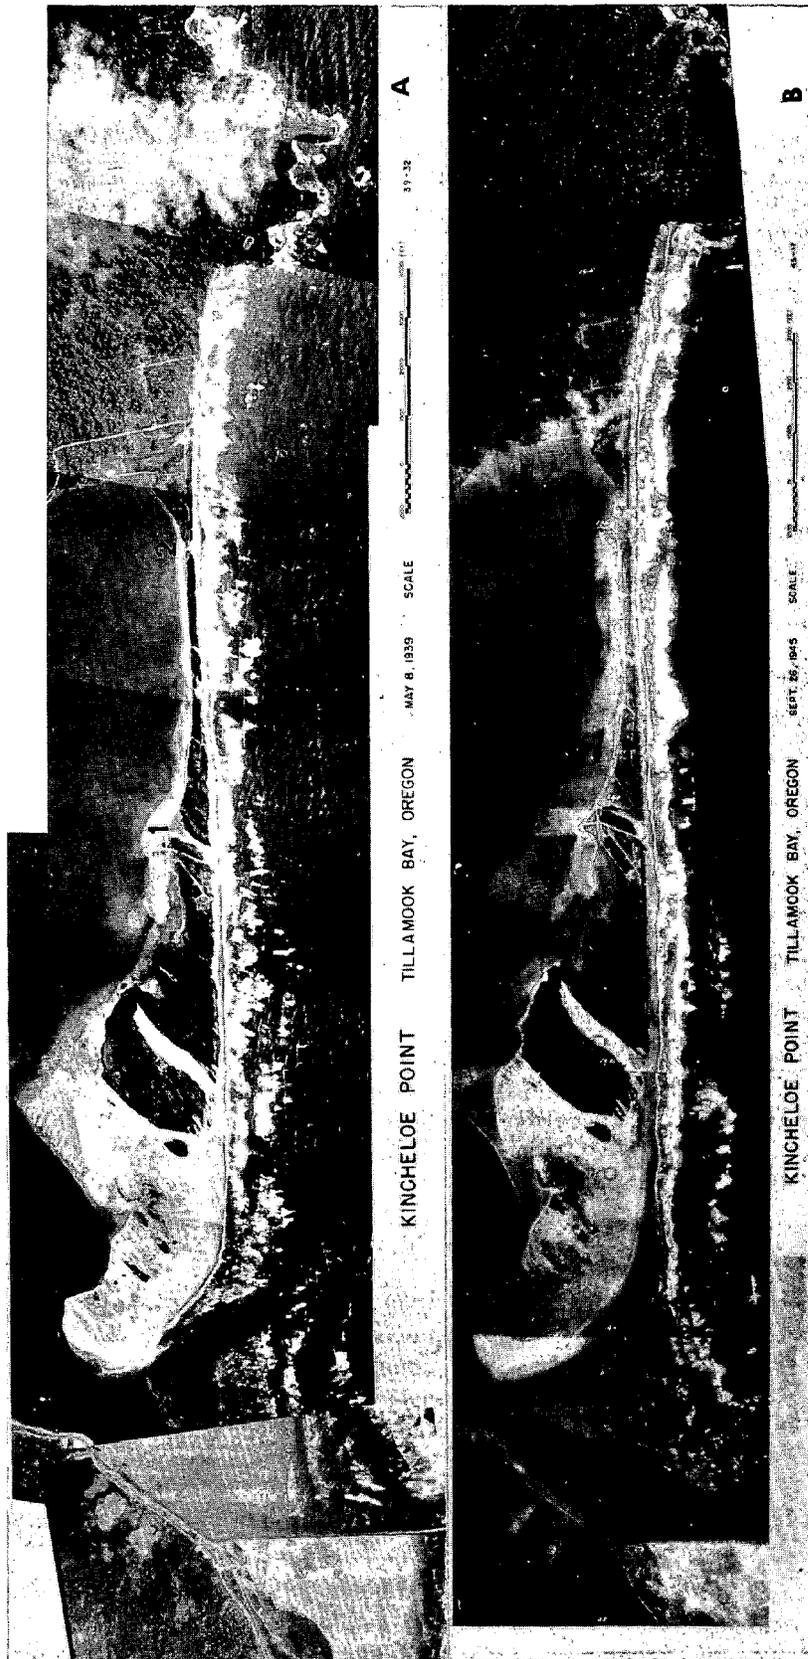
Figure 28 a, b. Aerial photos of Bayocean spit May 6, 1939 and September 26, 1945. U.S. Army Corps of Engineers.

Figure 28a (p. 71) is a mosaic of vertical aerial photographs of Bayocean spit taken May 8, 1939. The winter storms of 1939 had eroded much of the foredune of the spit and washed over the spit at Natatorium Gap (1) and Jackson Gap (2). The fear was that the narrow sand ridge would continue to erode and weaken while washovers widened and deepened the gaps, eventually breaching the spit. Figure 24 is a low oblique aerial view of the spit taken from a position inland of Cape Meares. The arrow points to lighter colored beach sands washed through the gaps and into the bay during former storms. The barren eroded seaward face of the foredune in 1939 is sharply
