**Development and Erosion
History of Bayocean Spit
Tillamook, Oregon**

Thomas A. Terich
and
Paul D. Komar

Reference 73-16
September 1973

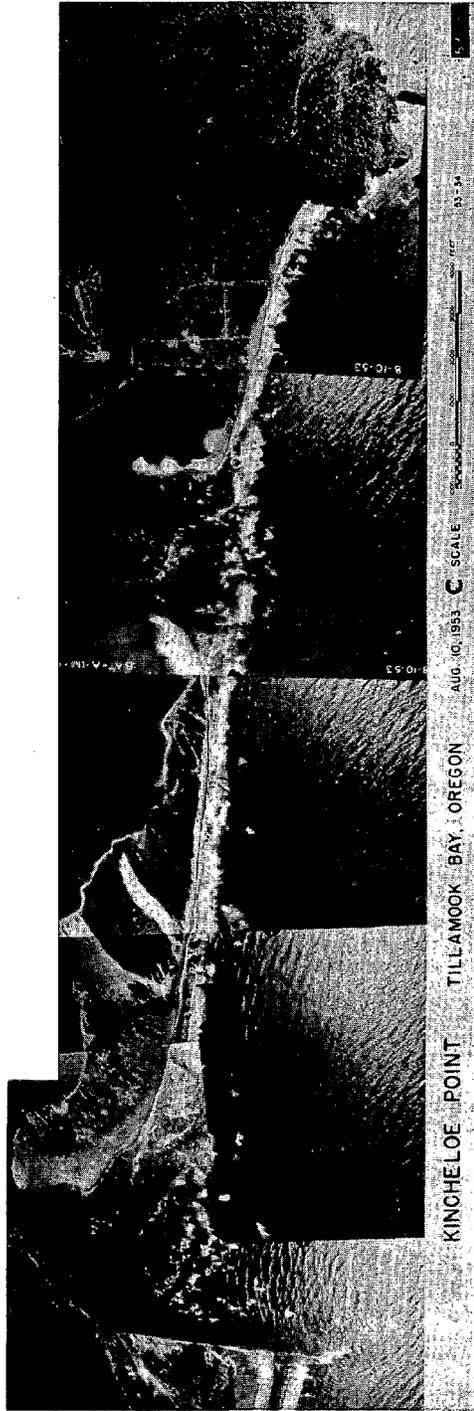
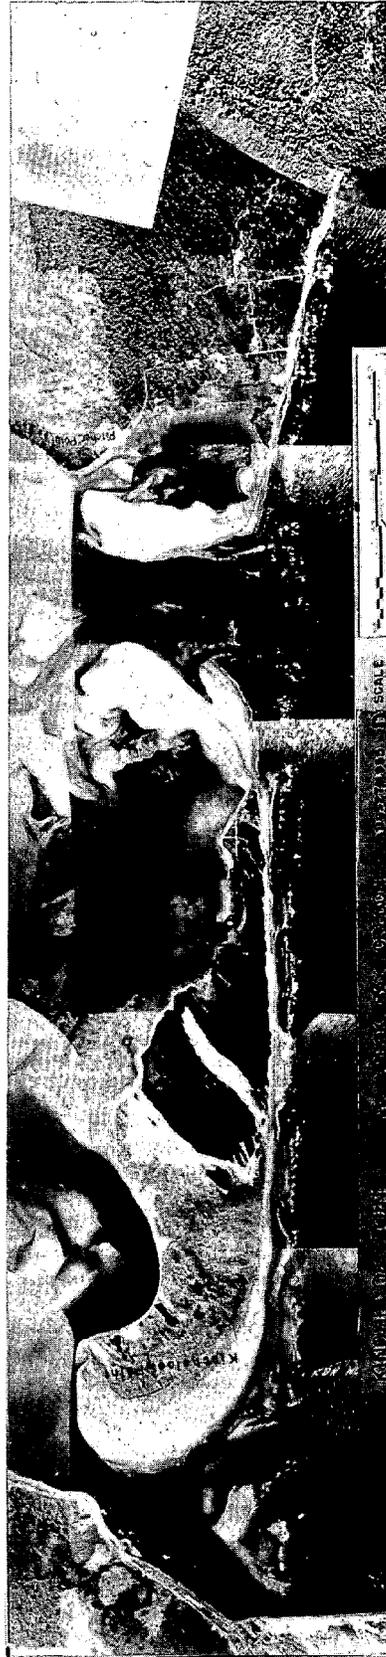
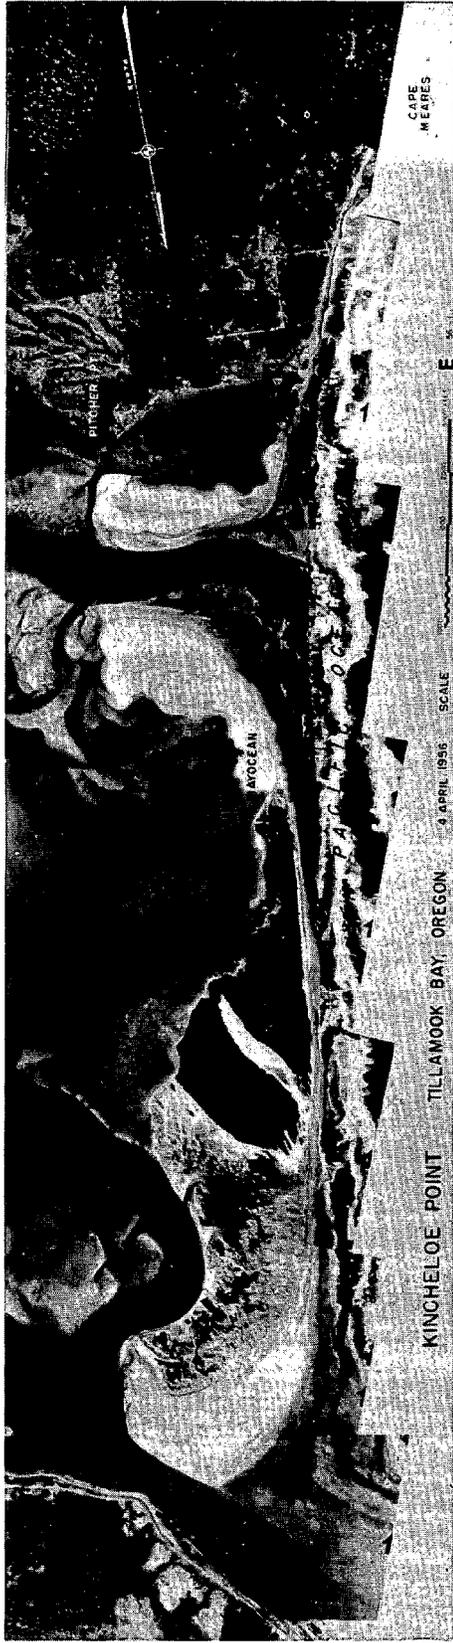
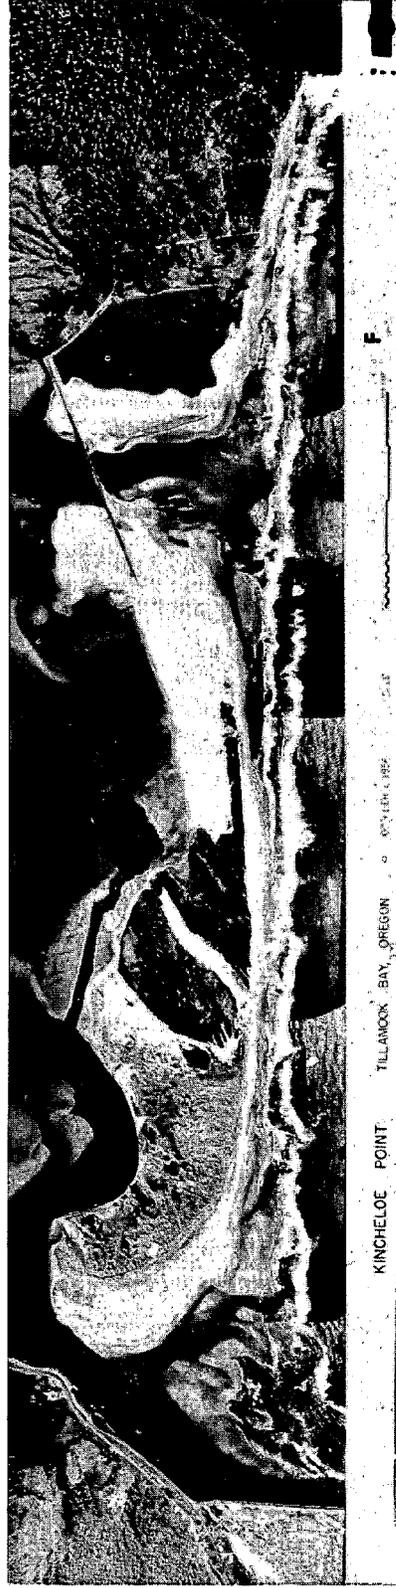
Figure 28 c, d. Aerial photos of Bayocean spit August 10, 1953 and August 27, 1955. U.S. Army Corps of Engineers.

Figure 28 e, f. Aerial photos of Bayocean spit April 4, 1956 and October 1, 1956. U. S. Army Corps of Engineers.

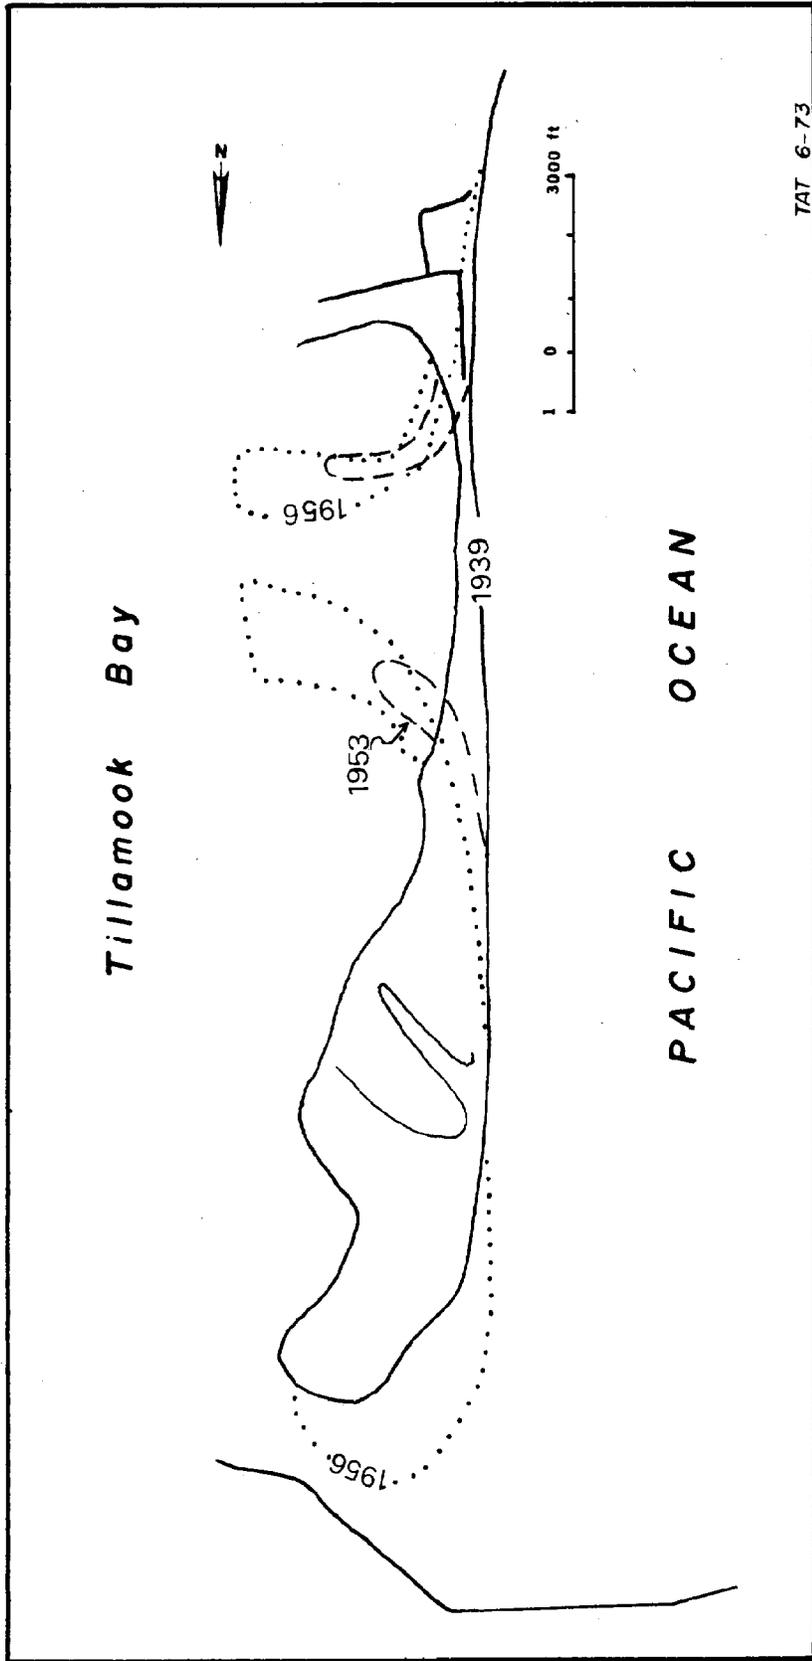
Figure 29. Major shoreline changes resulting from breaching of Bayocean spit.

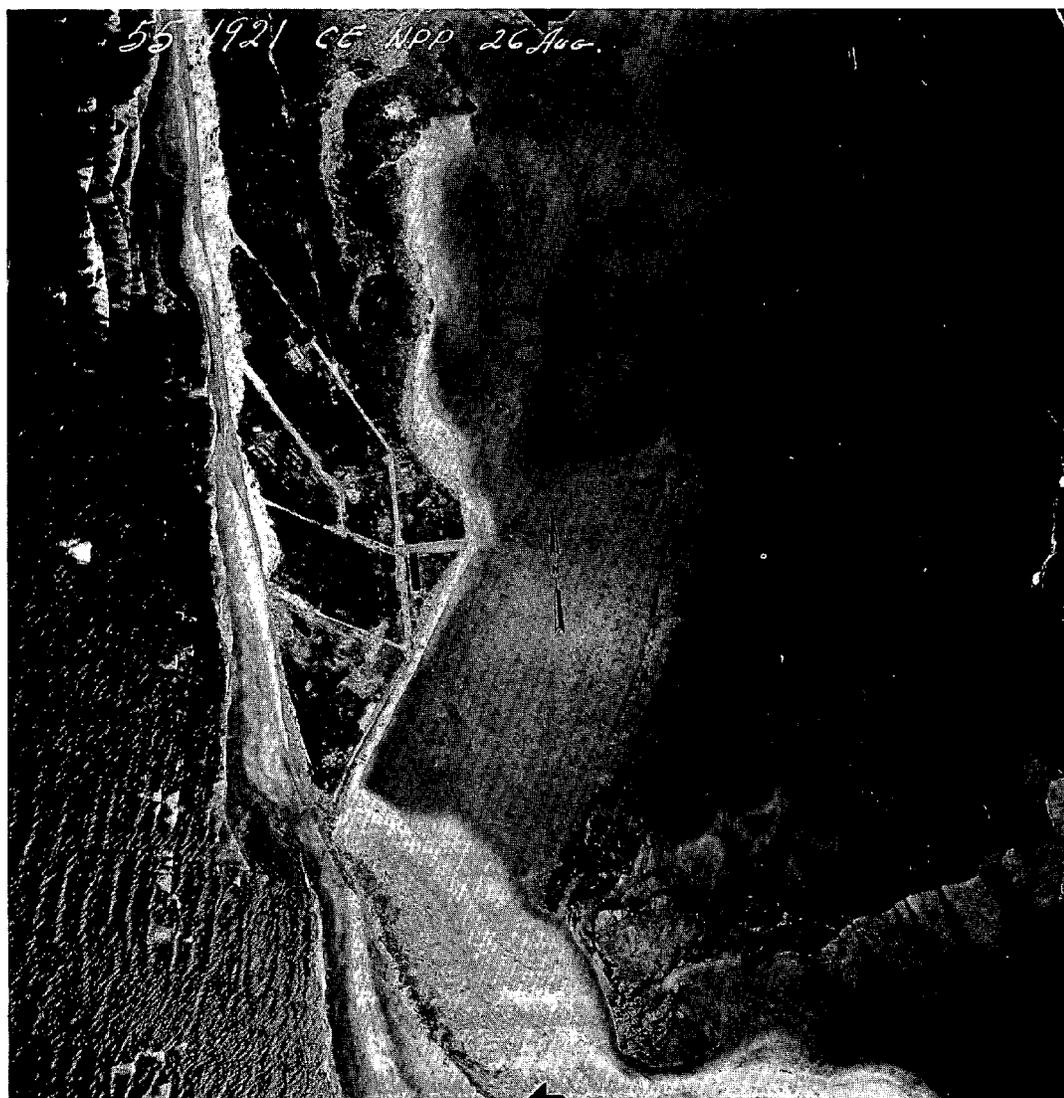
Figure 30. 1955 aerial photo of breach. U. S. Army Corps of Engineers.

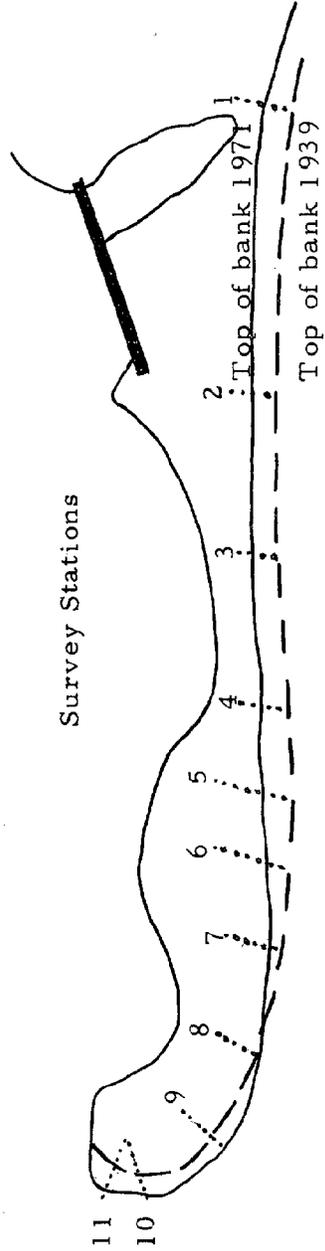
Figure 31. Shoreline retreat at the Village of Cape Meares.

Since the 1956 closure of the beach, erosion has continued along much of the seaward face of Bayocean spit. The U. S. Army Corps of Engineers has periodically surveyed the spit's shoreline changes. An abbreviated tabulation of their surveys is presented in Table 5. For cross reference purposes, station numbers 4 and 6 in Table 5 coincide with stations 146 and 190, respectively, for Table 4. Erosion has continued unabated save at station 2 where progradation of the shoreline occurred following the dike construction. Rapid rates of erosion are occurring north of the former breach site along a mile long stretch of the spit's mid-section. The continuing rapid rates of erosion at station 4 has raised some concern as it is the narrowest part of the spit, most subject to future breaching. The Corps of Engineers foresees the average rate of -15 feet per year declining as sand accretes south of the new south jetty, constructed from 1969-1971, slowing the erosion process (Figure 32). The shoreline retreat at the Village of Cape Meares south of Bayocean spit has been ascertained from Tillamook County Assessor maps (Figure 31). The 1953 shoreline was

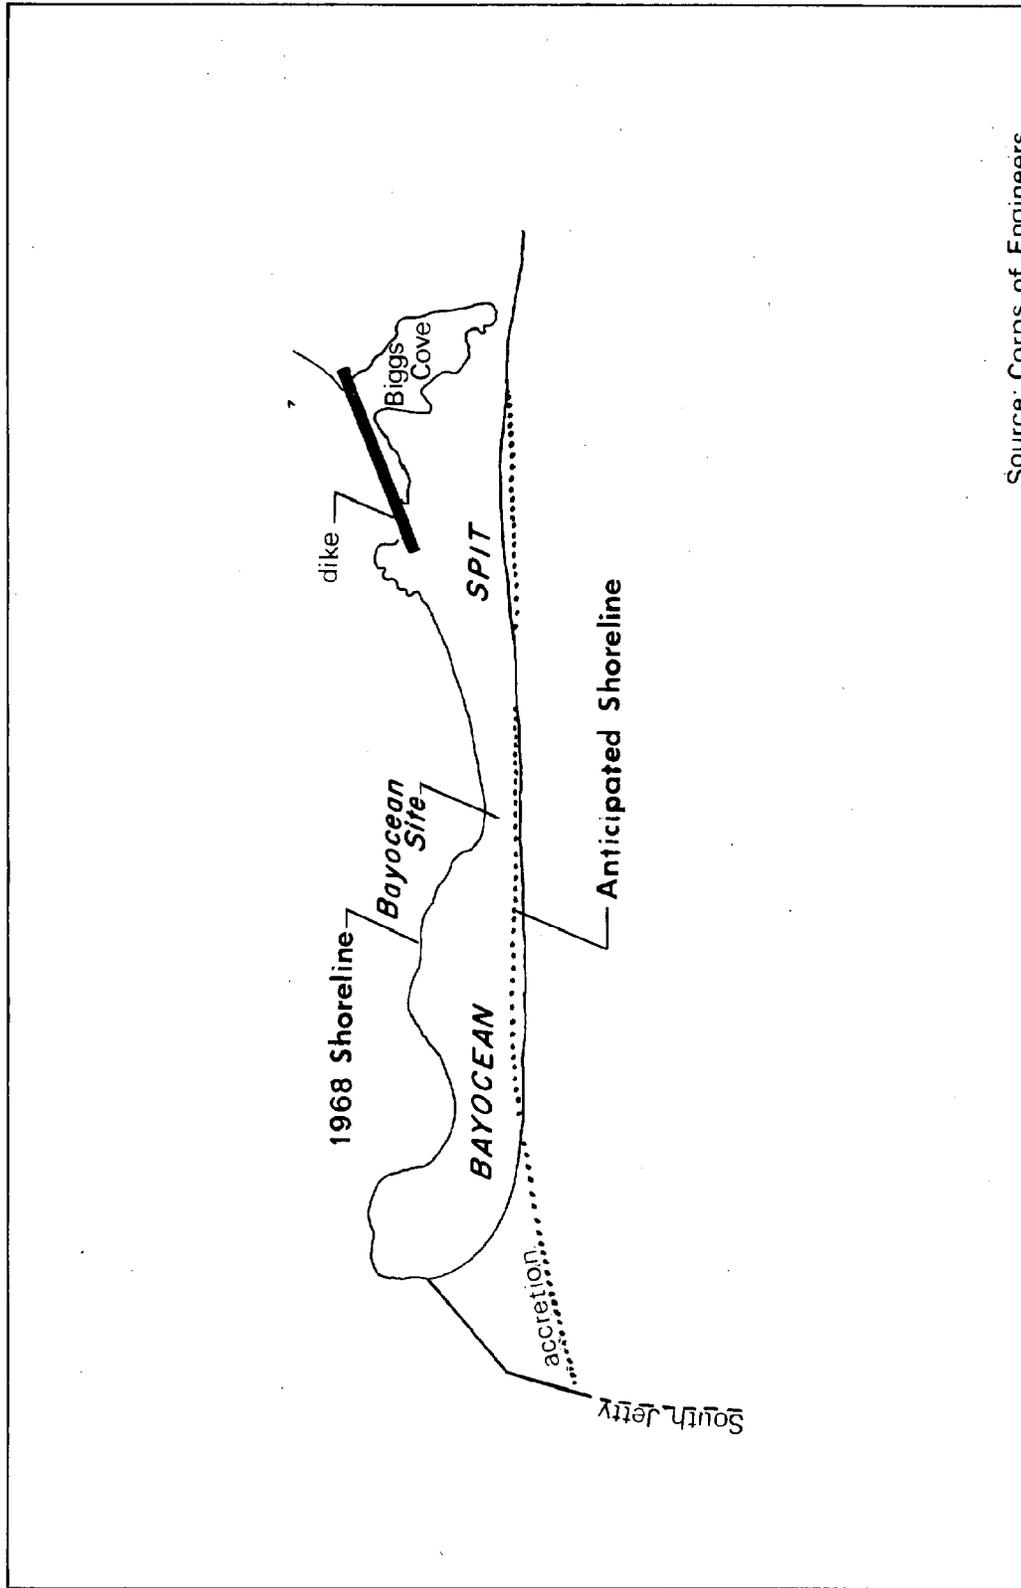
Figure 32. Anticipated shoreline change to Bayocean spit.

The Corps of Engineers maintains that the south jetty will create a beneficial straightening of the Bayocean shoreline as demonstrated in Figure 32 with continued erosion in some zones and deposition in others. As illustrated, the beach near survey stations 146 and 190, which lie approximately 7,500 feet and 11,500 feet, respectively, south of the south jetty, will likely continue to experience erosion as this zone supplies sand to the accreting beach immediately south of the south jetty.

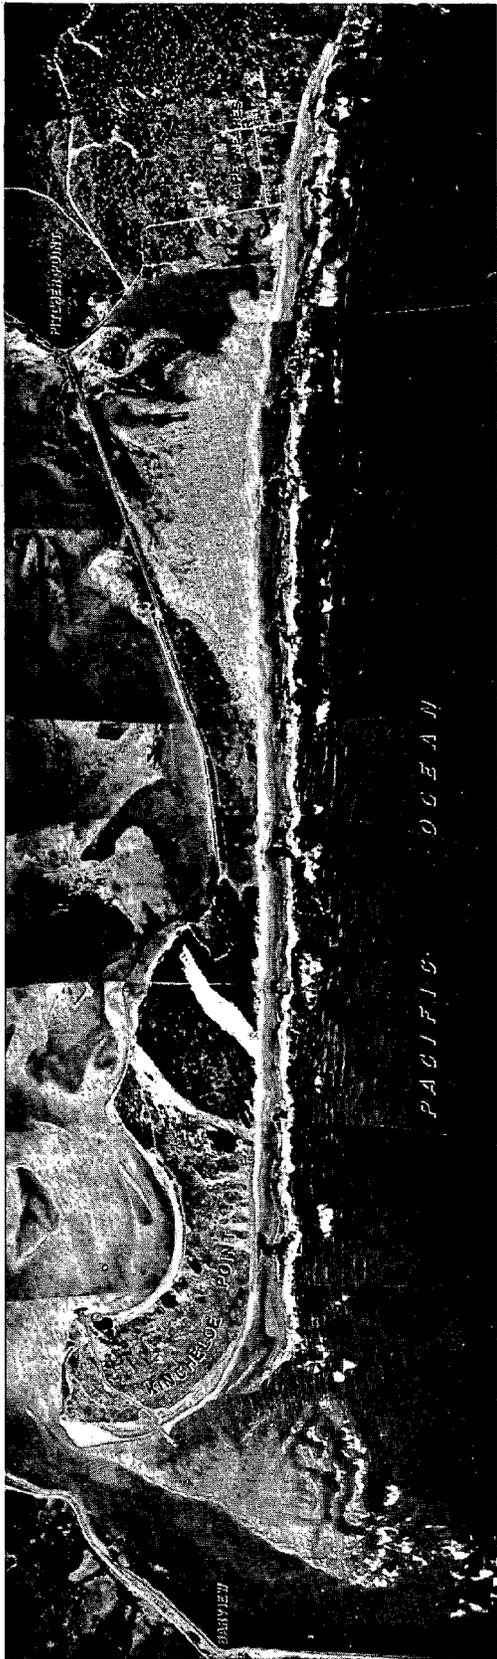
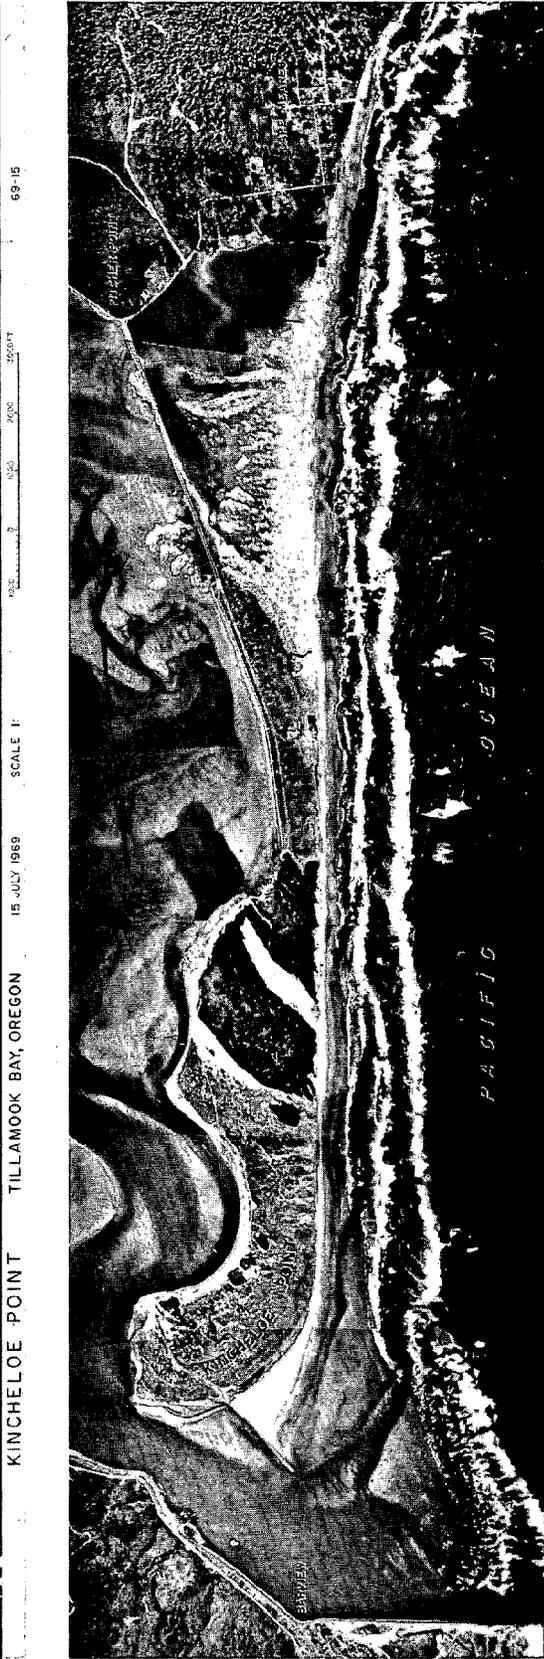
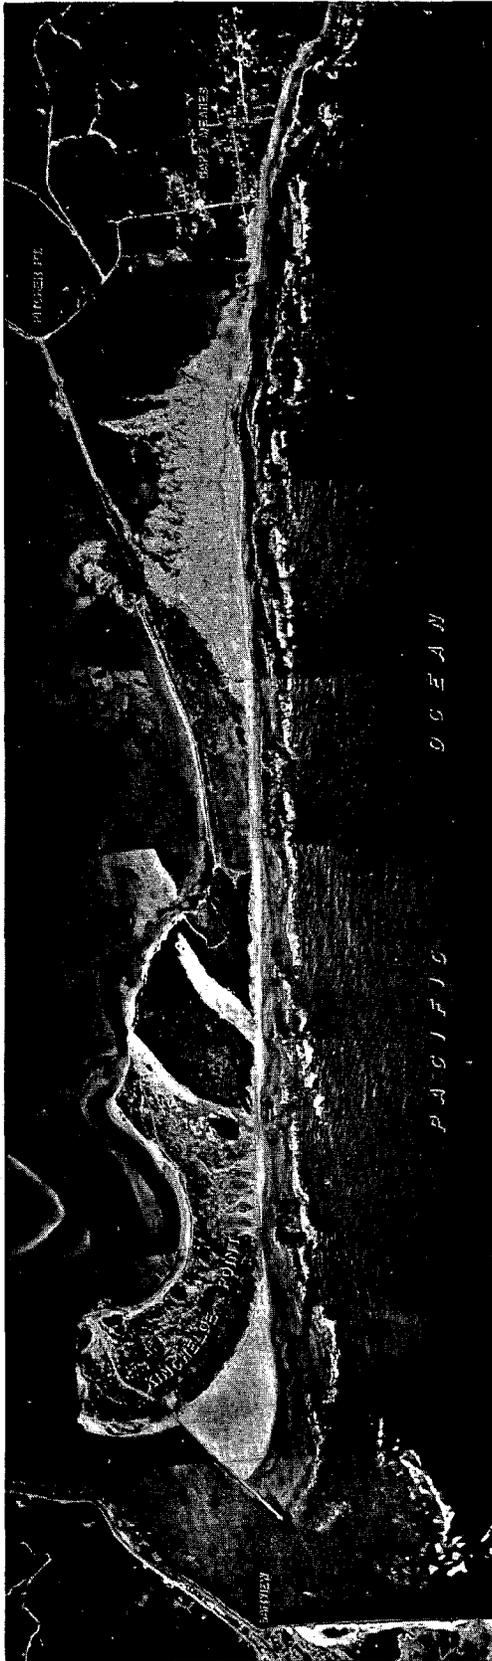
Figure 33a, b. Aerial photos of Bayocean spit July 15, 1969 and April 13, 1970. U. S. Army Corps of Engineers.

Figure 33c. Aerial photo of Bayocean spit June 30, 1971. U.S. Army Corps of Engineers.

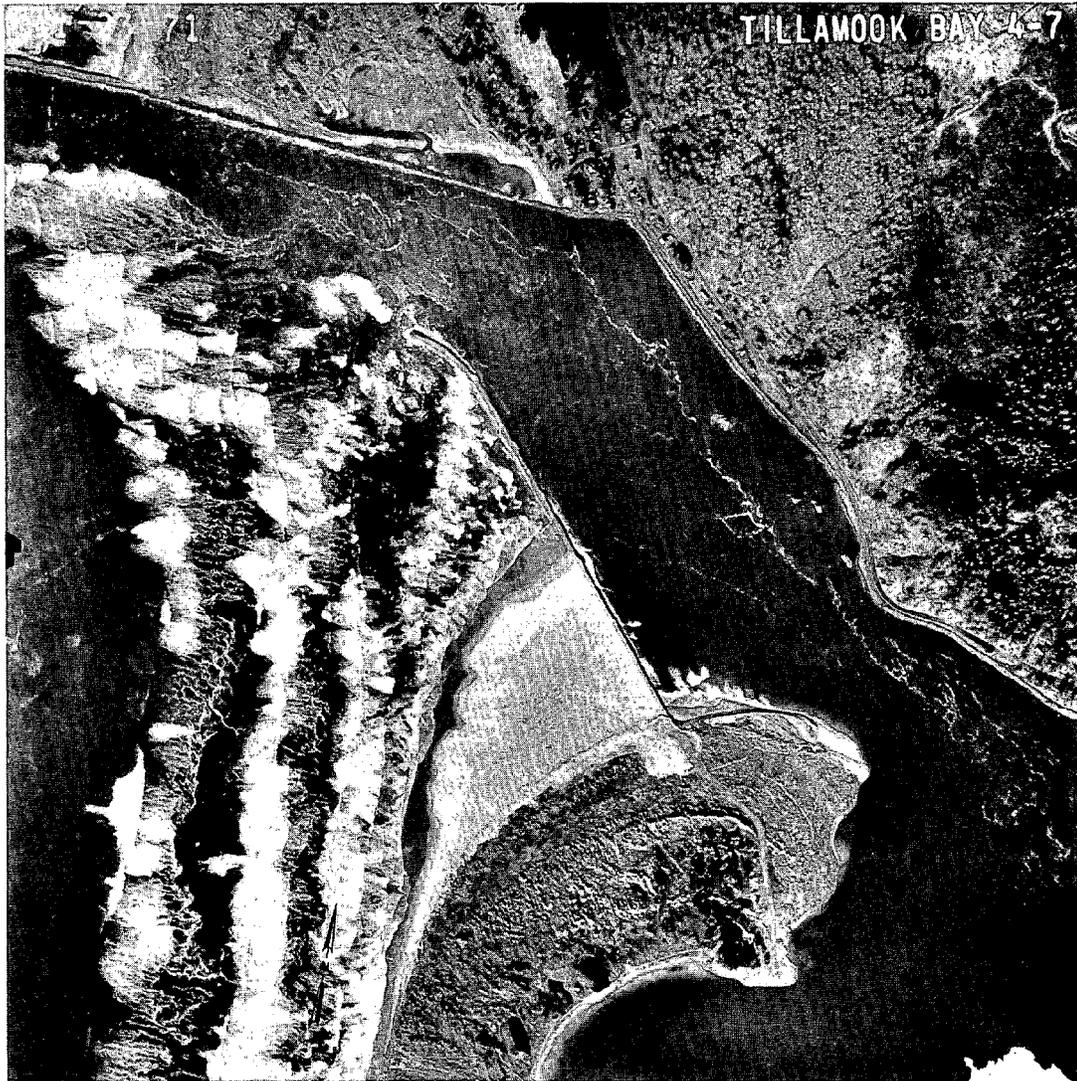
Figure 34a. Aerial photo of south jetty November 23, 1971.

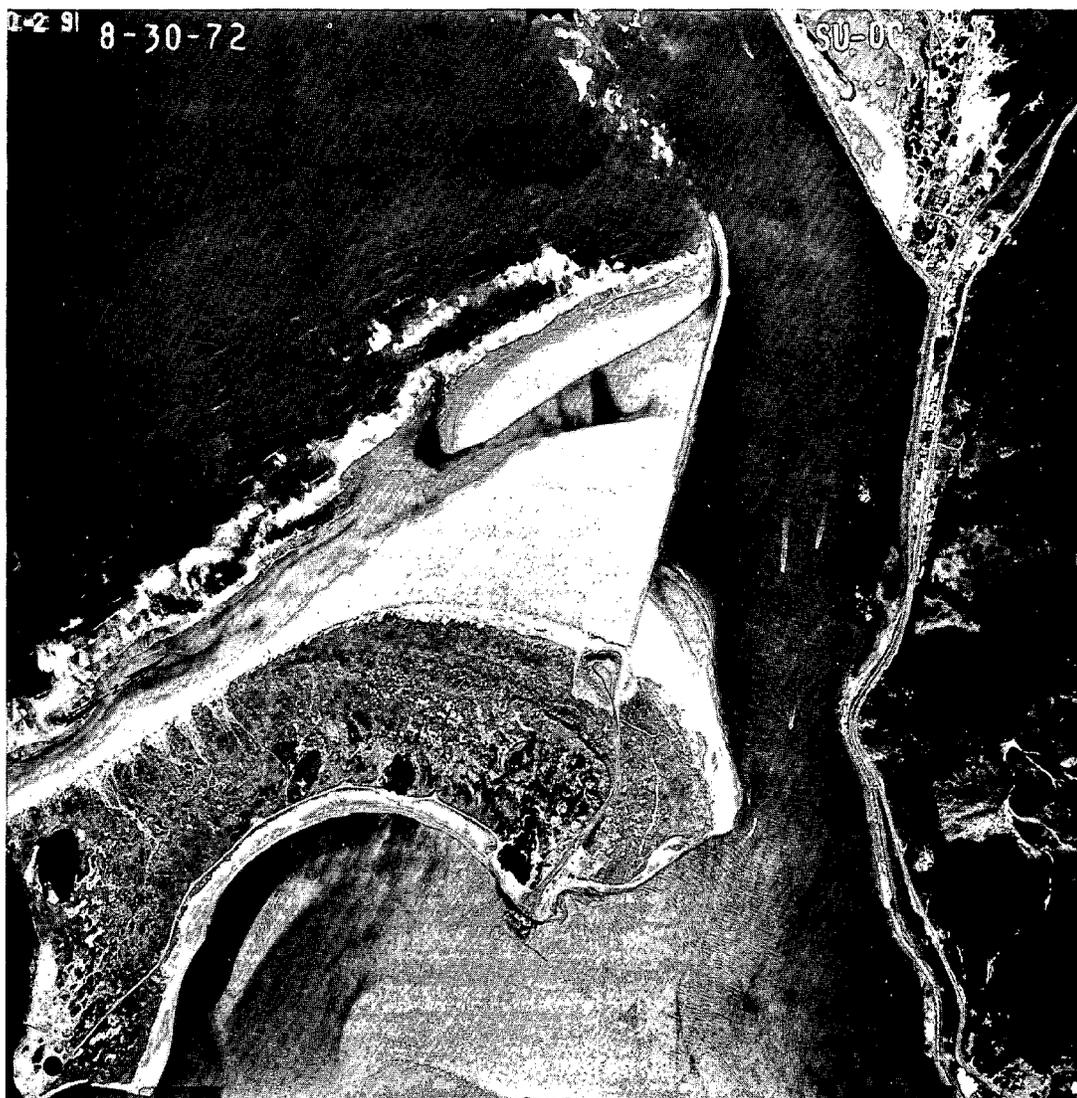
Figure 34b. Aerial photo of south jetty August 30, 1972.

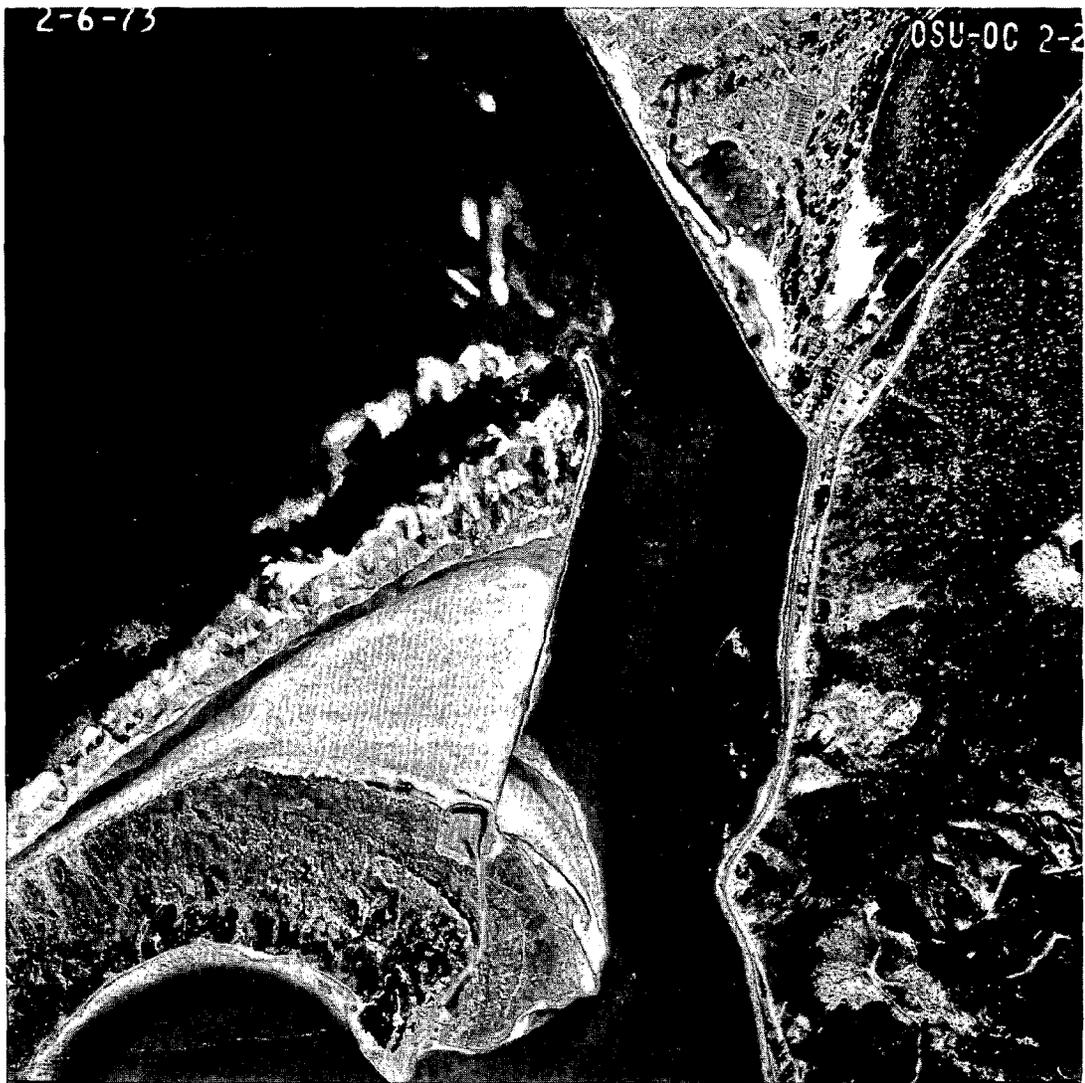
Figure 34c. Aerial photo of south jetty February 6, 1973.

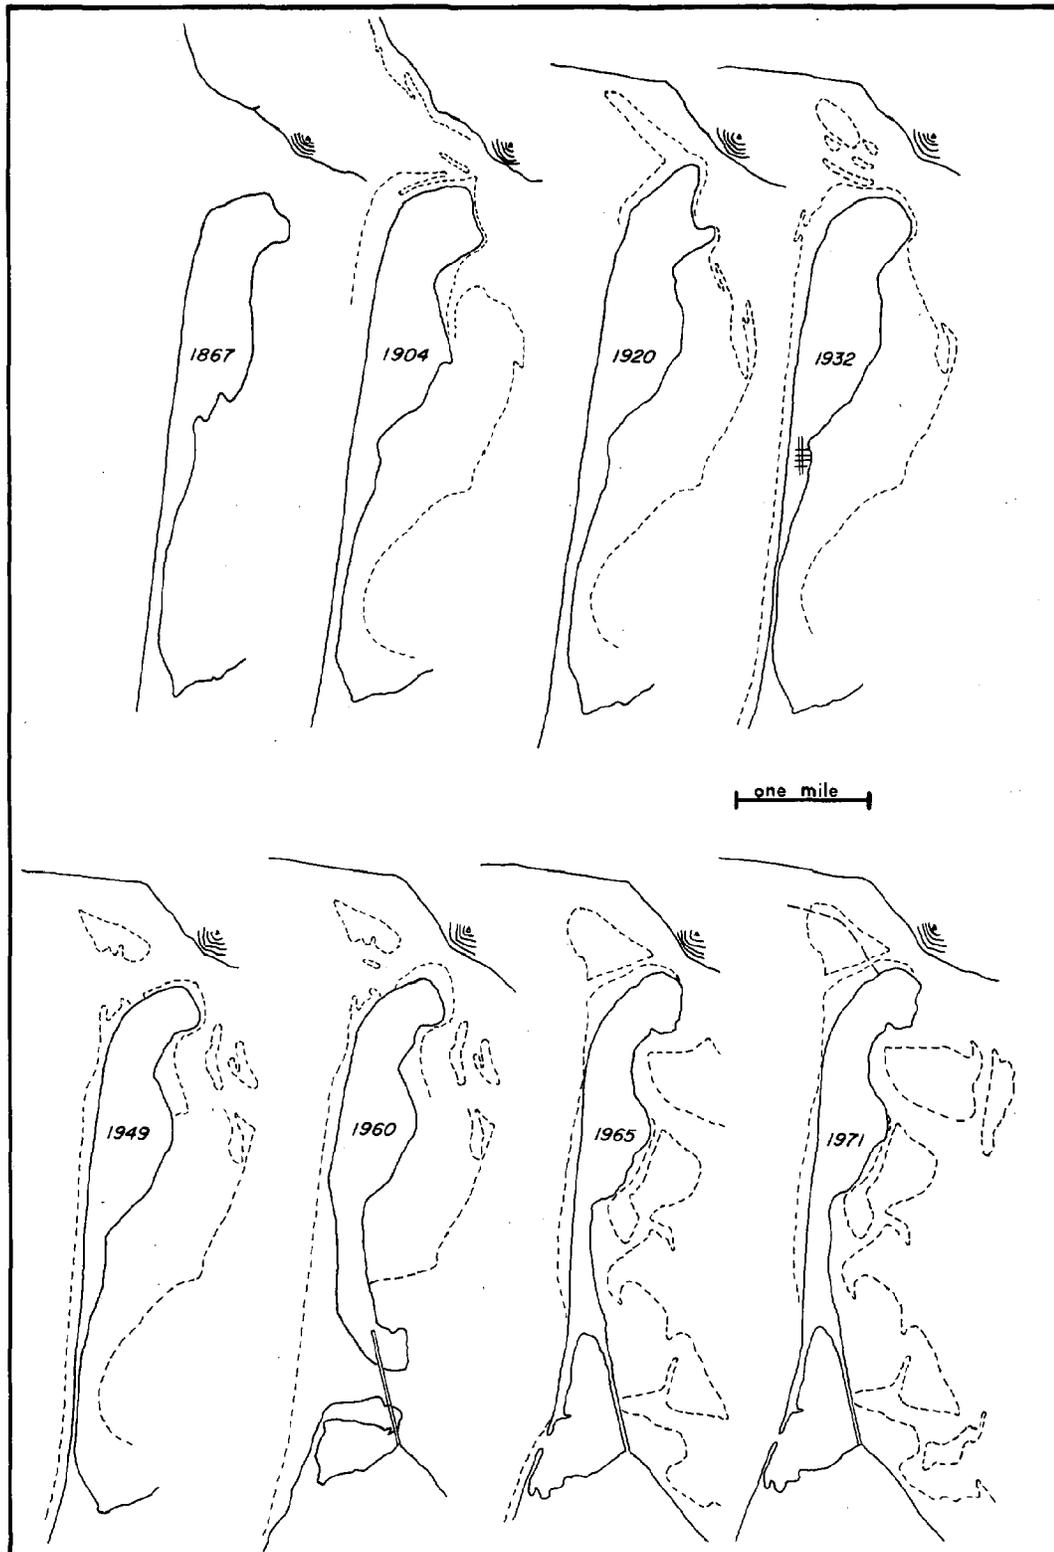
Figure 35. U. S. Coast and Geodetic Survey charts of Tillamook Bay 1904-1971.

Figure 35 represents mean lower low water shoreline configurations of Bayocean spit taken from United States Coast and Geodetic Survey charts for 1867, 1904, 1920, 1932, 1949, 1960, 1965, and 1971. Very little change occurred between 1867 and 1904; however, between 1920 and 1932 erosion is indicated by the narrowing of the southern sand ridge. The retreat of the shoreline along the southern

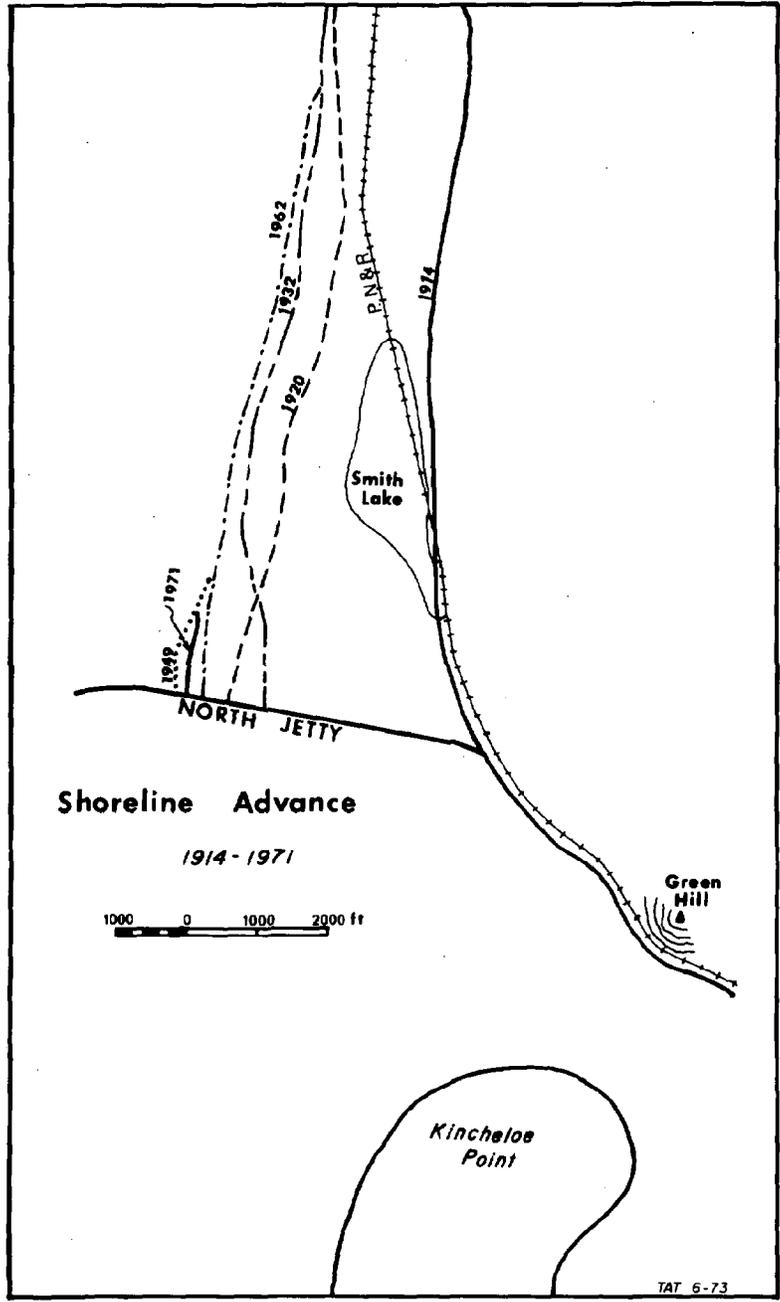
Figure 36. Shoreline advance north of north jetty.

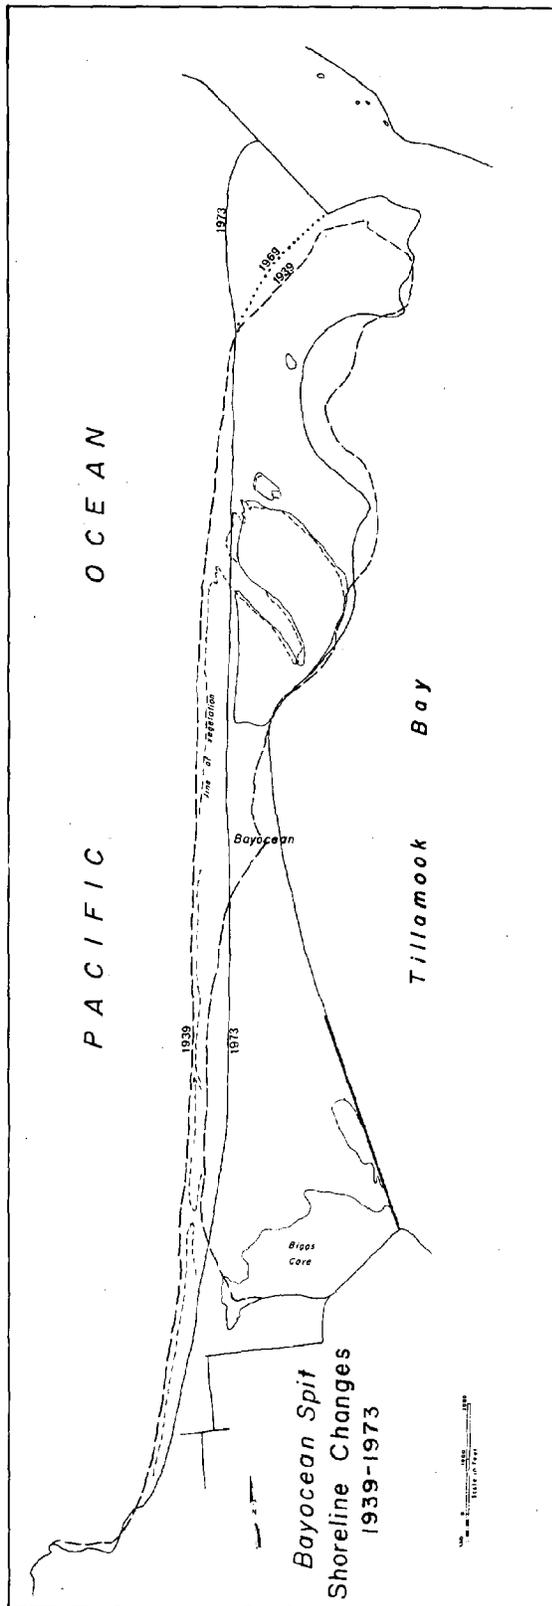
Figure 37. Bayocean spit shoreline changes 1939-1973.

Figure 37 represents shoreline changes to Bayocean spit as taken from 1939 and 1973 aerial photographs. Most of the seaward face of the spit has retreated several hundred feet since 1939. The most severe recession has occurred where the former narrow sand ridge connected Bayocean to Cape Meares. The breach destroyed nearly a

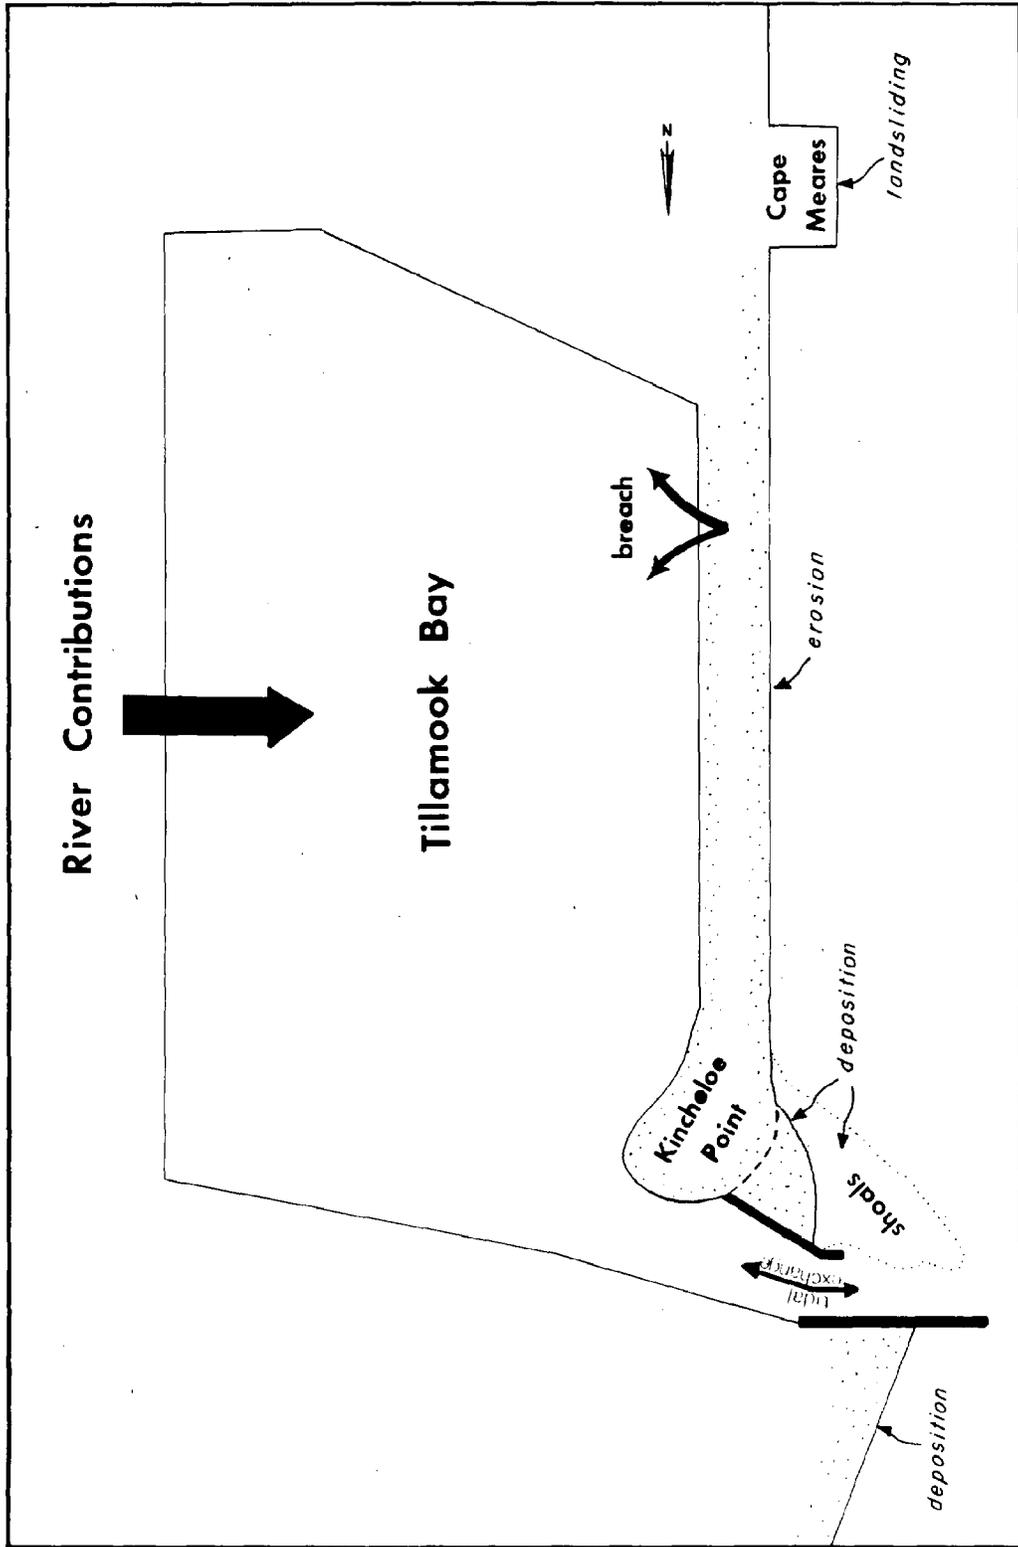
Figure 38. Sediment sources and losses to bayocean spit.

Figure 38 illustrates the major potential sediment sources and losses to Bayocean spit. Potential sediment sources include: landslide and headland erosion, and fluvial discharge. Major sediment losses are erosion to Bayocean spit, deposition in Tillamook Bay, and trapping by jetties. The identified sediment sources and losses to Bayocean spit will be discussed in order of the above presentation.

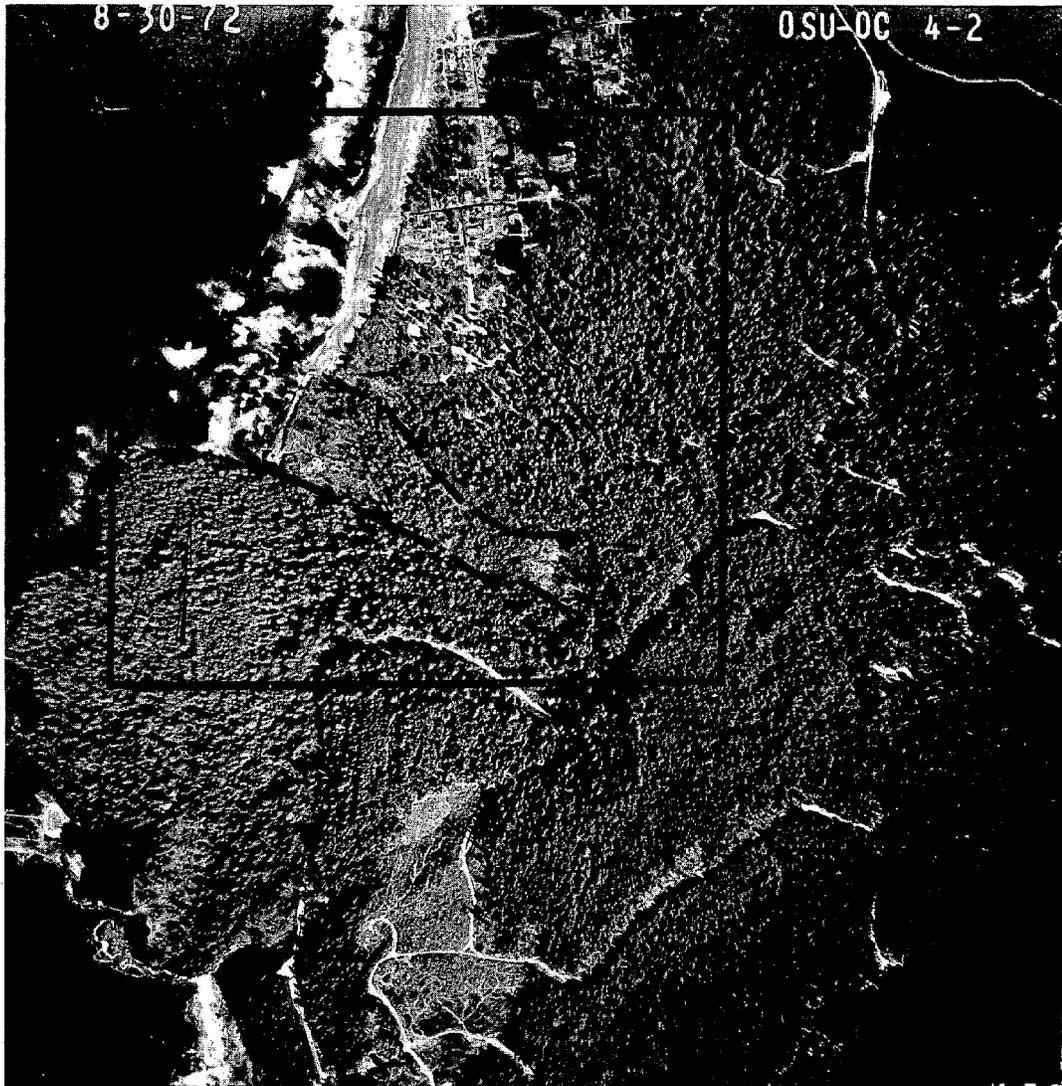
Figure 39. 1972 aerial view of landslide north of Cape Maeres.
U. S. Army Corps of Engineers.

Figure 39 outlines a large landslide on the north side of Cape Meares. Aerial photos for 1939 and 1955 showed no advance of the

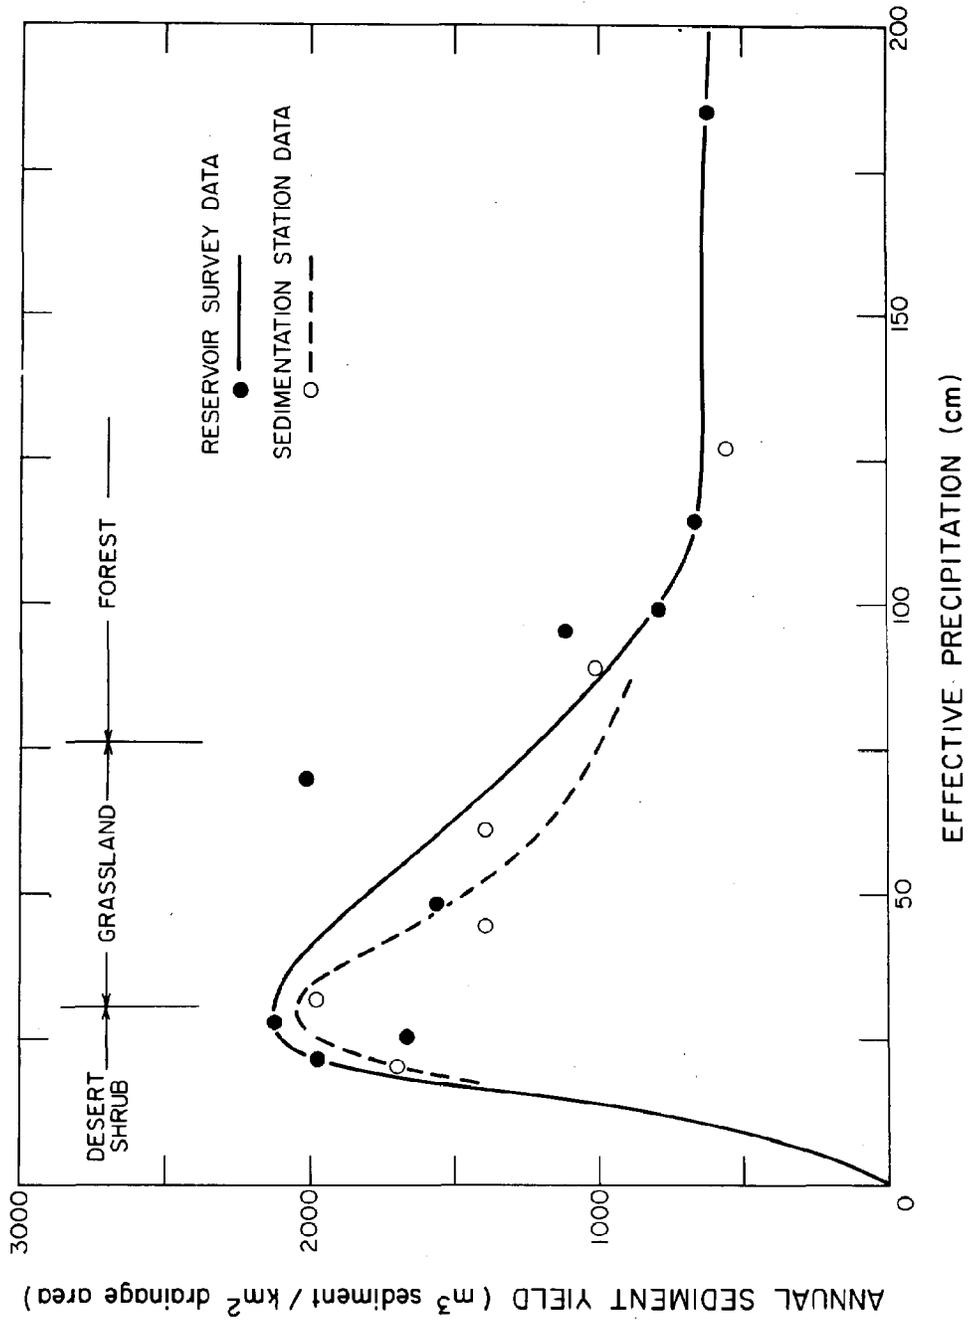
Figure 40. Climatic variation of sediment yield. After Langbein and Schumm, 1958.

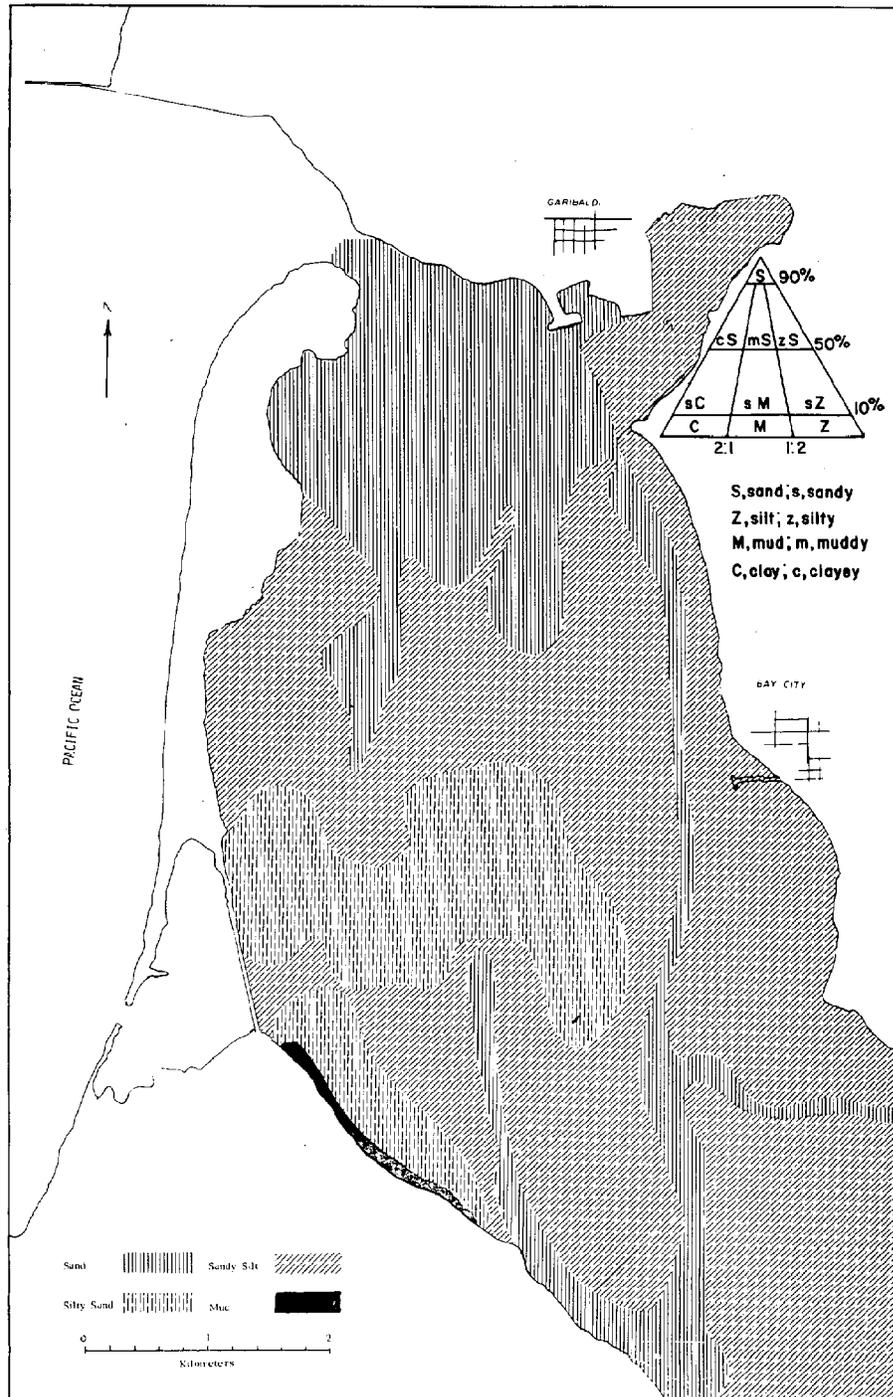
Figure 41. Distribution of sediment type in Tillamook Bay. Avolio, 1973.
