**Development and Erosion
History of Bayocean Spit
Tillamook, Oregon**

Thomas A. Terich
and
Paul D. Komar

Reference 73-16
September 1973

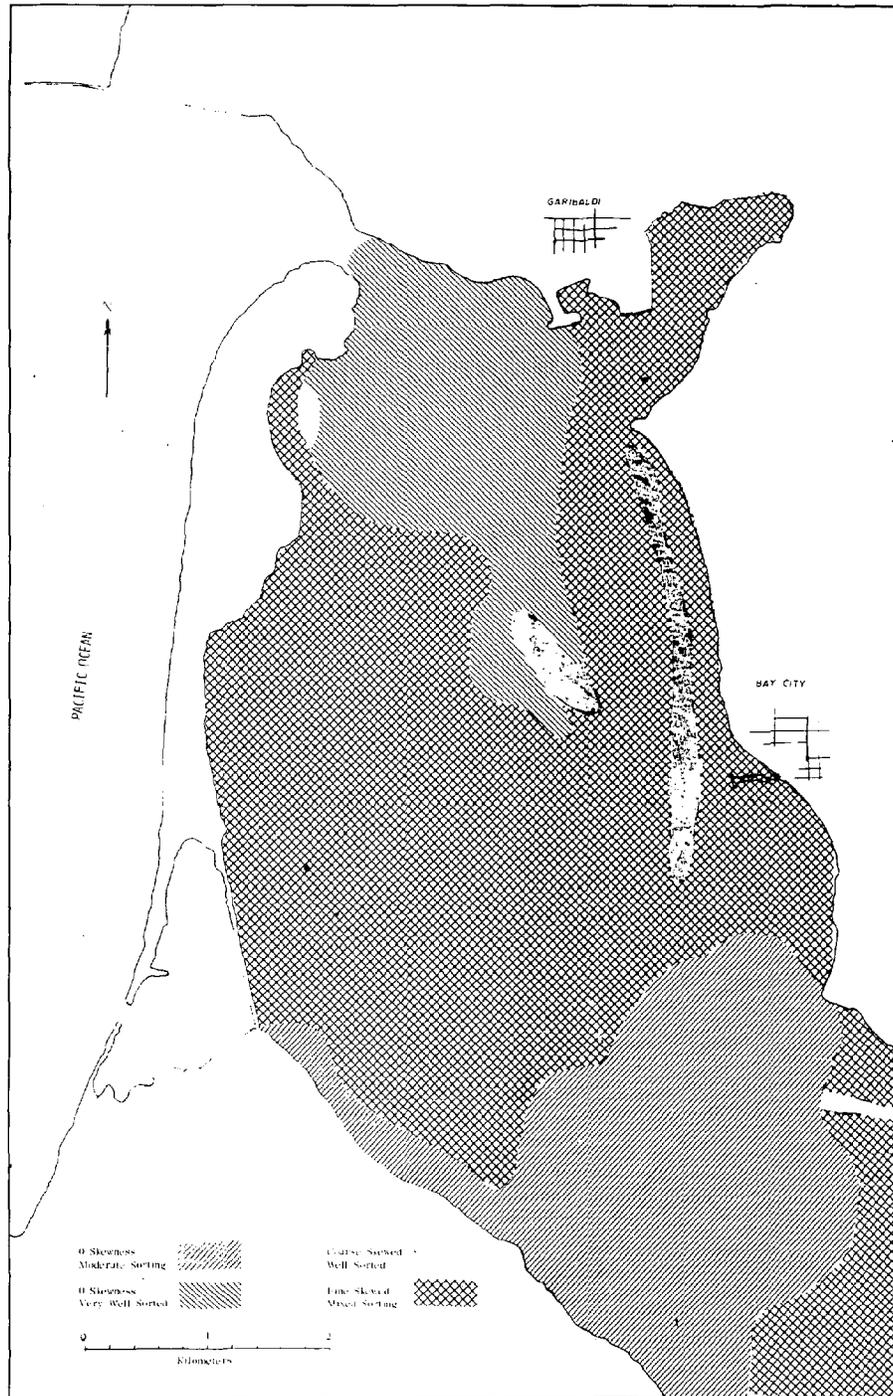
Figure 42. Distribution of skewness and sorting of sediments in Tillamook Bay. Avolio, 1973.

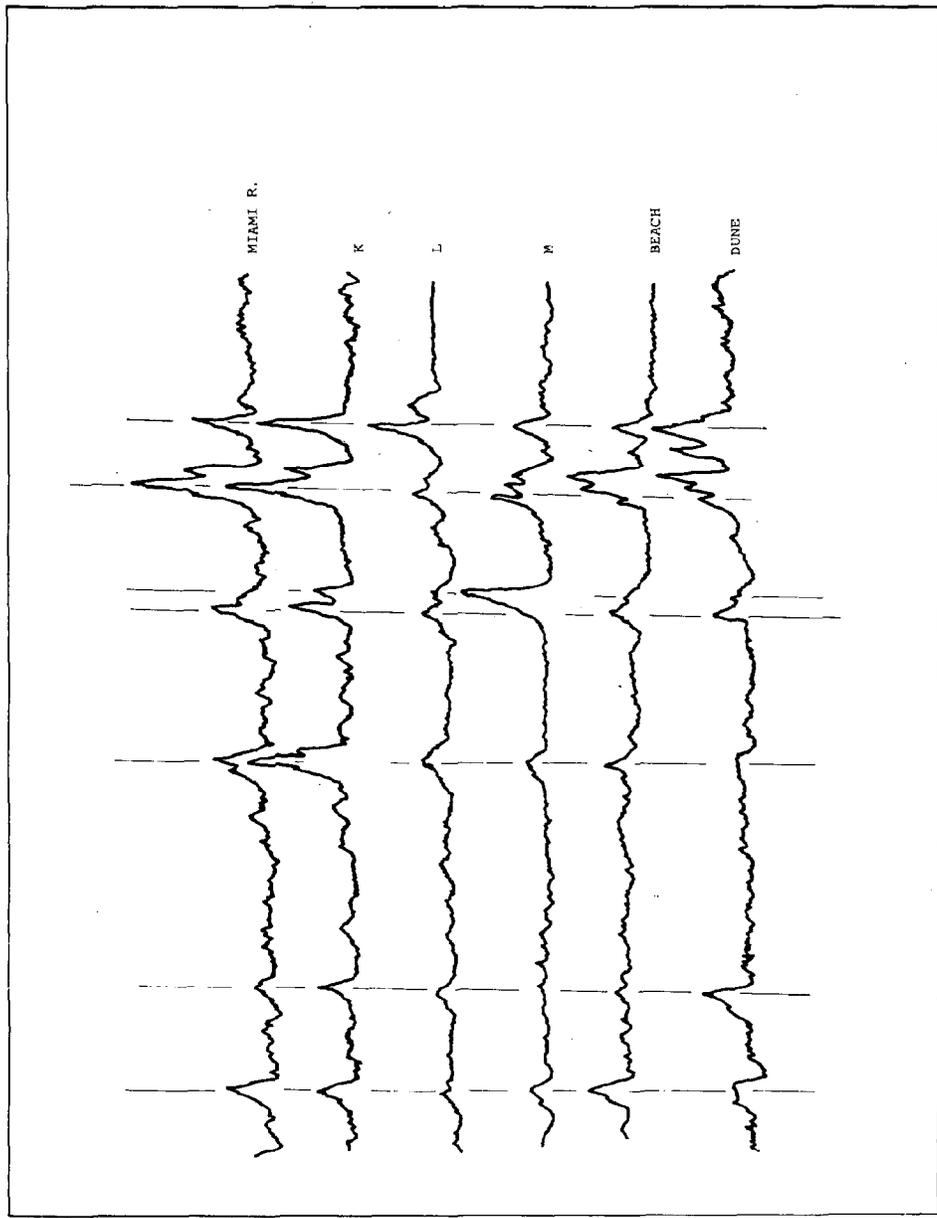
Figure 43. X ray diffraction "fingerprints" of heavy mineral samples from the northern part of Tillamook Bay. The easternmost locations are at the top and westernmost at the bottom. Avolio, 1973.

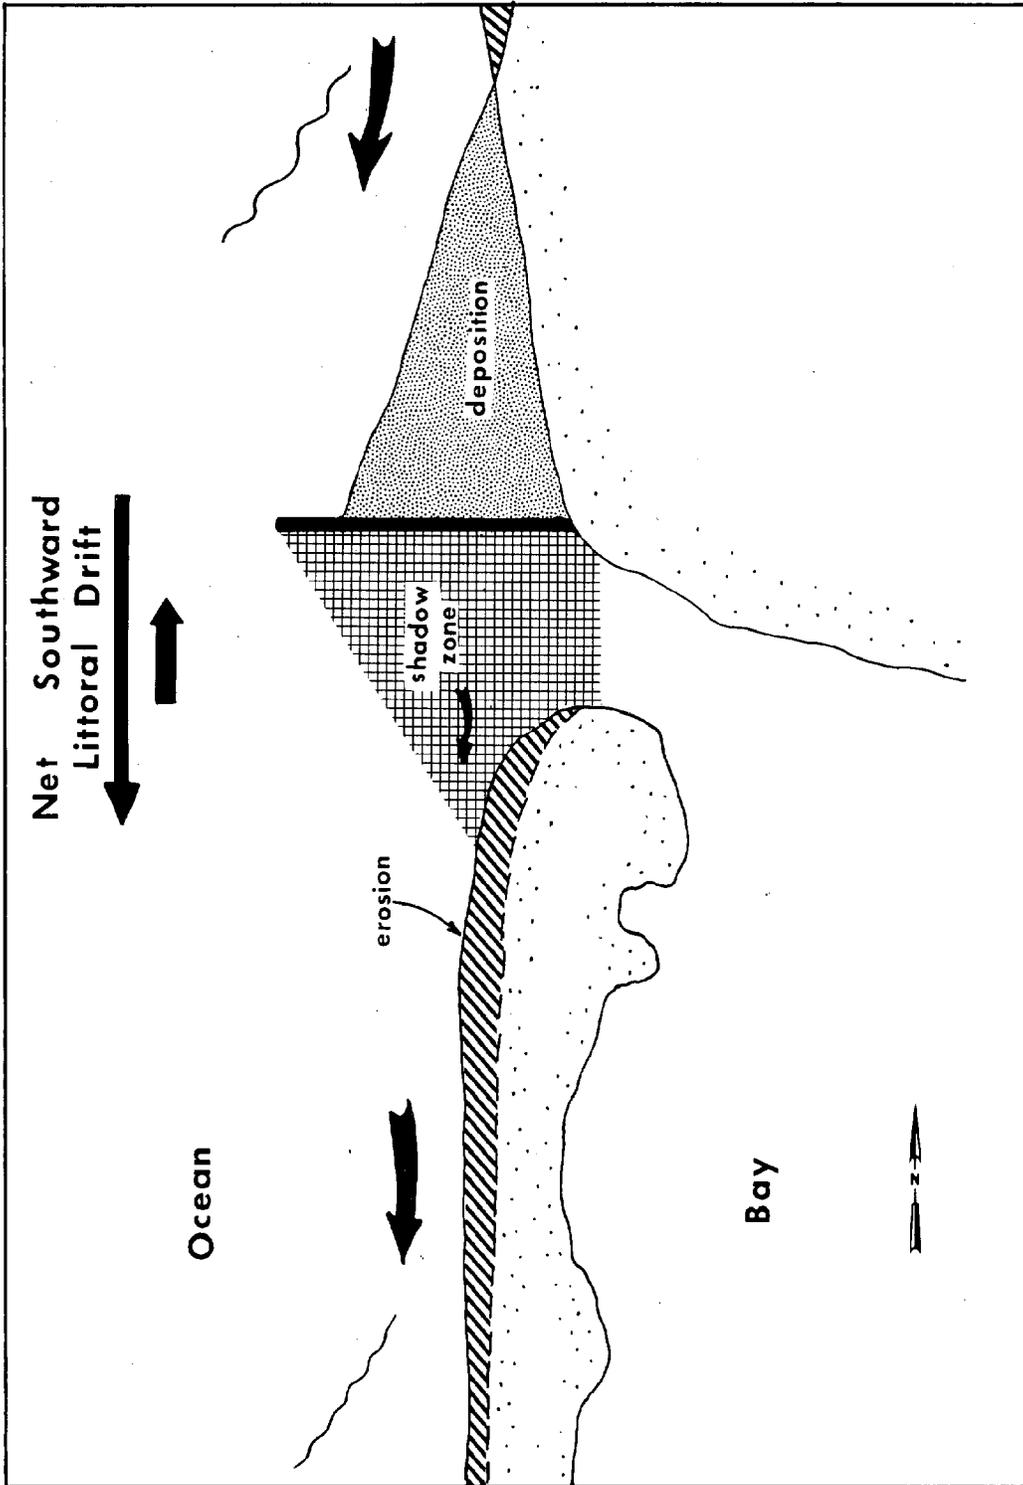
Figure 44. Schematic diagram of shoreline configuration of Bayocean spit resulting from net south longshore transport.

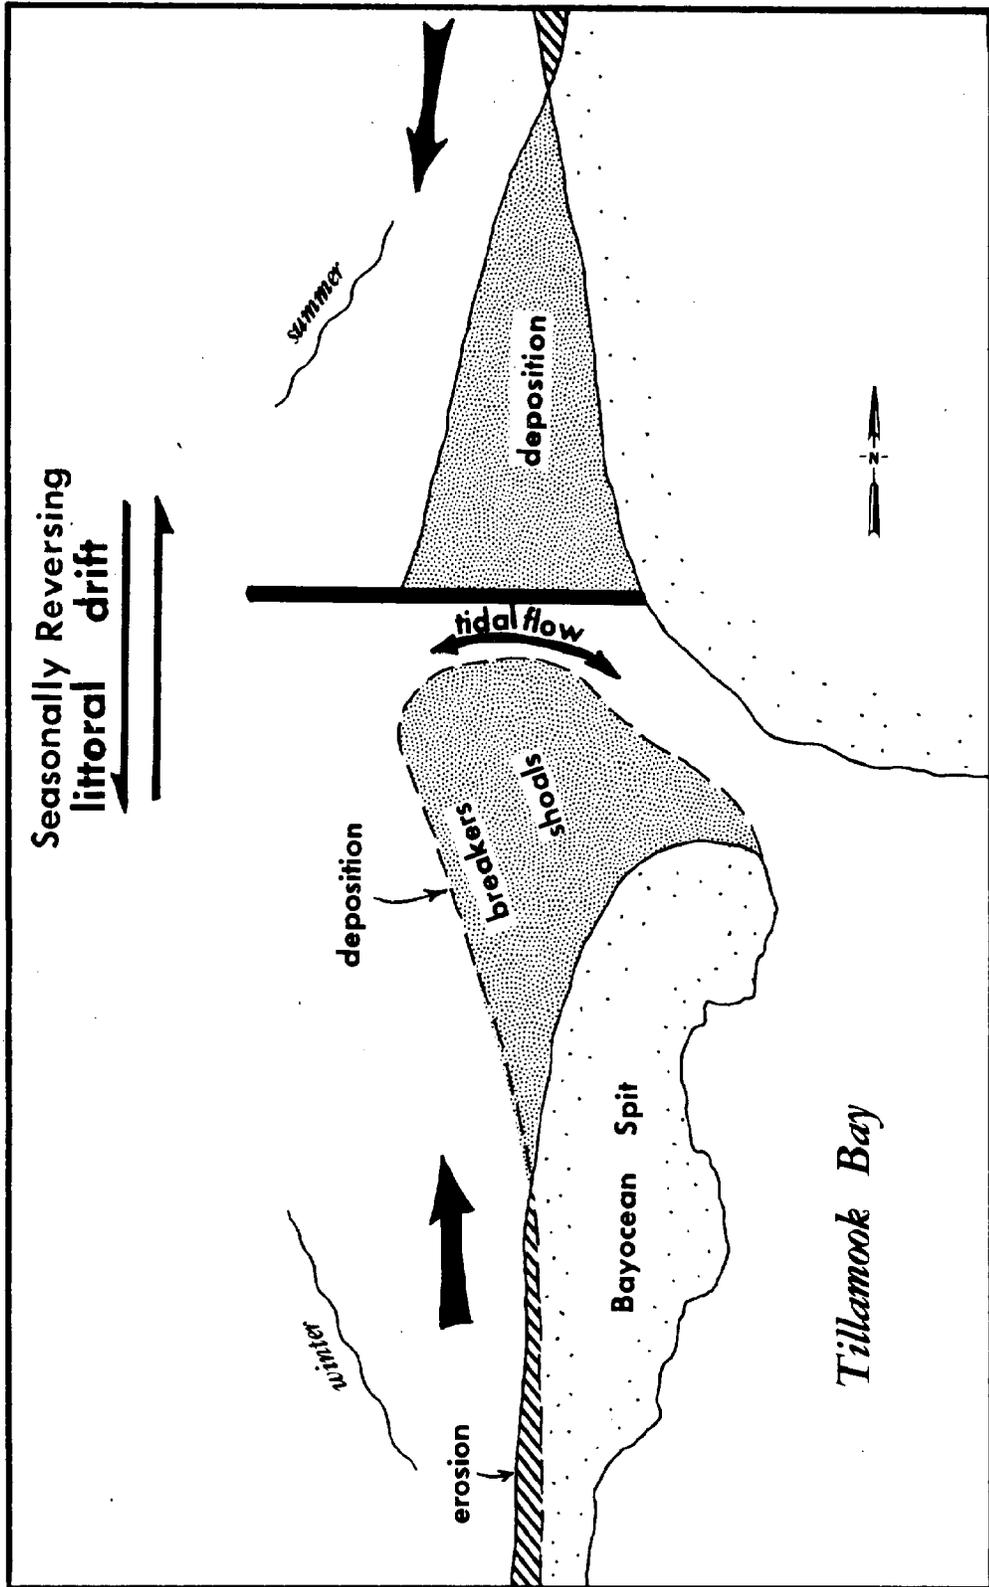
Figure 45. Schematic diagram of shoreline configuration resulting from near-zero net longshore transport.

Erosional and depositional shoreline patterns revealed in Figures 25 and 45 support the presence of a seasonally reversing longshore sand transport as opposed to a predominant north to south transport identified by the U. S. Army Corps of Engineers (1970). As discussed in Chapter I, National Marine Consultants (1961) and Neal et al. (1969) evidence is presented that the south longshore transport predominates during spring and summer, reversing to a north transport during autumn and winter. Figure 45 suggests that the north jetty has trapped and forced the deposition of the seasonally reversing transported sand. The result has been sand deposition, beach progradation, and shoaling, both north and south of the north jetty. Figure 36 illustrates the shoreline progradation north of the north jetty; similarly, Figure 35 shows the growth of the channel shoals south of the jetty since 1920. Figure 46 shows depth and width cross-sections for Tillamook Channel before and after construction of the

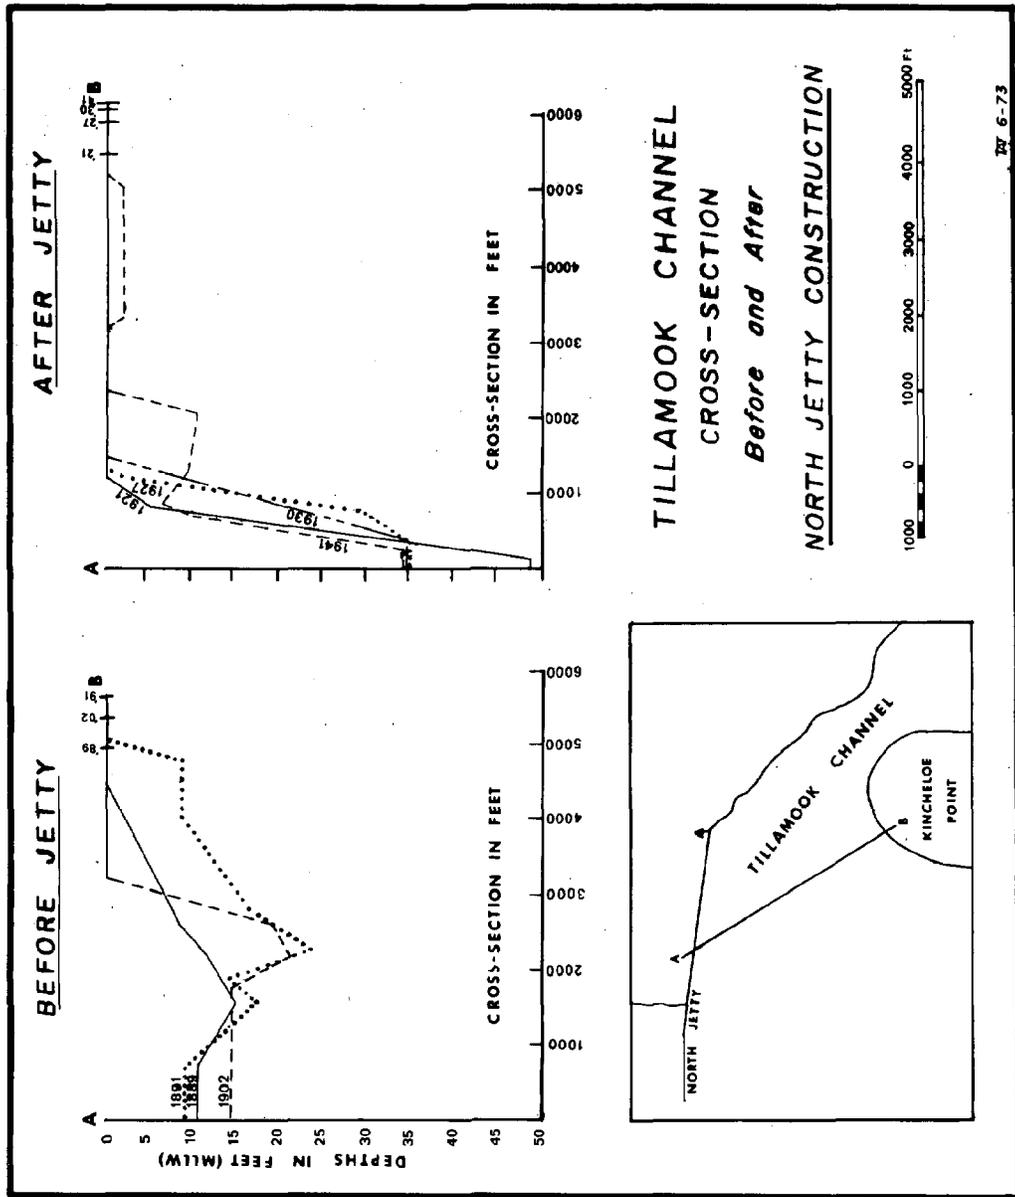
Figure 46. Tillamook channel cross-sections.

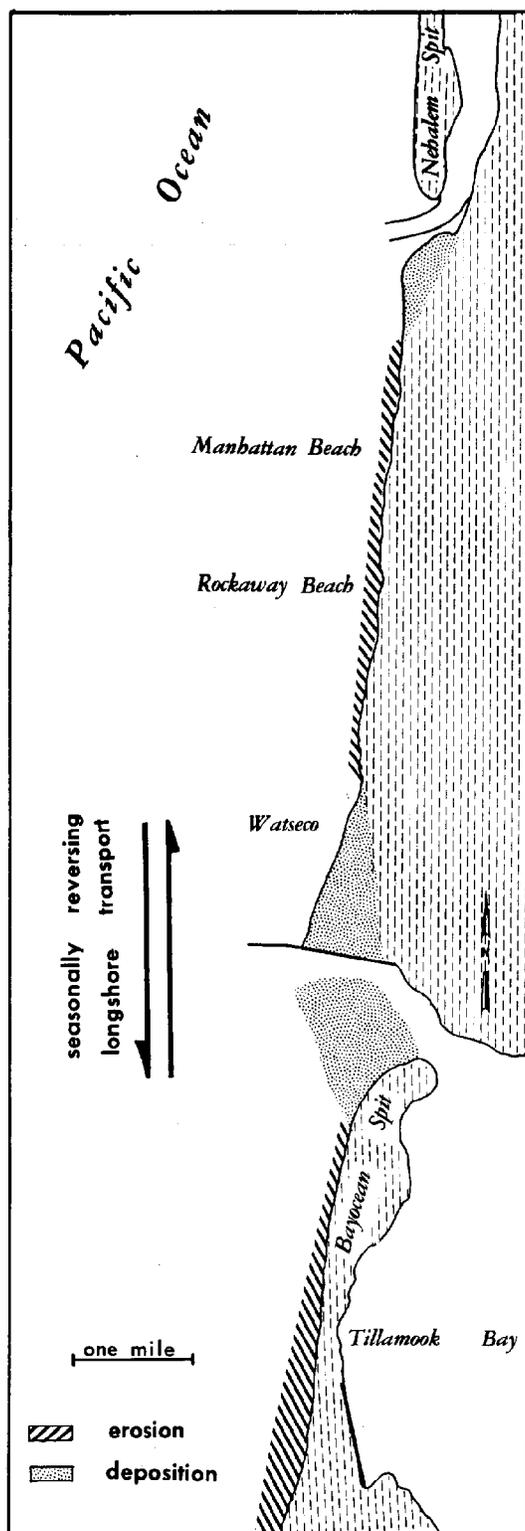
Figure 47. Shoreline symmetry north and south of Tillamook channel.

A view of the shoreline extending from Bayocean spit to Nehalem spit reveals a symmetry of shoreline erosion and deposition north and south of the Tillamook Channel (Figure 47). Cooper (1958) and Dicken (1961) report beach erosion along the Manhattan-Rockaway shoreline, although less severe than along Bayocean spit. It is suggested that the symmetry of shoreline erosion and deposition both north and south of the Tillamook Channel has occurred as a result of the north jetty trapping the seasonally reversing longshore sand transport. The entrapment of the sands in the immediate vicinity of the jetty has resulted in a net loss of beach sand for much of Bayocean spit and Manhattan-Rockaway beaches. The effect has been the loss of a beach sand "buffer" for these beaches, particularly Bayocean; this has allowed storm waves to reach the spit with greater energy and erosional capability to continue the erosion process.
