FWS/OBS-77/51
March 1980

**Biological Impacts of Minor Shoreline
Structures on the Coastal Environment:
State of the Art Review
VOLUME I**

E. L. Mulvihill, C. A. Francisco, J. B. Glad,
K. B. Kaster, and R. E. Wilson

Beak Consultants, Inc.
317 S.W. Alder
Portland, Oregon 97204

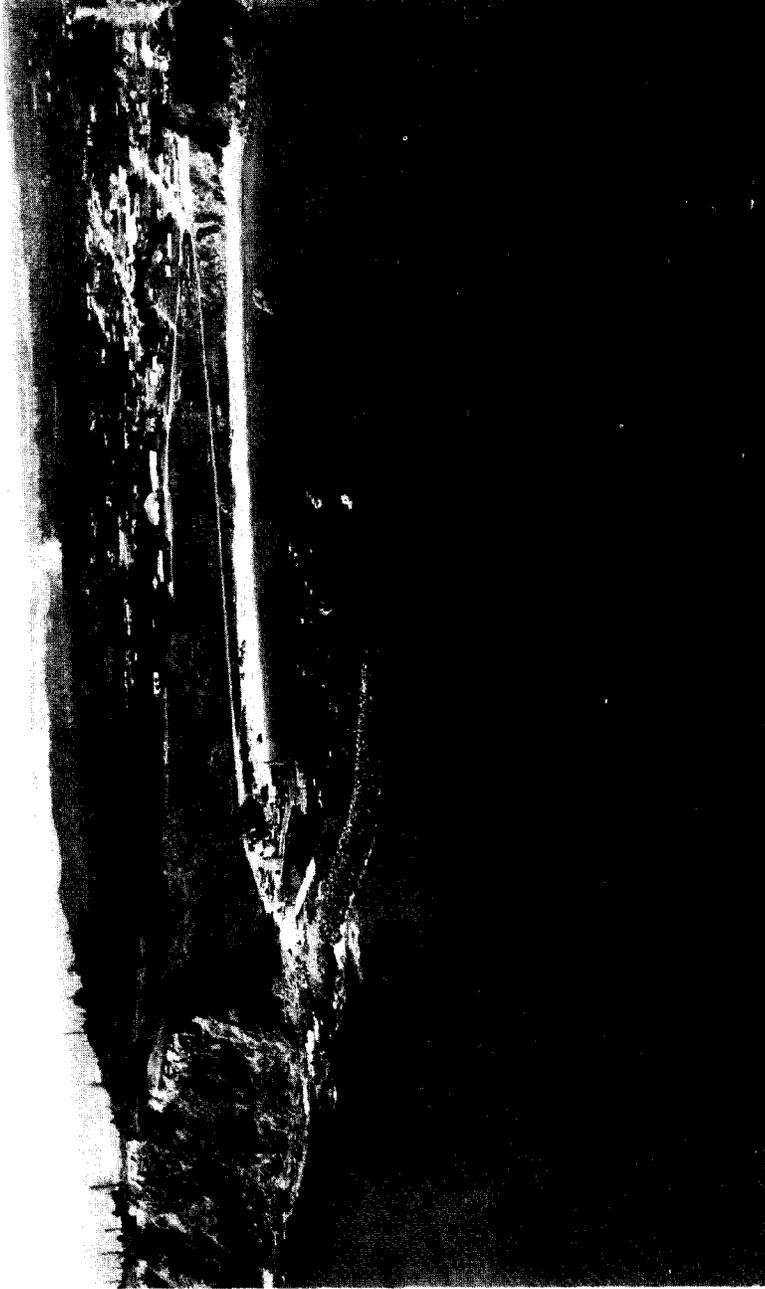
Figure 5. A small naturally protected harbor at Port Orford, Oregon is provided wave protection by a connected dogleg breakwater. Photograph courtesy of the U.S. Army Engineer District, Portland, Oregon.

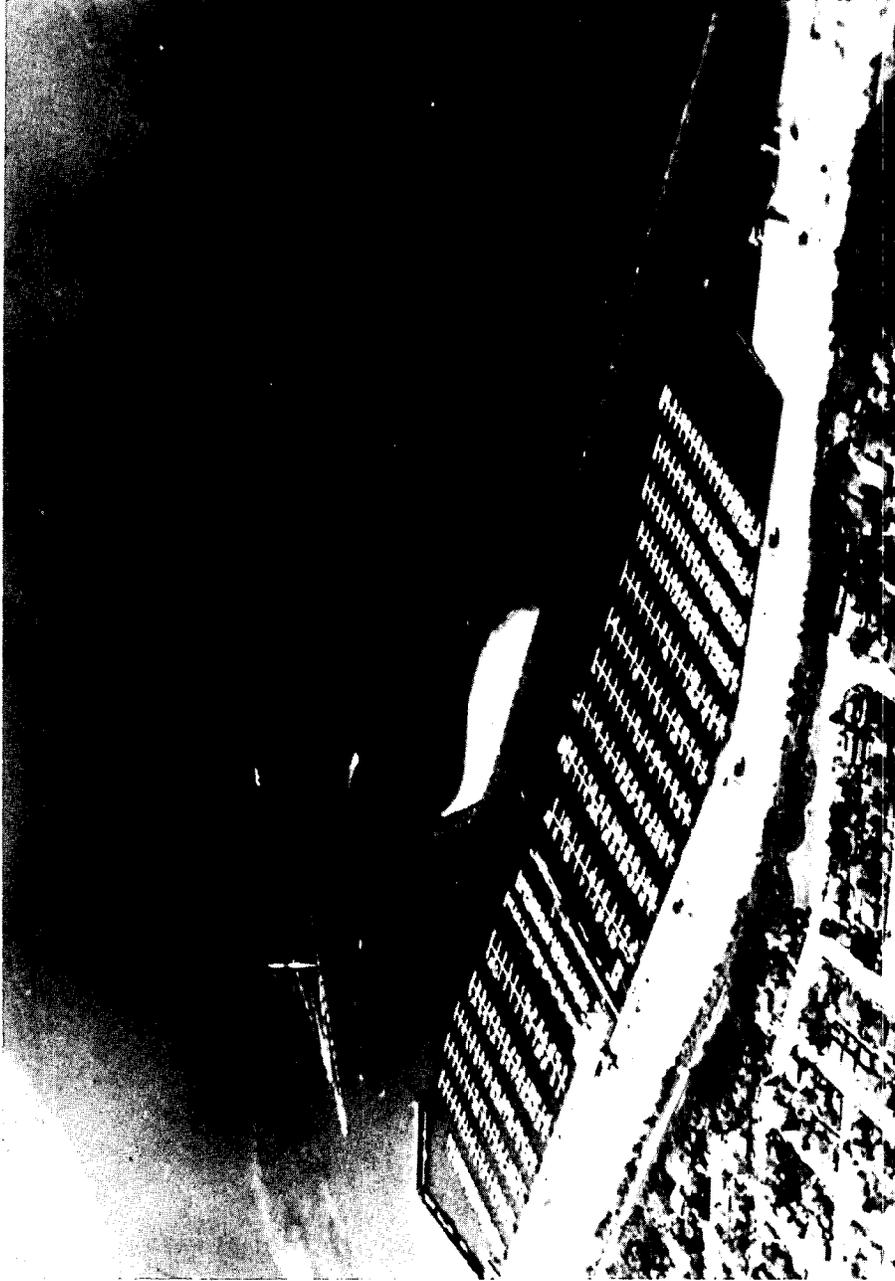
Figure 6. Protection for the Shilshole Marina is afforded by the offshore breakwater. The marina was designed to allow good flushing. An attached dogleg breakwater is visible in the upper left corner of the photograph. Photograph courtesy of the Washington State Department of Fisheries.

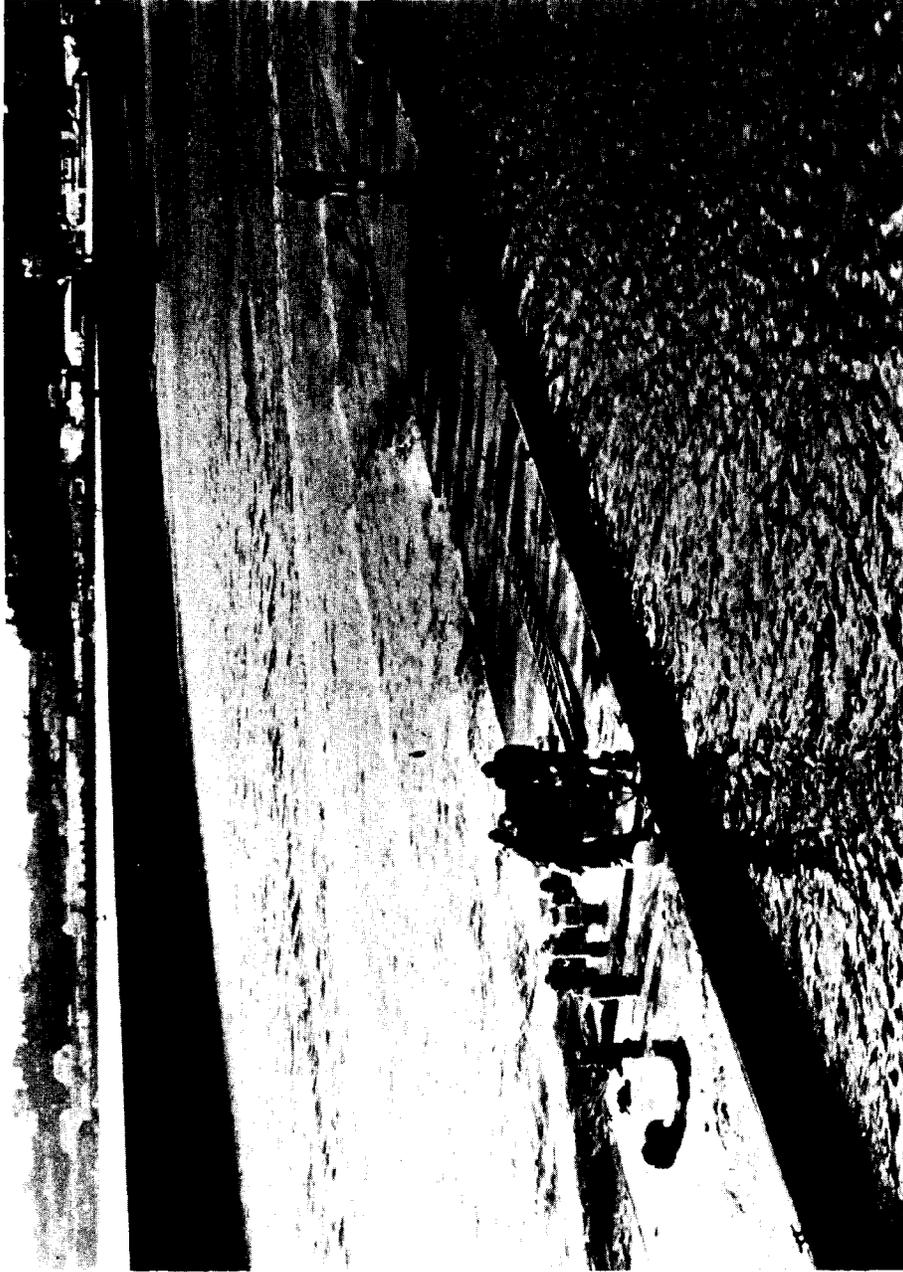
Figure 7. A floating breakwater shelters a marina in Yaquina Bay, Oregon. A navigation channel exists between the floating breakwater and the timber pile breakwater. Photograph courtesy of CH2M Hill, Inc.

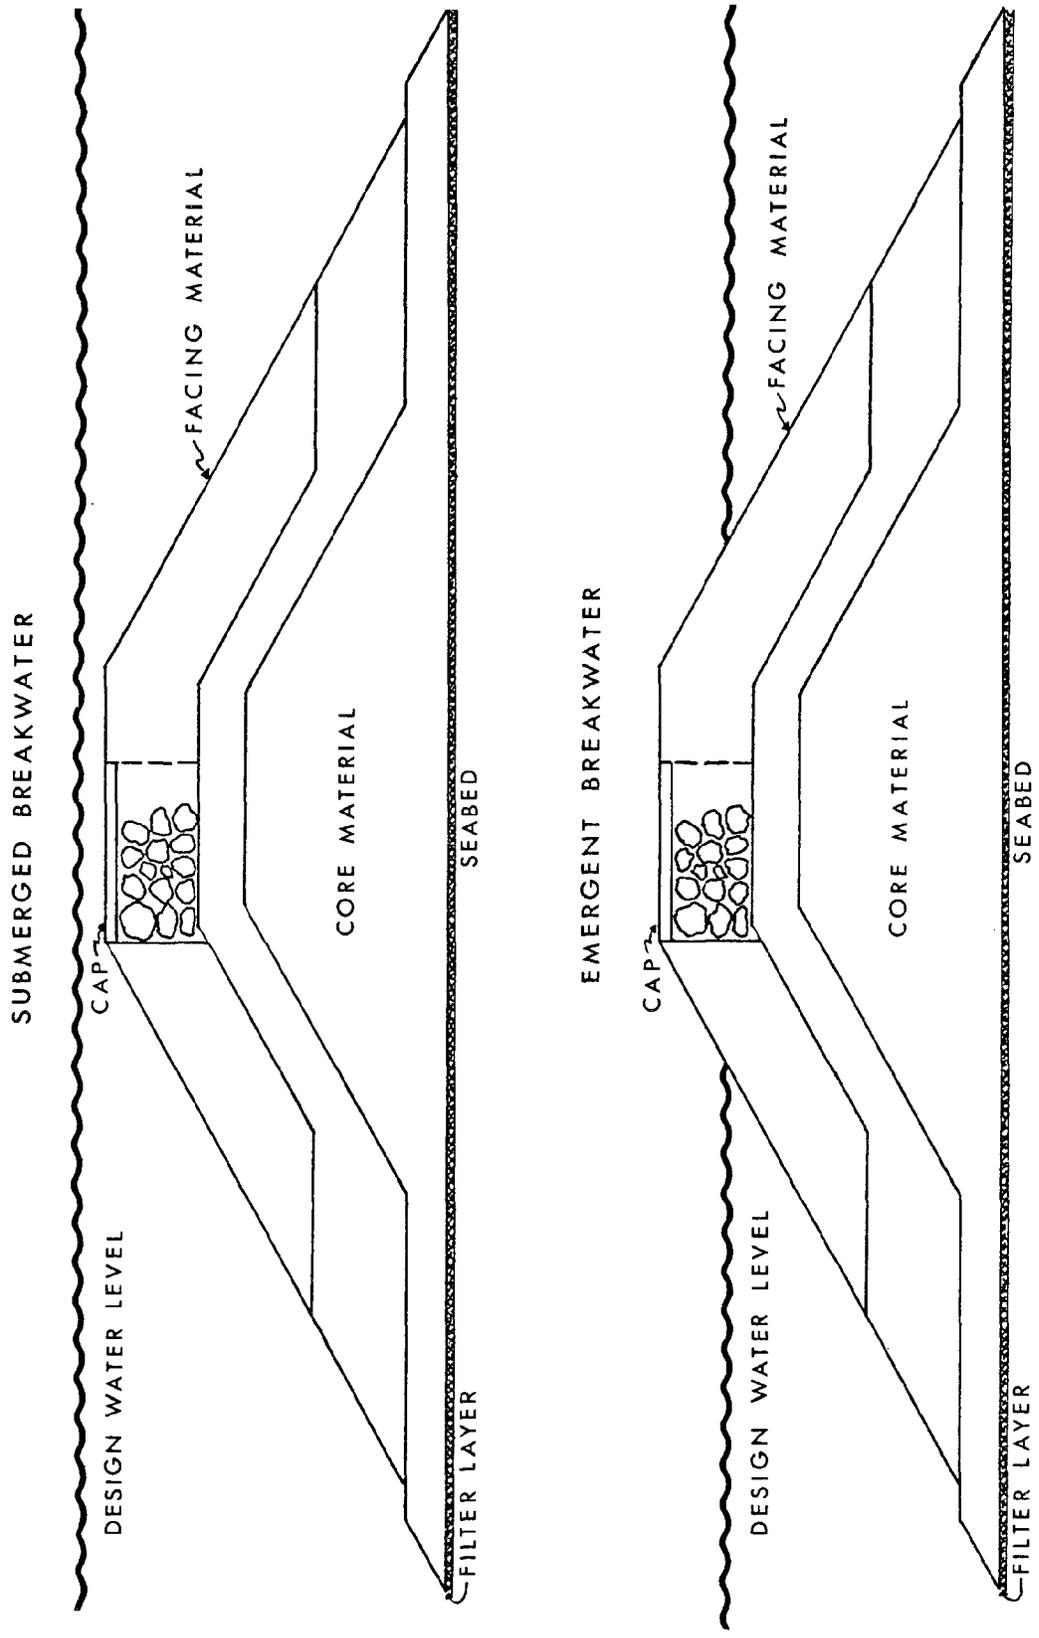
Figure 8. Cross-sectional view of typical submerged and emergent rubble-mound breakwaters. Dimensions and details are determined by particular site conditions.

Design criteria for fixed breakwaters must consider several factors of the physical environment, including wave climate, sediment transport, bottom topography, characteristics of the protected areas, tides, and currents at the site. The design wave and the maximum wave must be determined. At this point a trade-off is often necessary between economic feasibility and failure-proof design (Saville et al. 1965). A generalized diagram of a typical rubble-mound breakwater is contained in Figure 8.

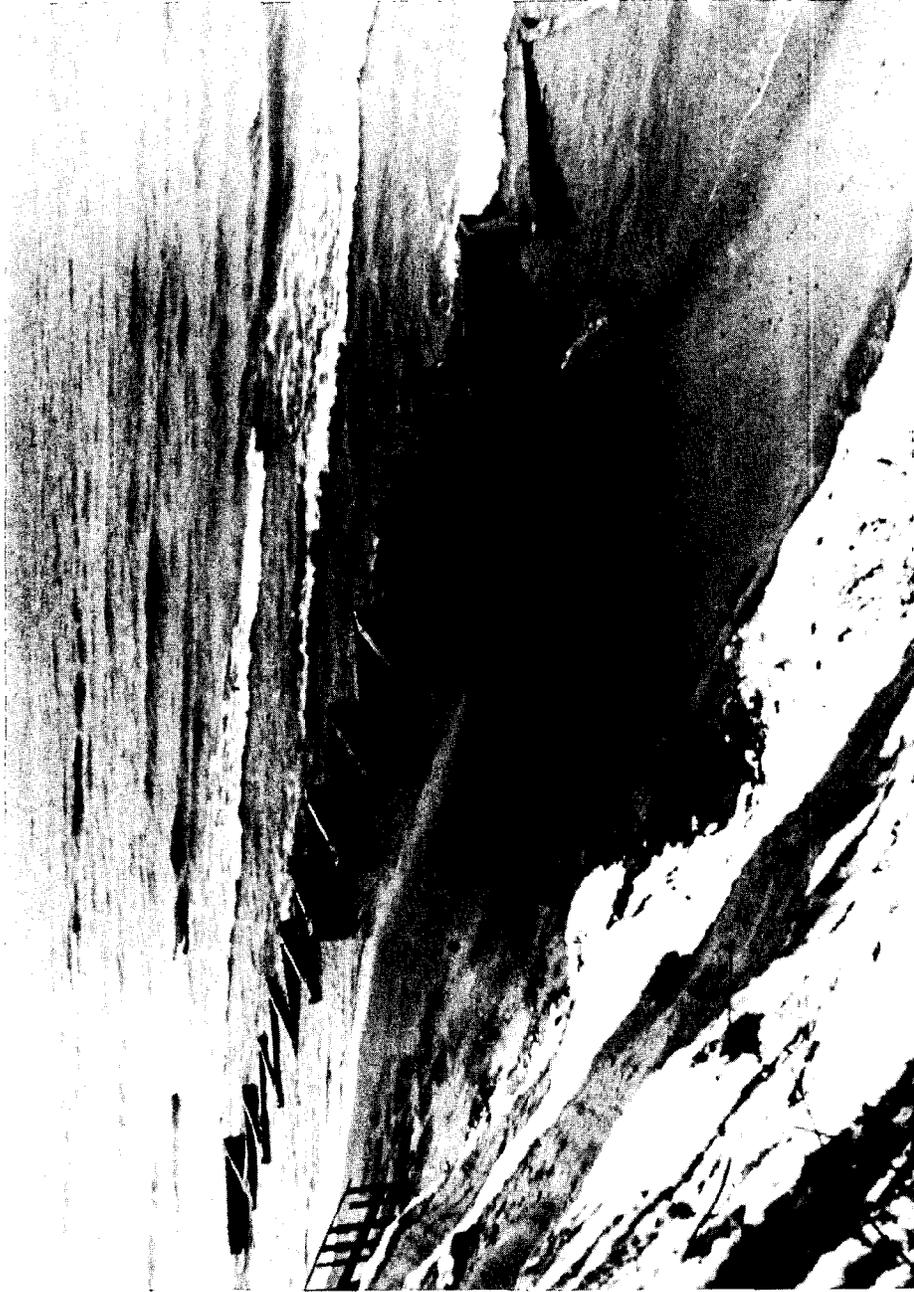
Figure 9. This unconventional zig-zag breakwater design has performed well and has stopped further erosion of the bluff at this site. Photograph courtesy of the State of Michigan, Department of Natural Resources.

Breakwaters are used for shore protection either with other structures (e.g., revetments, seawalls, groins) or as an alternative to them. Steep shorelines and sandy beaches can be protected and sand accretion can be caused or enhanced by breakwaters. Sometimes a breakwater is placed in the intertidal or subtidal zone as an erosion prevention device (Figure 9).

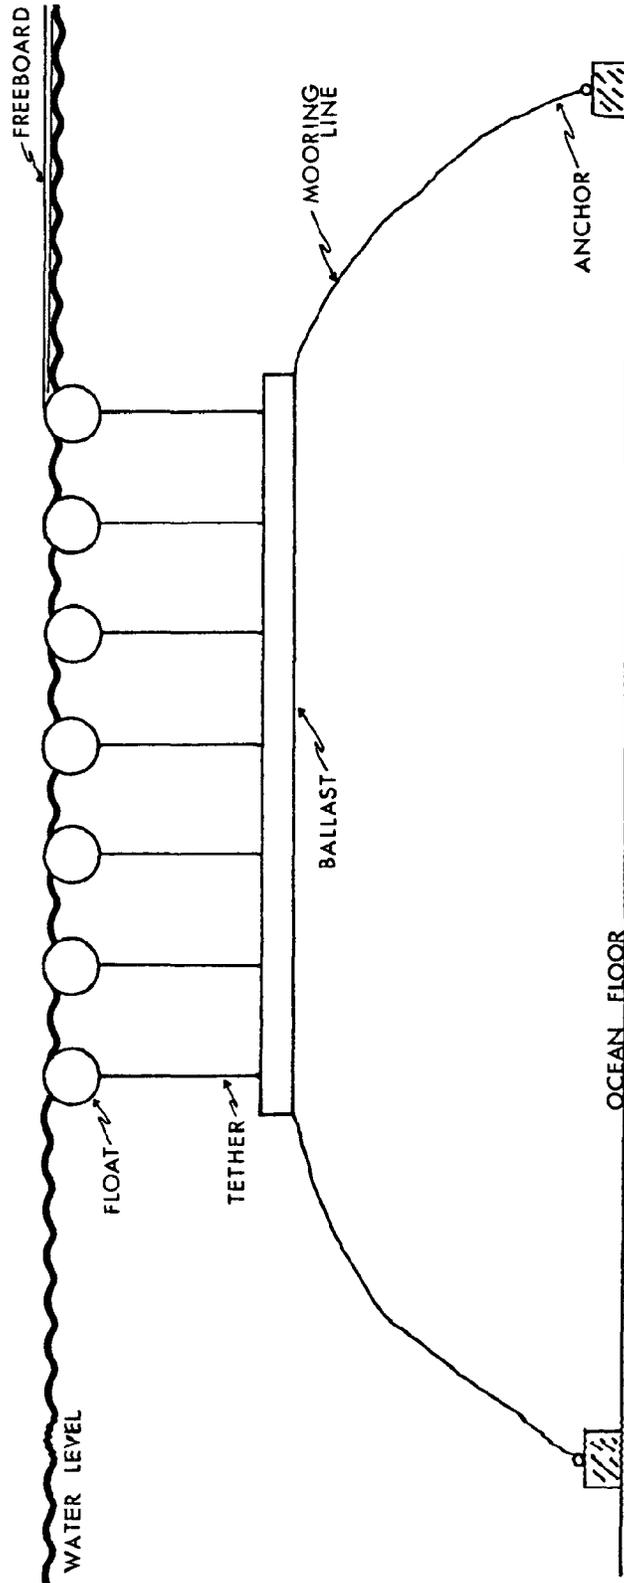
Figure 10. Cross-sectional view of a tethered floating breakwater. Materials, dimensions and details are determined by particular site conditions.

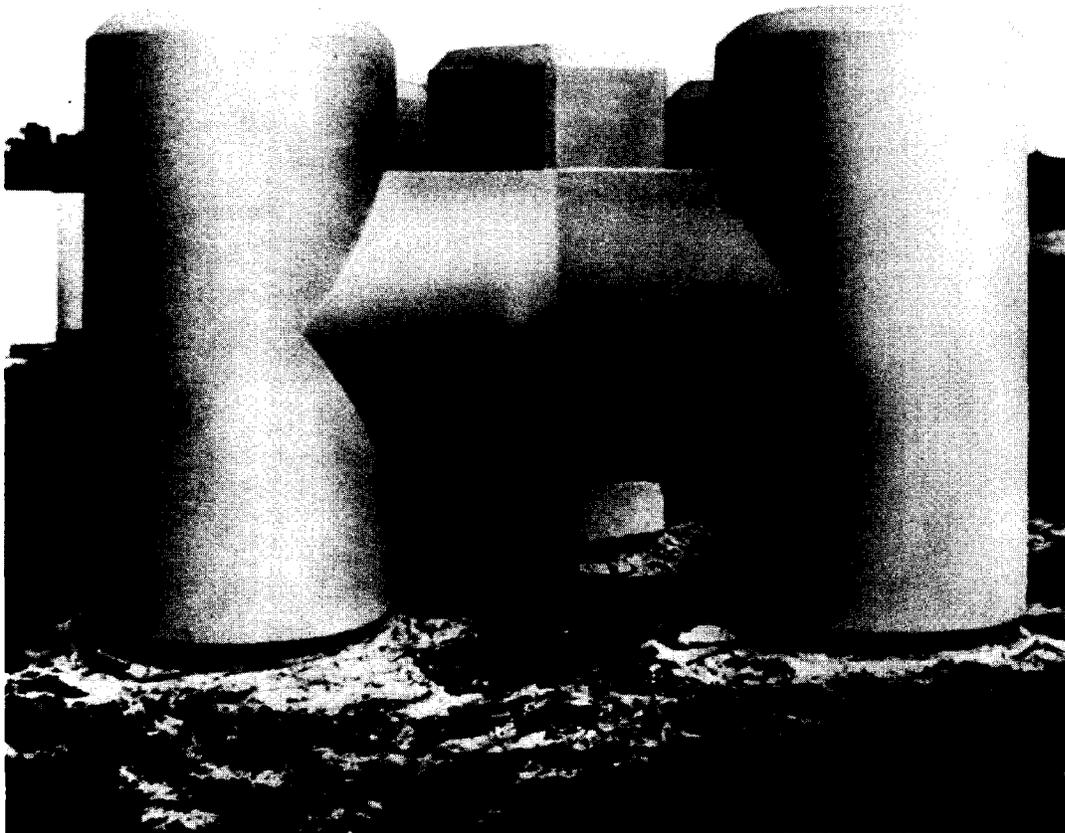
Figure 11. Tribar, a precast, reinforced concrete structure used as facing on breakwaters and jetties. Photograph courtesy Portland Cement Association.

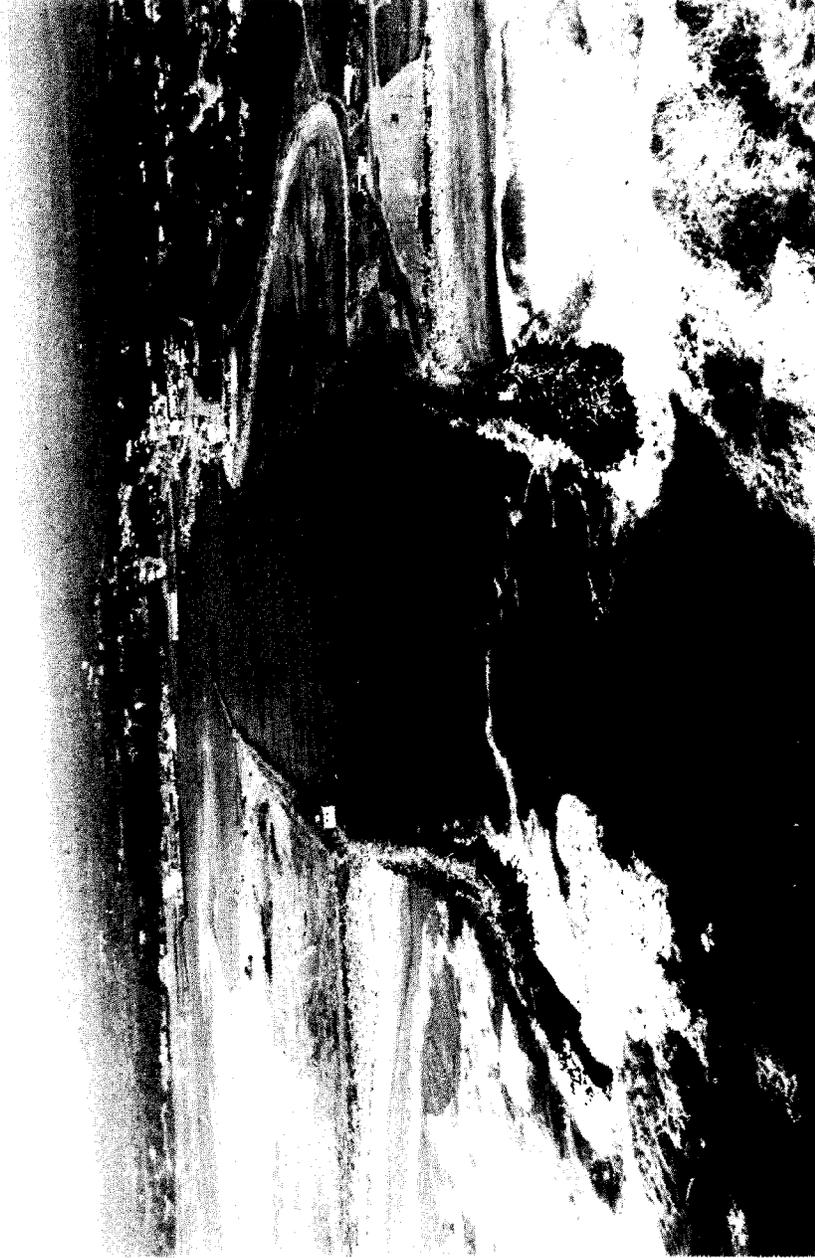
Figure 13. Jetties at mouth of Coquille River, Bandon, Oregon. Photograph courtesy of U.S. Army Engineer District, Portland, Oregon.

The most common type of jetty is one extending into the ocean at the entrance to a bay or river (Figure 13). However, training works (including training walls) located in estuaries and along rivers to guide currents and assist in channel deepening are also commonly called jetties. Sometimes a structure placed in a river or on an estuarine beach to direct currents and stabilize the beach is called a jetty or a groin (see Glossary).

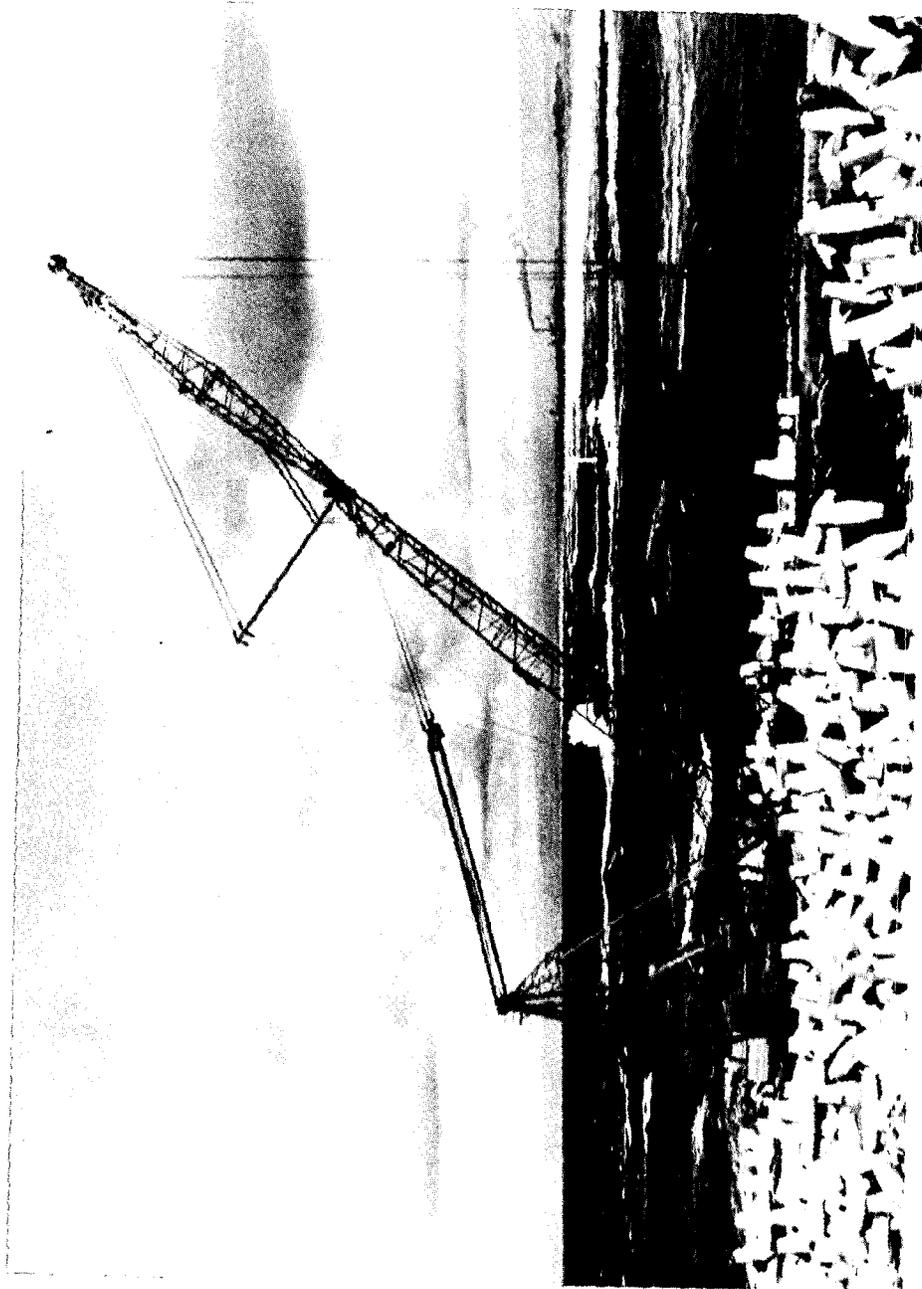
Figure 14. Dolosses are being installed as protective facing on this rubble mound jetty in Humboldt Bay, California. Note north jetty in background. Photograph courtesy of U.S. Army Corps of Engineers, South Pacific Division.

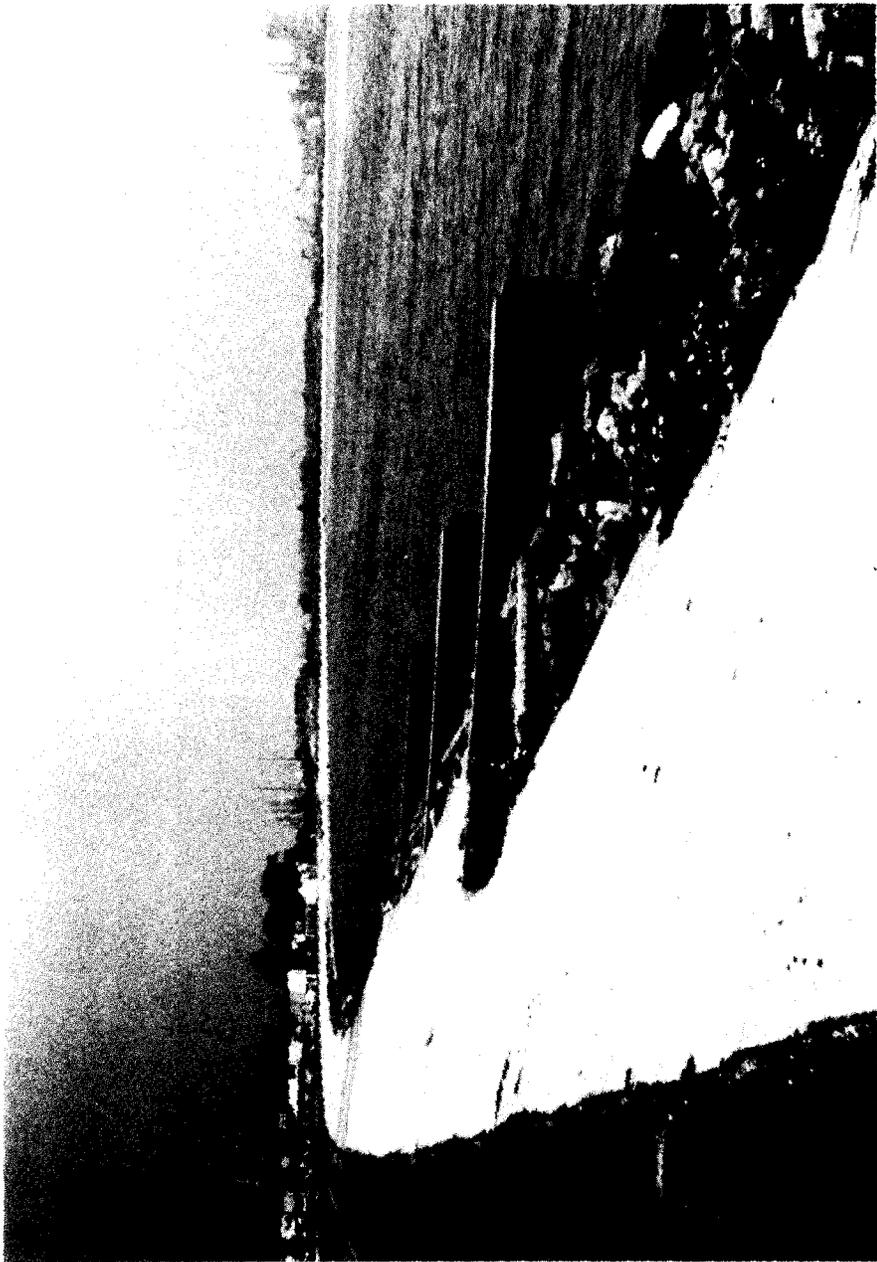
Figure 15. Concrete groins at the base of a revetment on the Gulf Coast of Florida.
Photograph by E. L. Mulvihill.

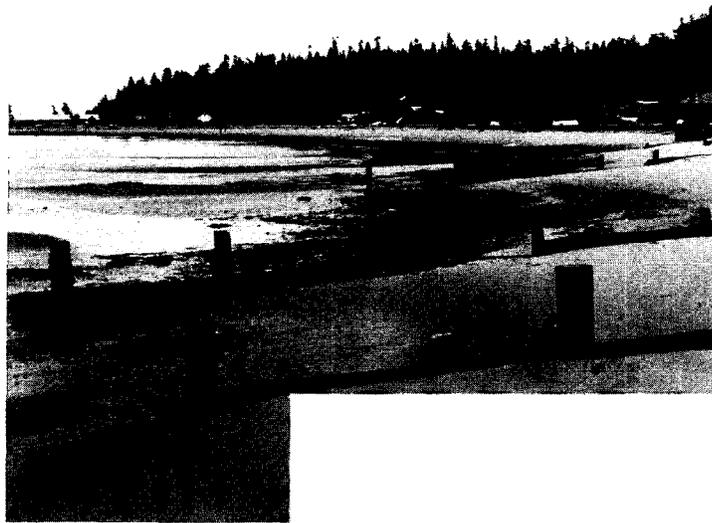
Figure 16. Timber pile groins, Puget Sound, Washington. Photographs by C. A. Francisco.

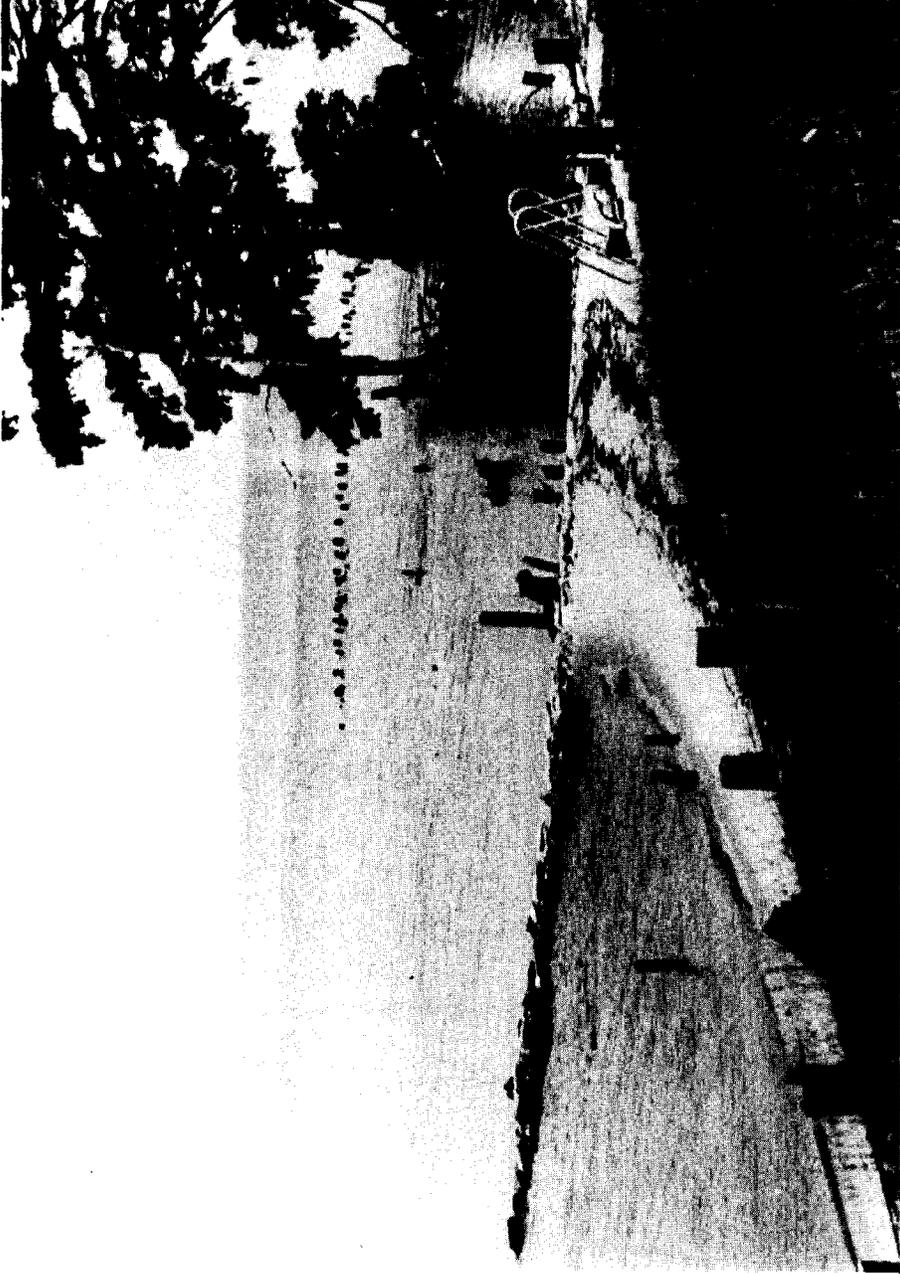
Figure 17. Rubble mound groin in the southeastern United States. Photograph by V. J. Bellis.

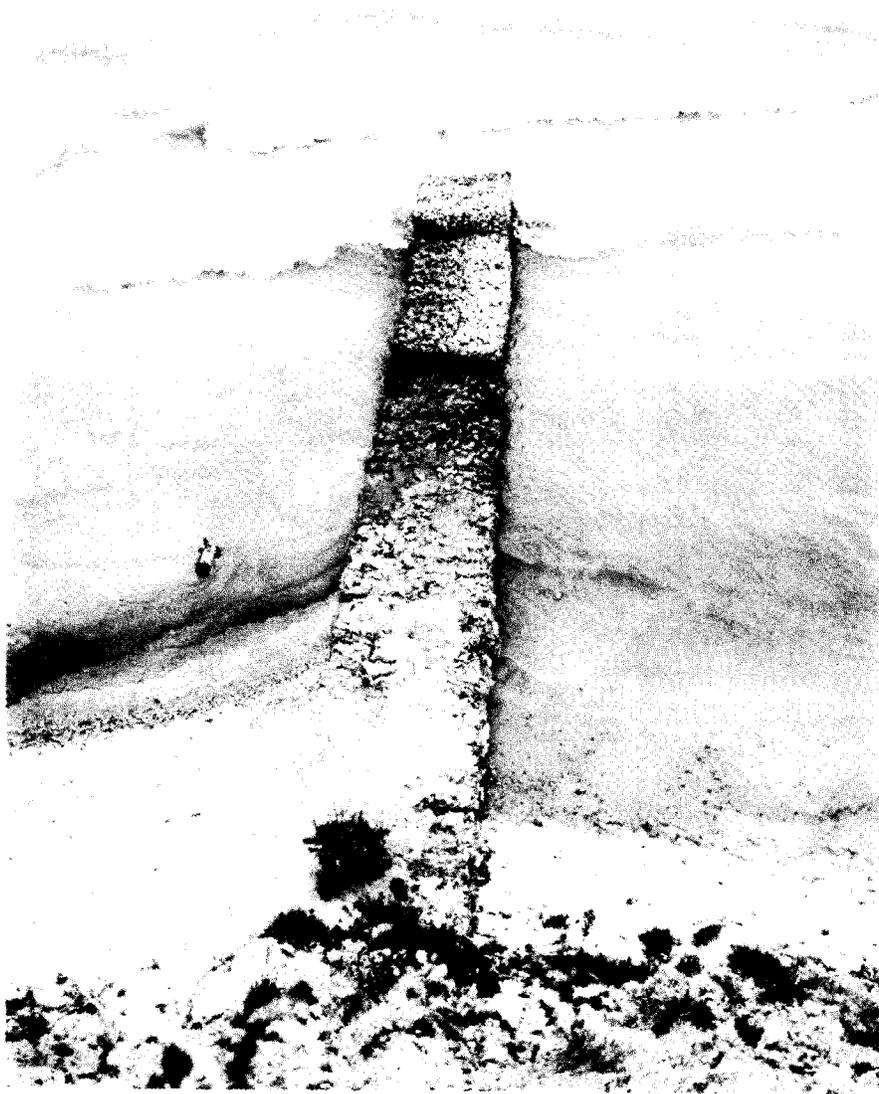
Figure 18. Gabions are used to construct groins on the Great Lakes. Photograph courtesy of State of Michigan, Department of Natural Resources.

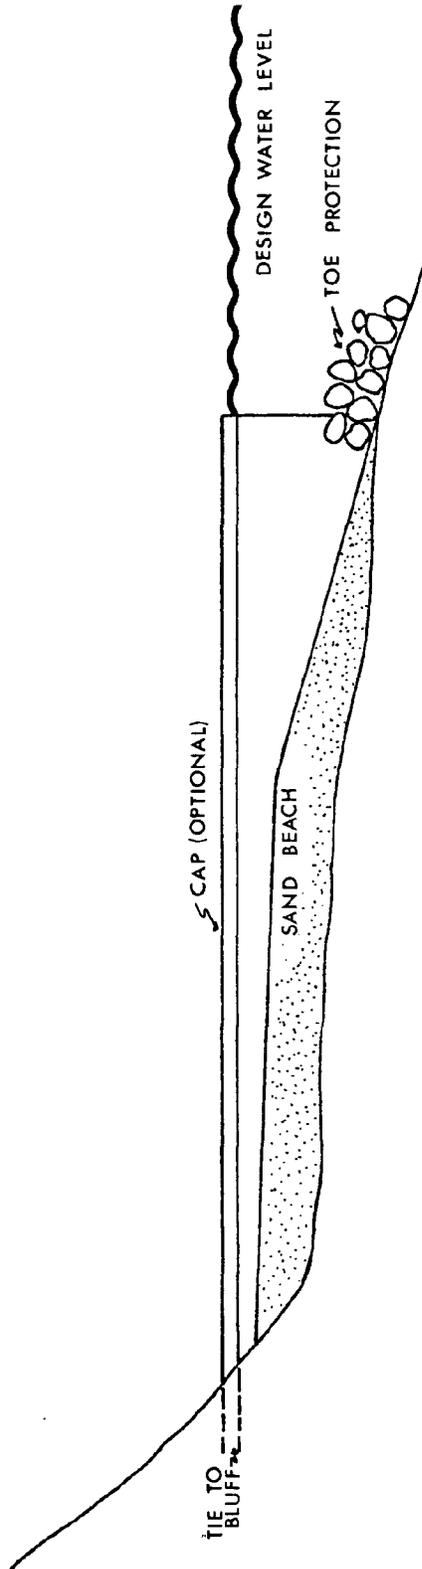
Figure 19. Side view of an impermeable groin. Construction materials, dimensions and details to be determined by particular site conditions.

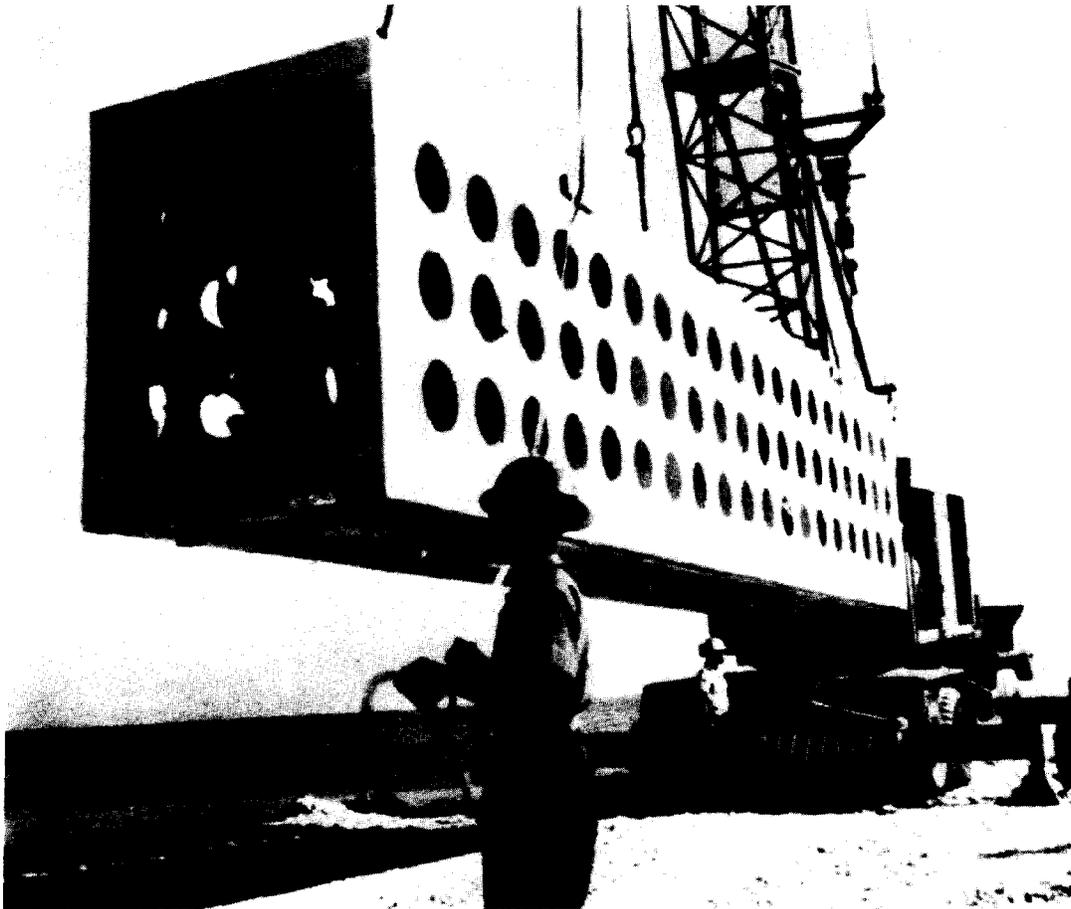
Figure 20. Prefabricated permeable groin. This component has also been used in the construction of breakwaters. Photograph courtesy of Portland Cement Association.

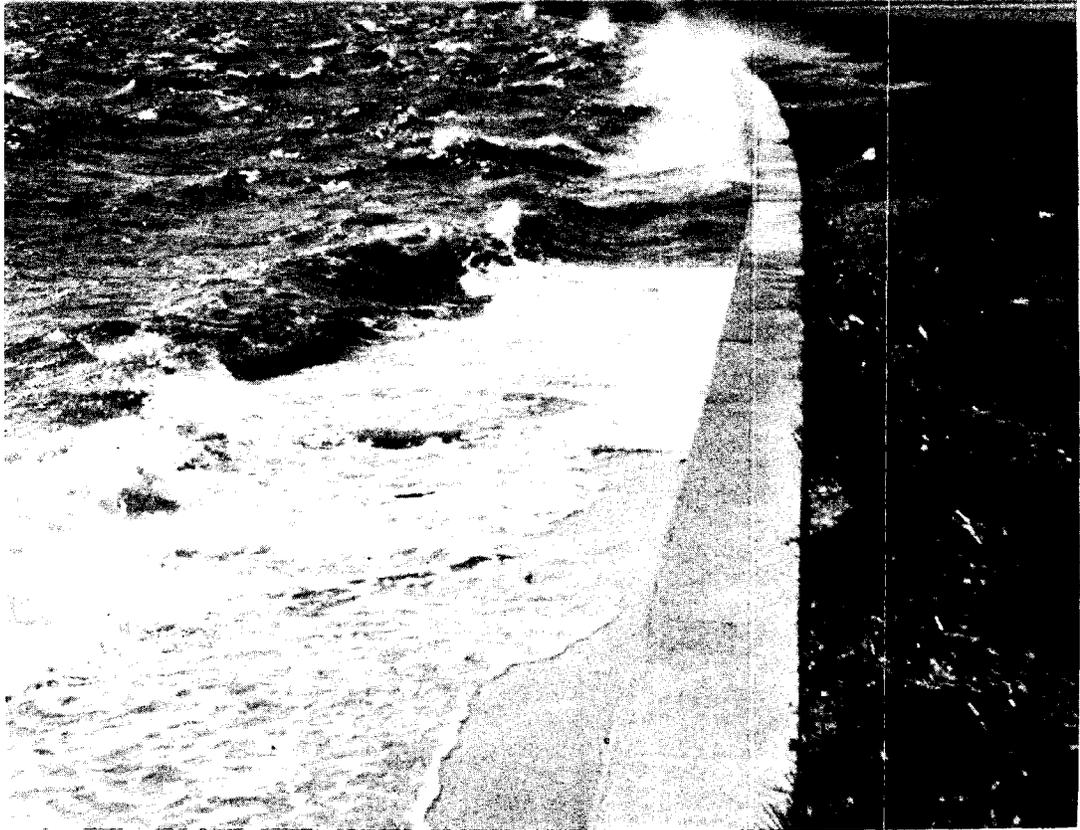
Figure 21. Waves breaking against the concrete bulkhead bordering the causeway in Apalachicola Bay, Florida. Photograph by E. L. Mulvihill.

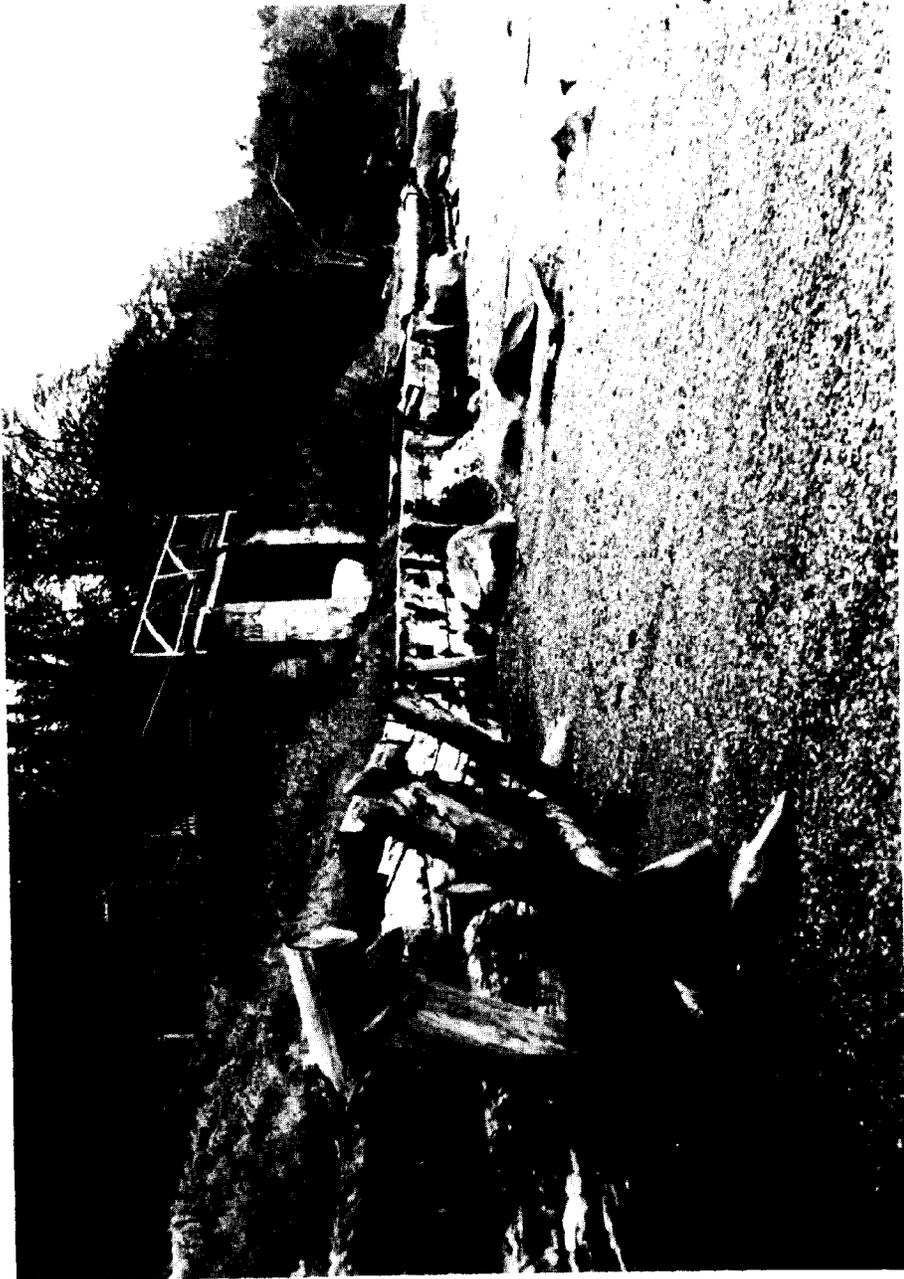
Figure 22. Wooden sheet pile bulkhead at low tide. The pressure of the embankment caused the top of the structure to tilt seaward. This probably resulted from inadequate anchorage and undermining of the structure at its toe. Photograph by T. Terich.

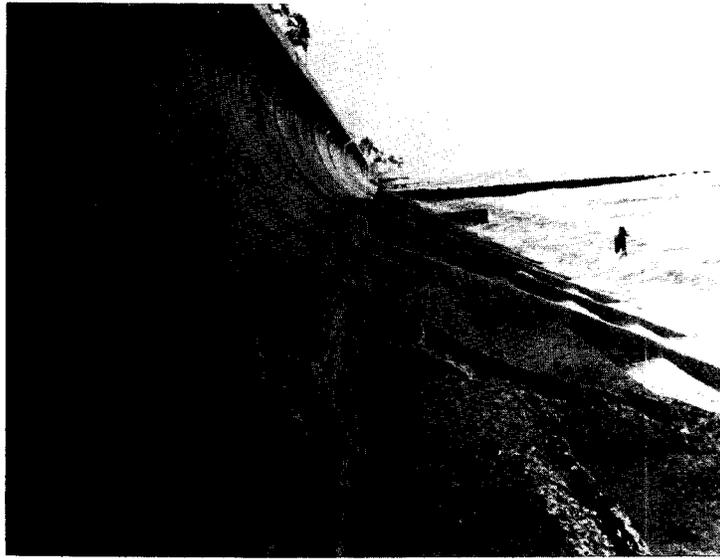
Figure 23. Concrete seawall in Florida. Note signs of wave damage to the base of the structure. Photograph courtesy of Florida Department of Natural Resources.

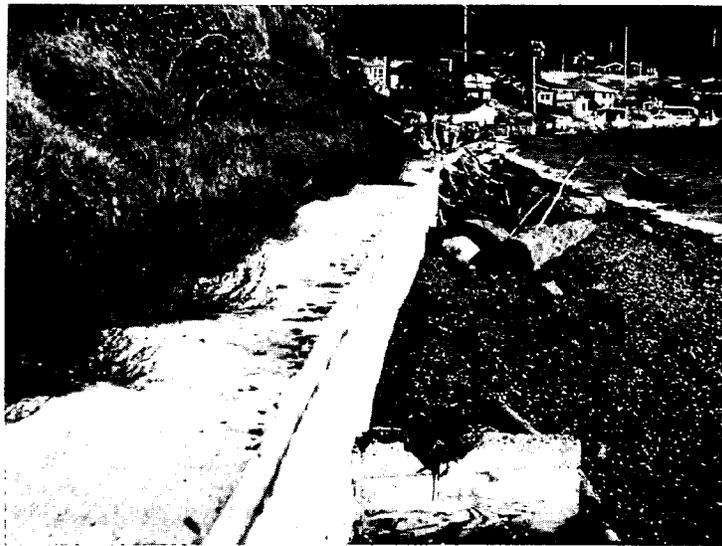
Figure 24. Concrete bulkhead on Fidalgo Island, Washington. Photograph by T. Terich.

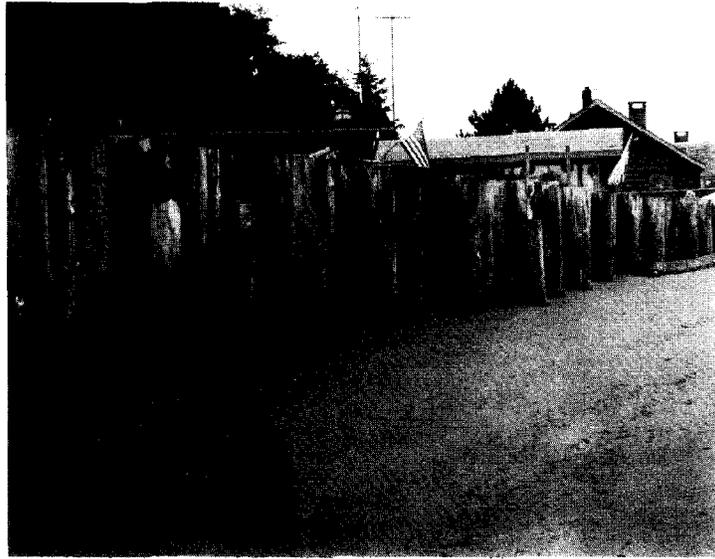
Figure 25. Bulkhead constructed of a series of wood piles. Photograph by C. A. Francisco.

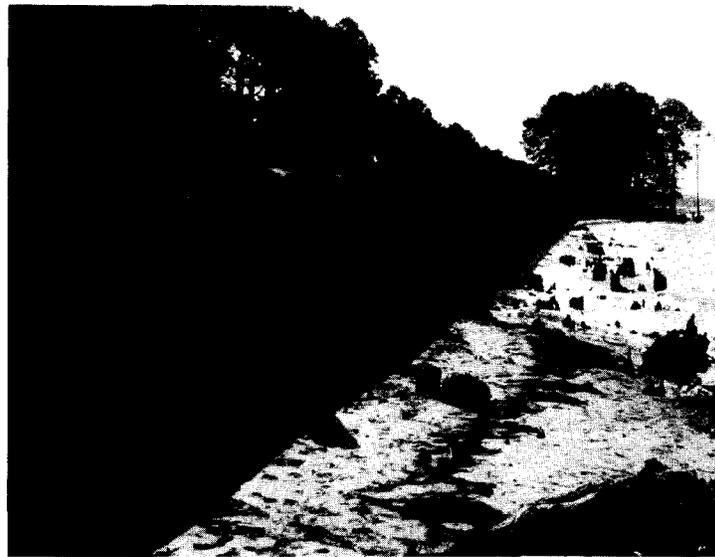
Figure 26. Wooden sheet pile bulkhead along the Gulf coast of Florida. Photograph by E. L. Mulvihill.

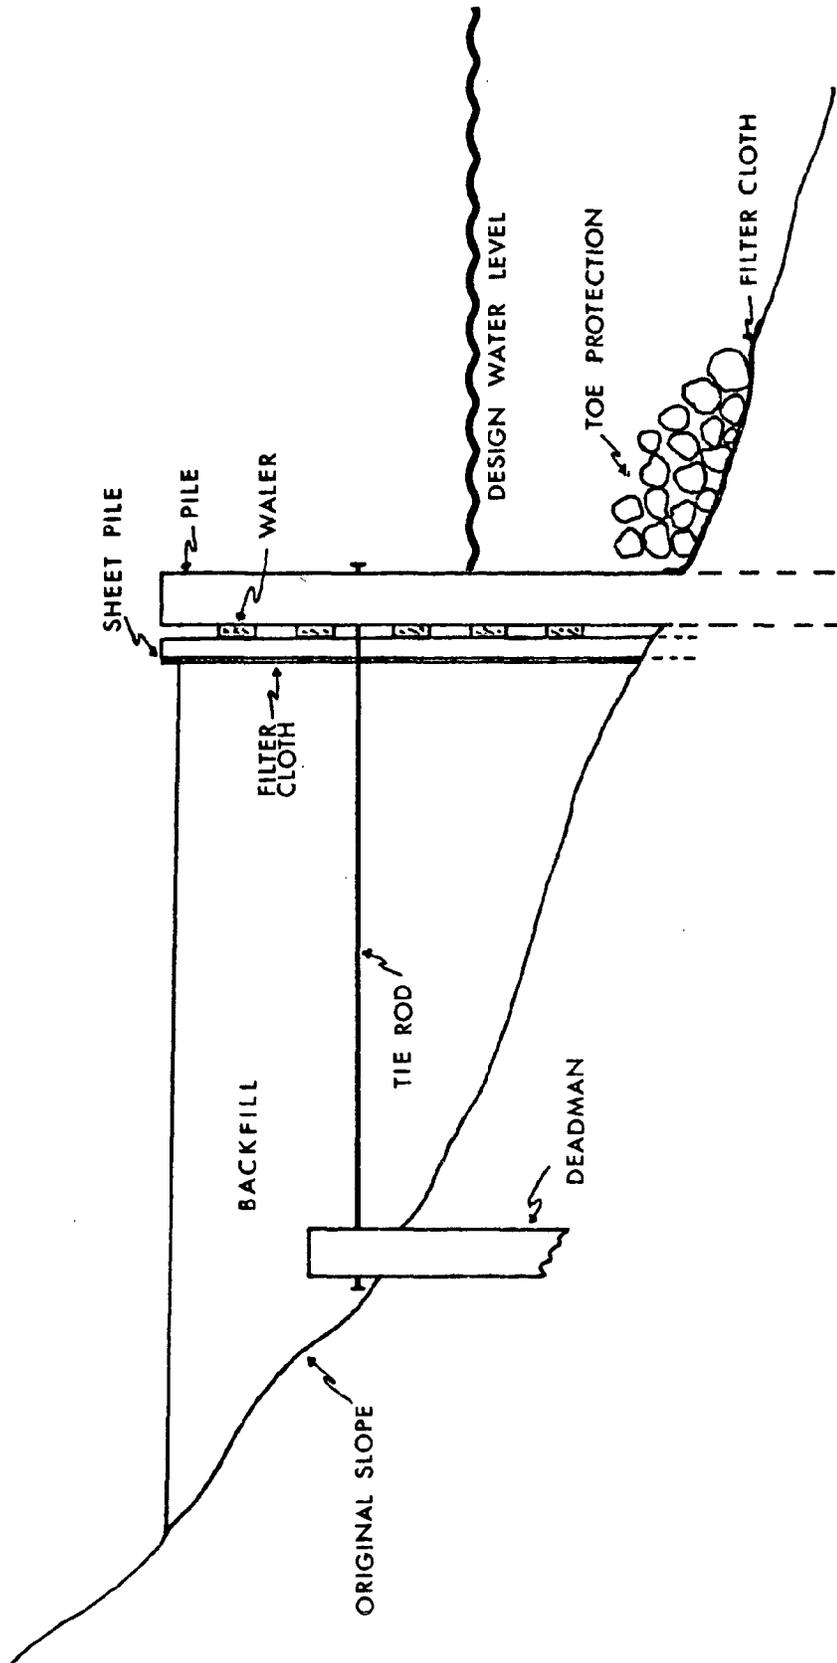
Figure 27. Side view of a typical sheet pile bulkhead. Dimensions and details to be determined by particular site conditions.

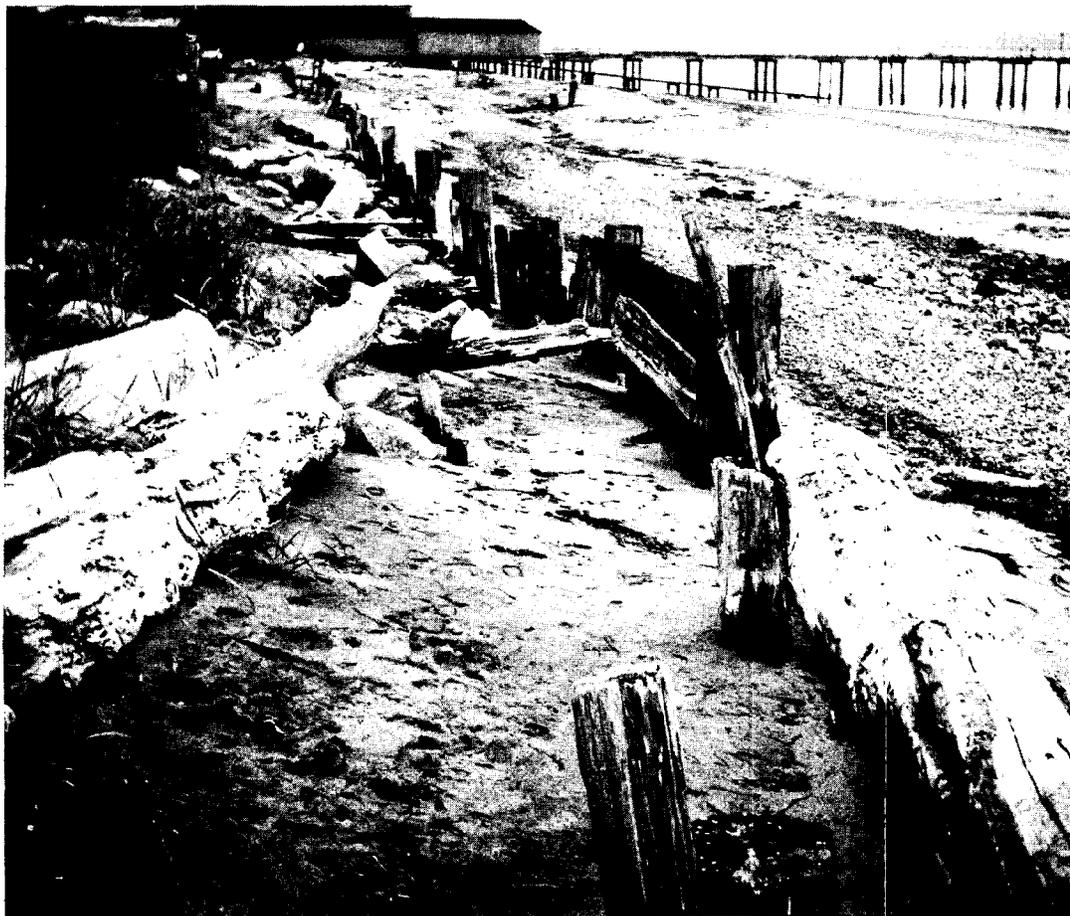
Figure 28. Old bulkhead line on a beach that has continued to erode in Skunk Bay, Washington. Photograph by C. A. Francisco.
