FWS/OBS-77/51
March 1980

**Biological Impacts of Minor Shoreline
Structures on the Coastal Environment:
State of the Art Review
VOLUME I**

E. L. Mulvihill, C. A. Francisco, J. B. Glad,
K. B. Kaster, and R. E. Wilson

Beak Consultants, Inc.
317 S.W. Alder
Portland, Oregon 97204

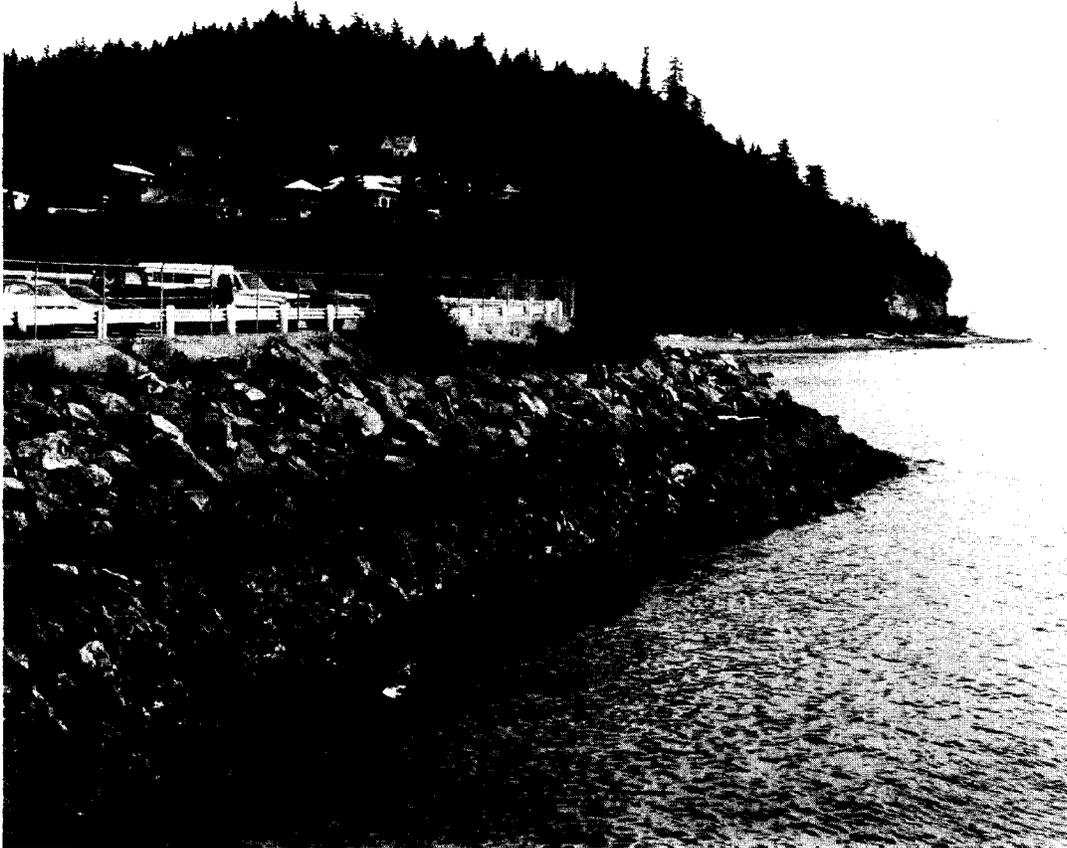
Figure 29. This riprap revetment functions to limit erosion of the parking lot at the Kingston, Washington, ferry terminal. Picture was taken at low tide. Light and dark colored bands on the revetment are due to biological zonation. Photograph by C. A. Francisco.

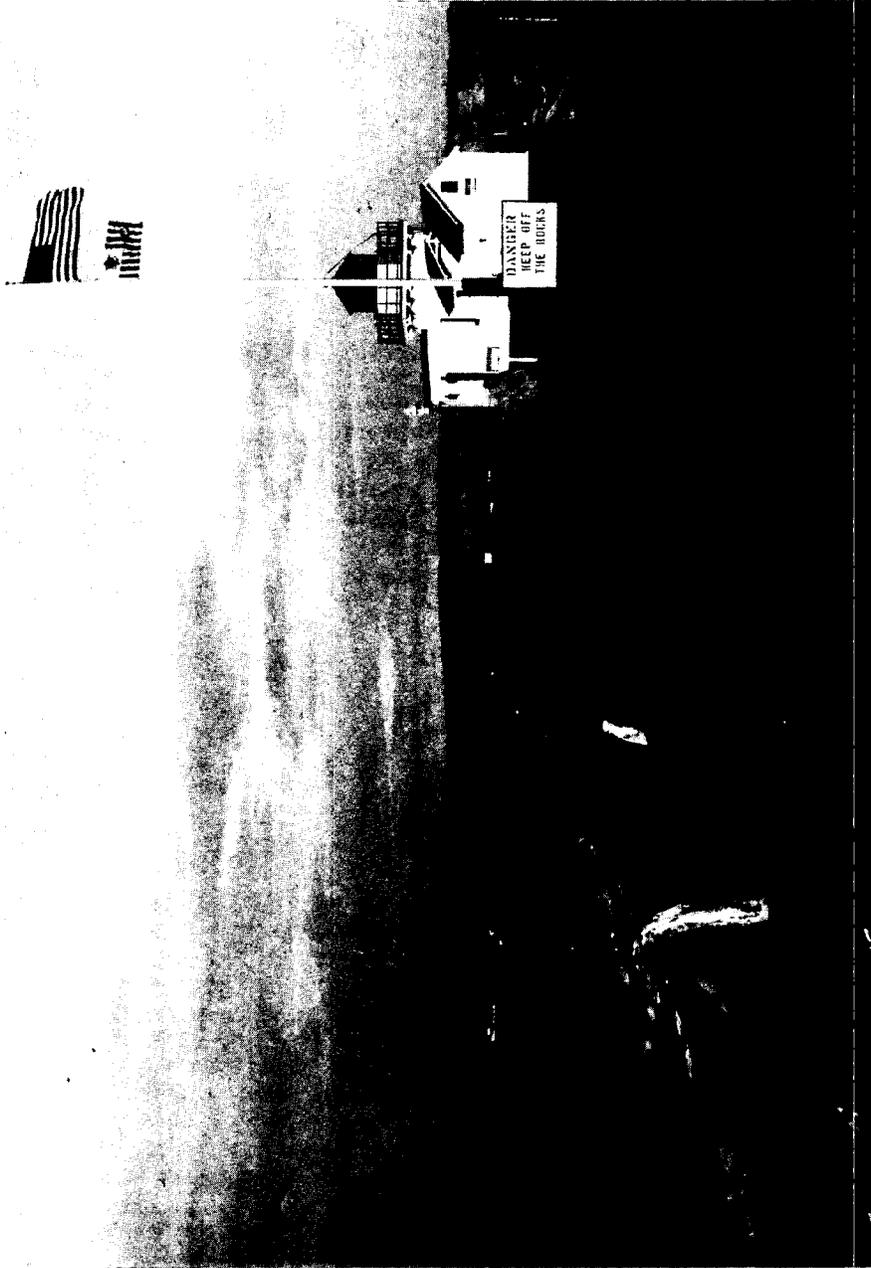
Figure 30. Riprap revetment protects the U.S. Coast Guard Light Station at Point No Point, Washington. Large drifting logs, such as the ones pictured in the foreground, make the use of gabion revetments impracticable in much of Puget Sound. Photograph by C. A. Francisco.

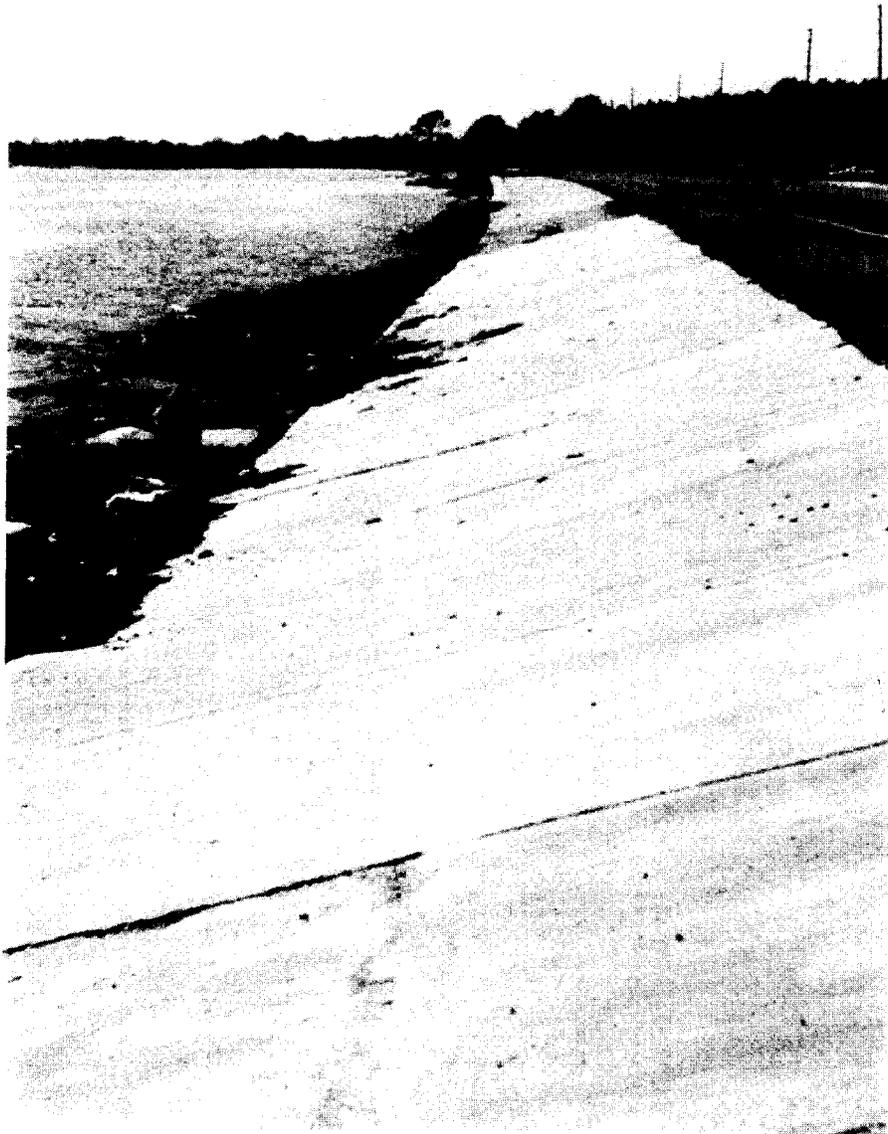
Figure 31. Concrete revetment along U.S. Highway 98 in the vicinity of Port St. Joe, Florida. Note the toe protection at the base of the revetment. Photograph by E. L. Mulvihill.

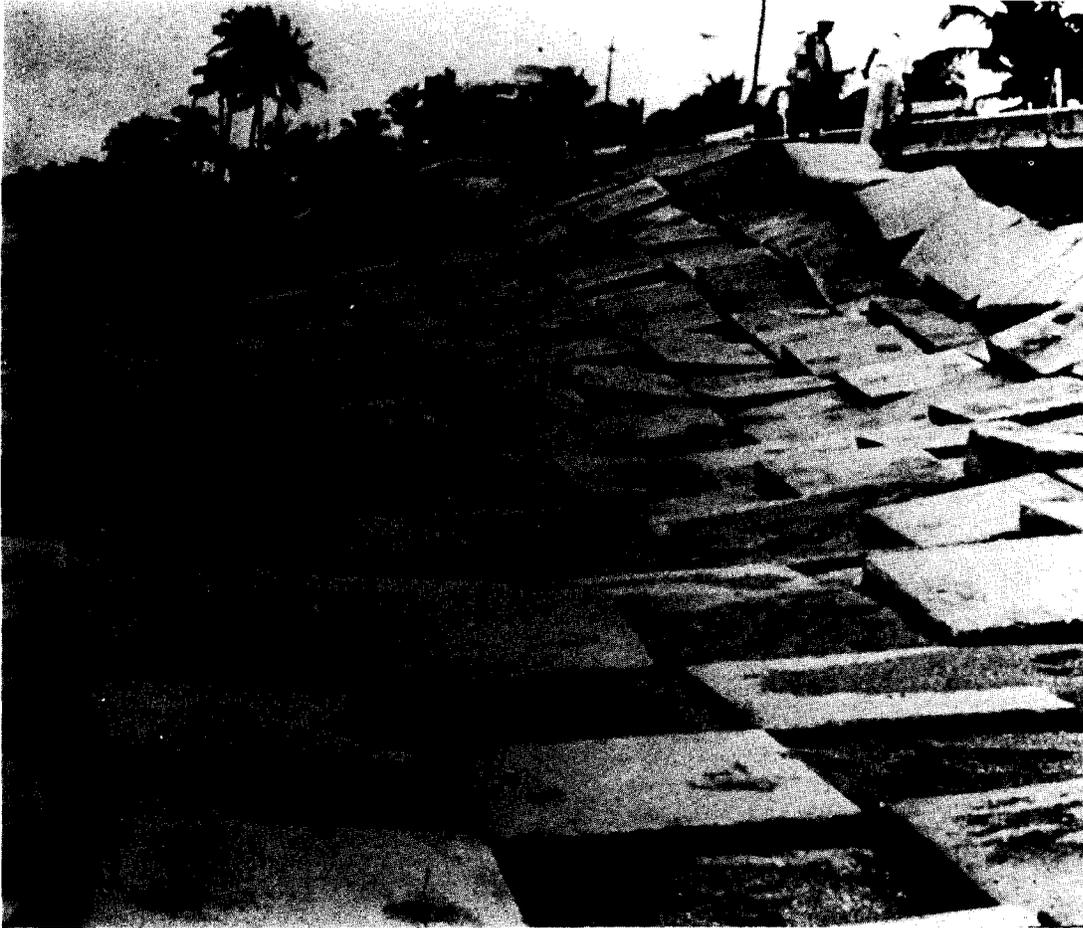
Figure 32. Failure of this interlocking concrete block revetment was primarily due to settling and erosion of supporting beach material. Due to its flexibility, this structure still affords some protection. Photograph courtesy of Florida Department of Natural Resources.

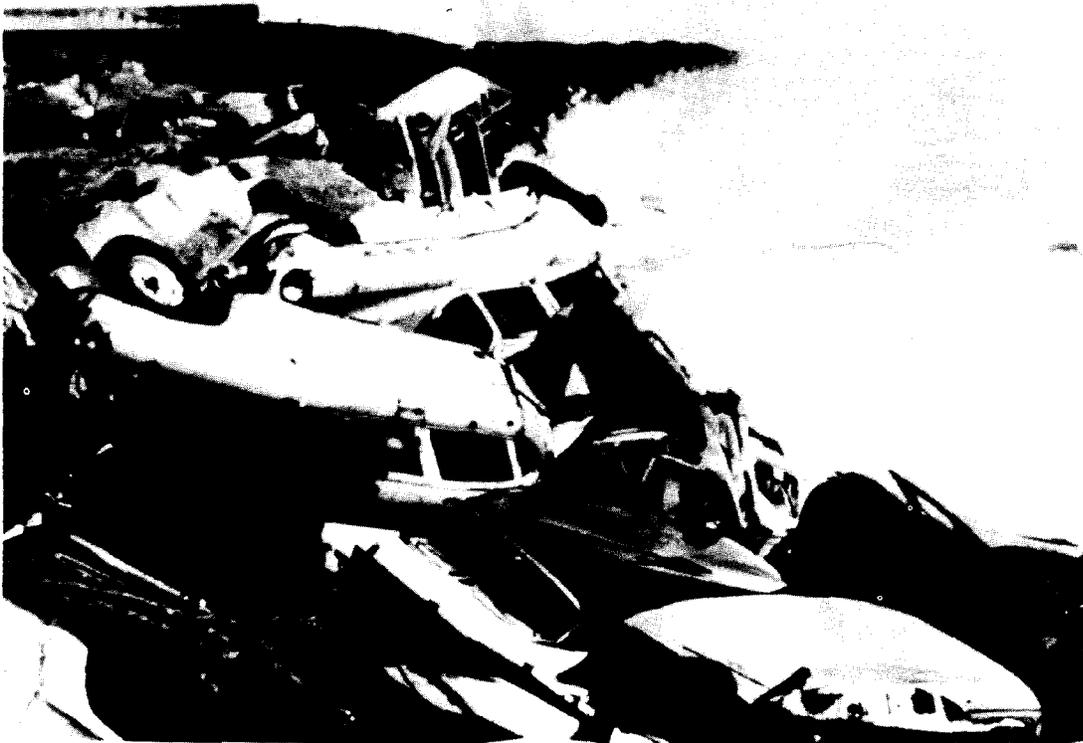
Figure 33. Pictured is a junk car revetment in Florida. Due to corrosion, the life span of car body revetments generally is less than 5 years in brackish water. There are also aesthetic considerations regarding this type of revetment. Photograph courtesy of Florida Department of Natural Resources.

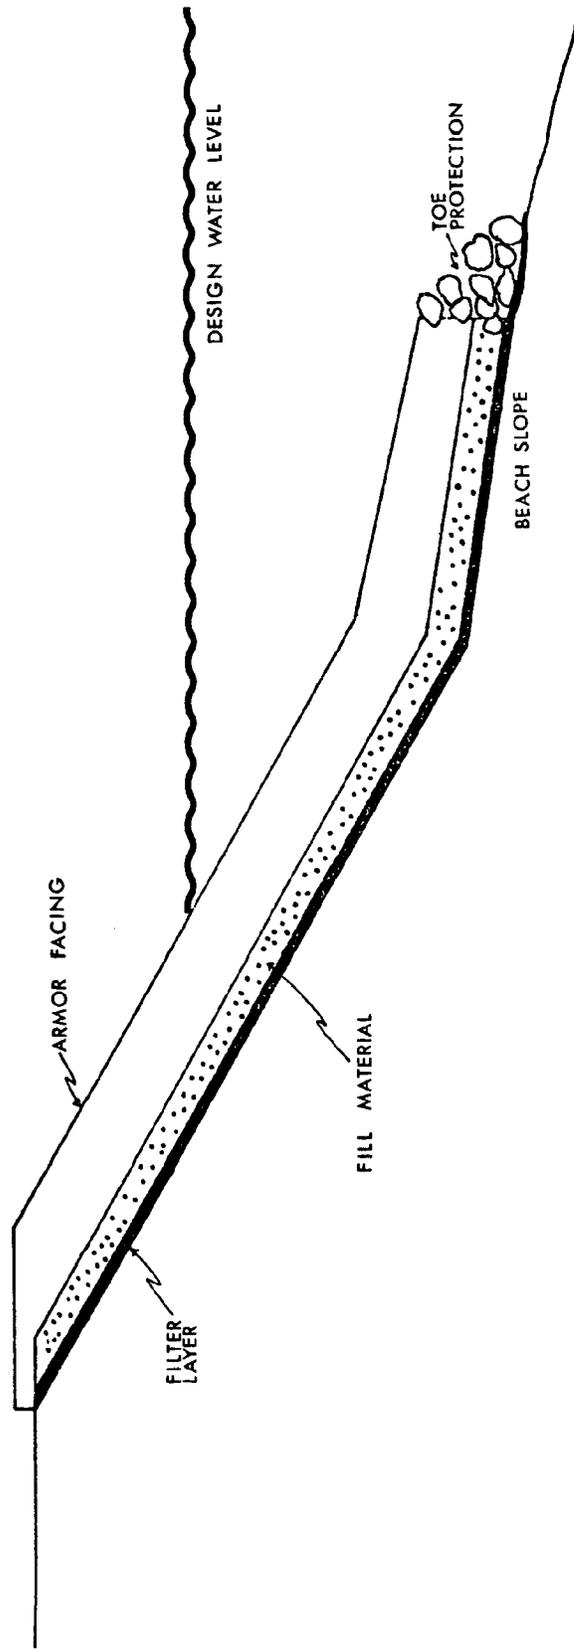
Figure 34. Profile of a revetment. Construction materials, dimensions and details are determined by particular site conditions.

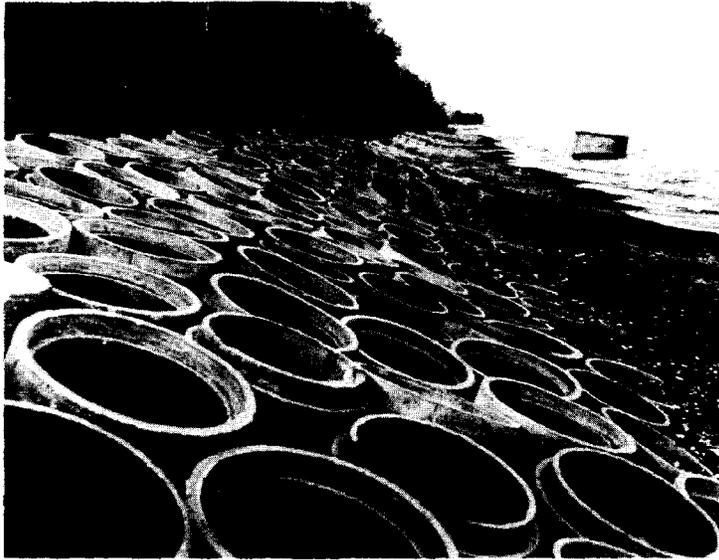
Figure 35. A Nami Ring revetment was constructed in 1974 at Little Girls Point on Lake Superior as part of the Michigan State Demonstration Erosion Control Program. Damage to this structure was extensive after two years of service. Photograph courtesy of the Michigan State Department of Natural Resources.

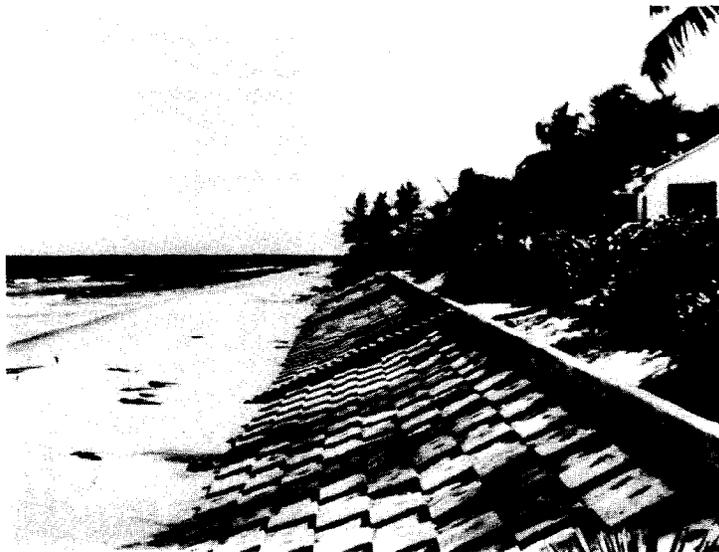
Figure 36. An interlocking concrete block revetment forms a checkerboard pattern on the shoreline. Vertical structure at top of revetment is a reinforced concrete wave screen. Photograph courtesy of Portland Cement Association.

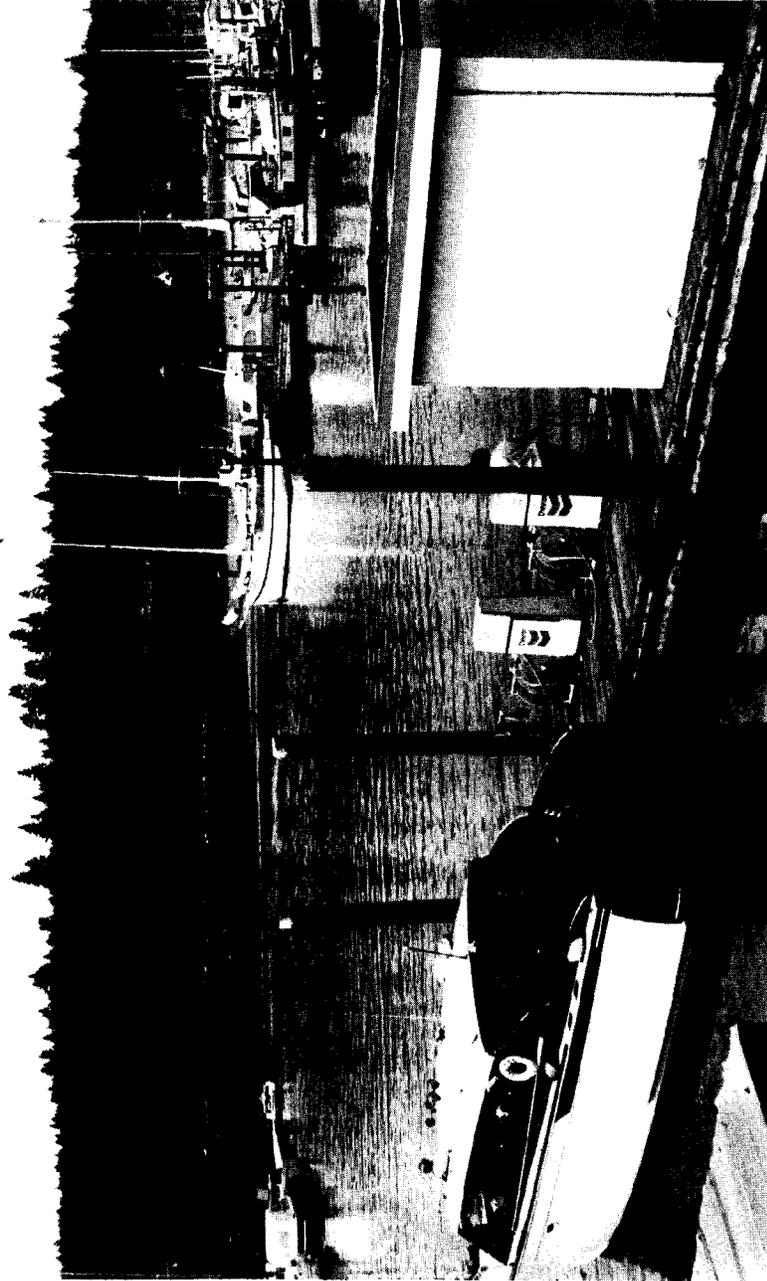
Figure 40. Floating pier at Kingston Marina, Kingston, Washington. Note rubble mound breakwater in background. Photograph by C. A. Francisco

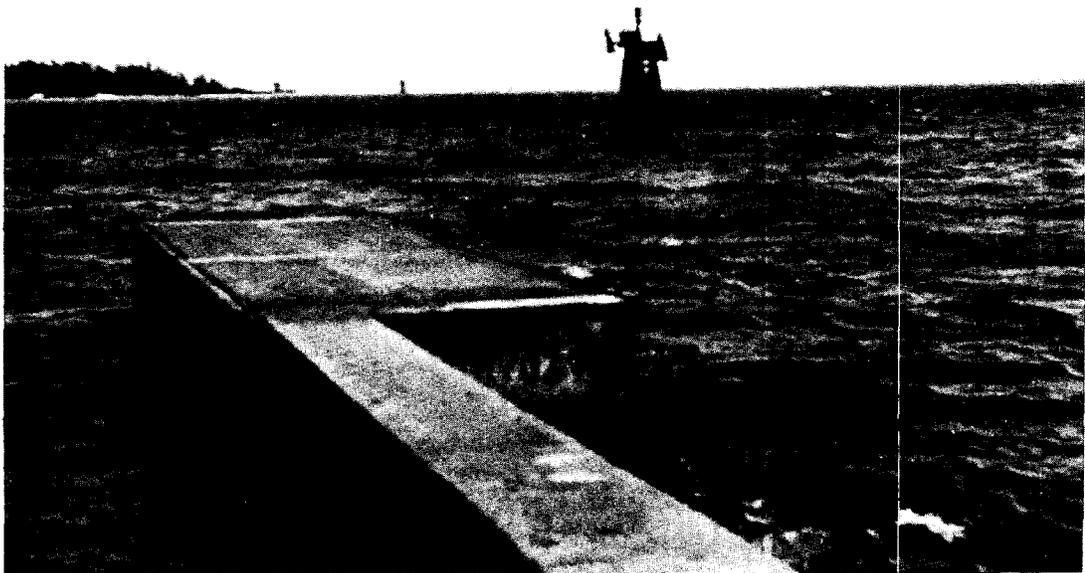
Figure 41. Piling in Key West, Florida supports navigational aids. A concrete capped pile pier is also noticeable in the picture. Photograph by E. L. Mulvihill.

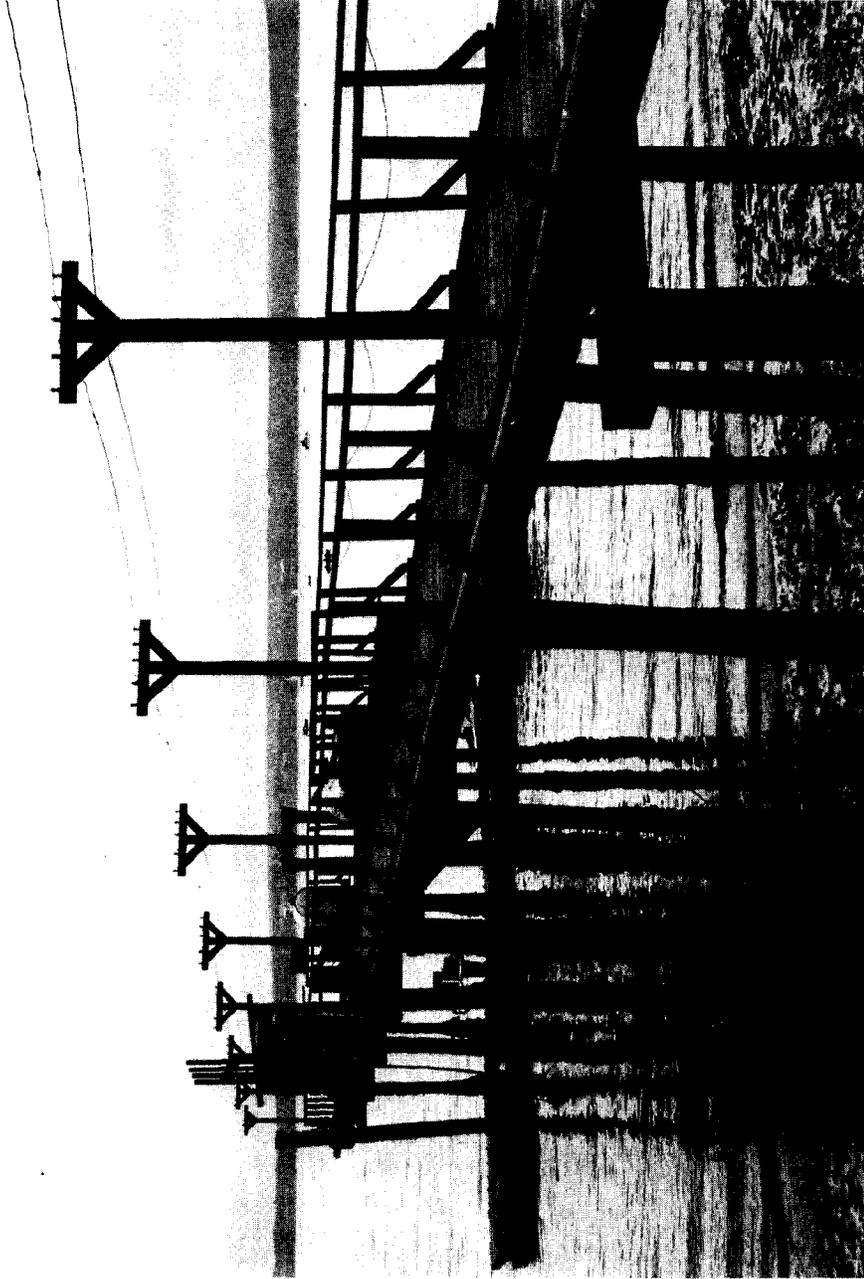
Figure 42. Open-pile pier near Hansville, Washington. Note the floating pier at the end. Photograph by C. A. Francisco.

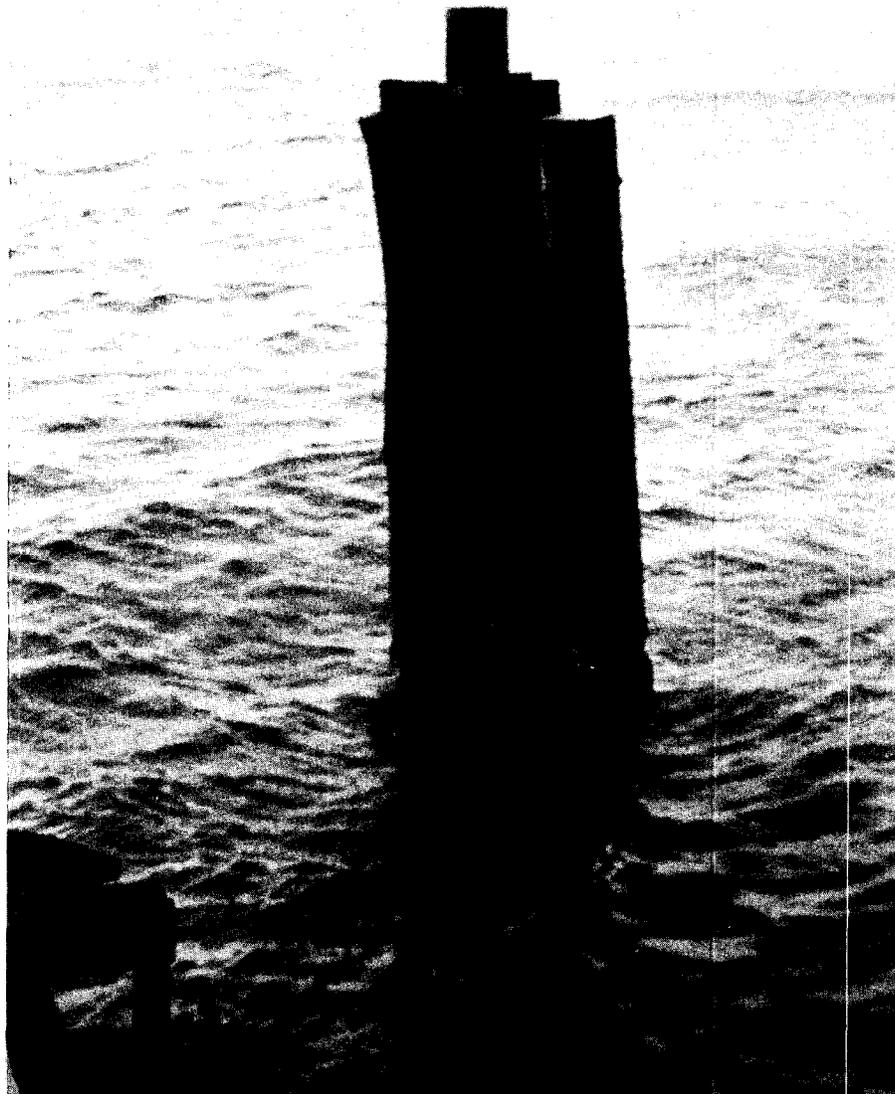
Figure 43. Gribble damage to a mooring dolphin in Key West, Florida can be seen near the water level. Photograph by E. L. Mulvihill.

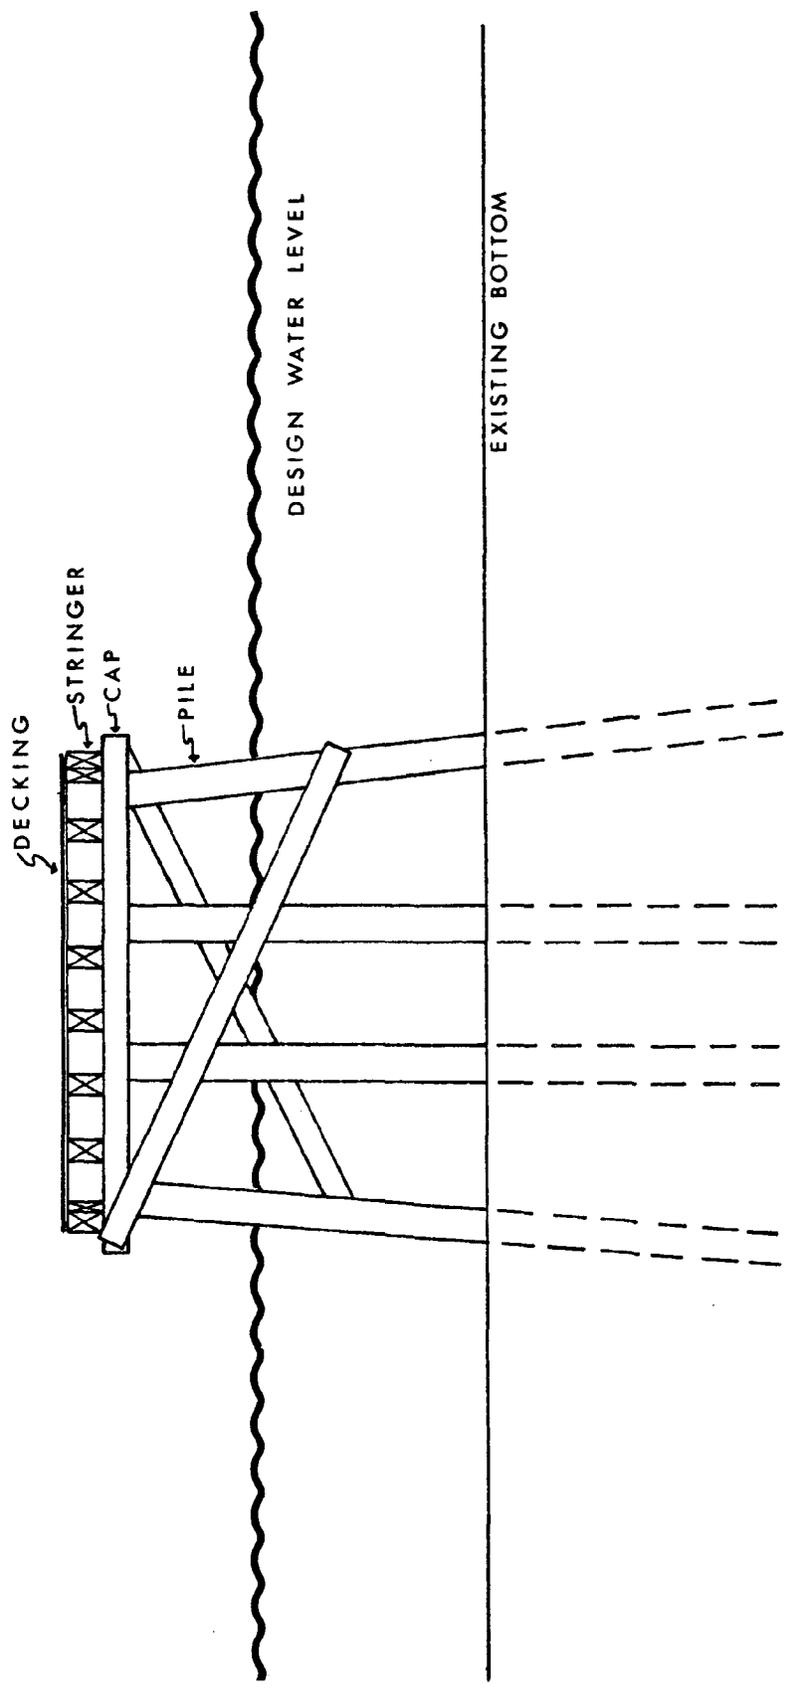
Figure 44. Cross-sectional view of a typical pier. Dimensions and details to be determined by particular site conditions.

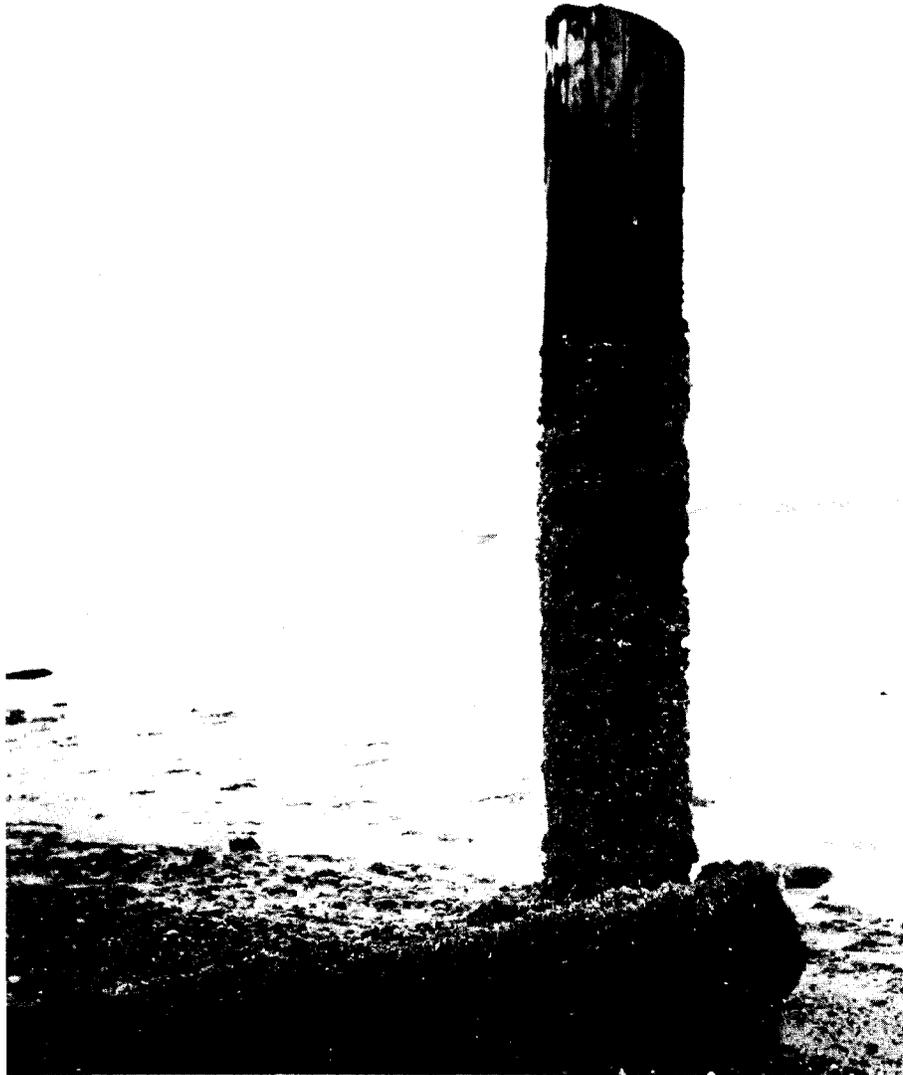
Figure 45. Submerged structures offer substrate for the attachment of various types of marine organisms. Photograph by C. A. Francisco.

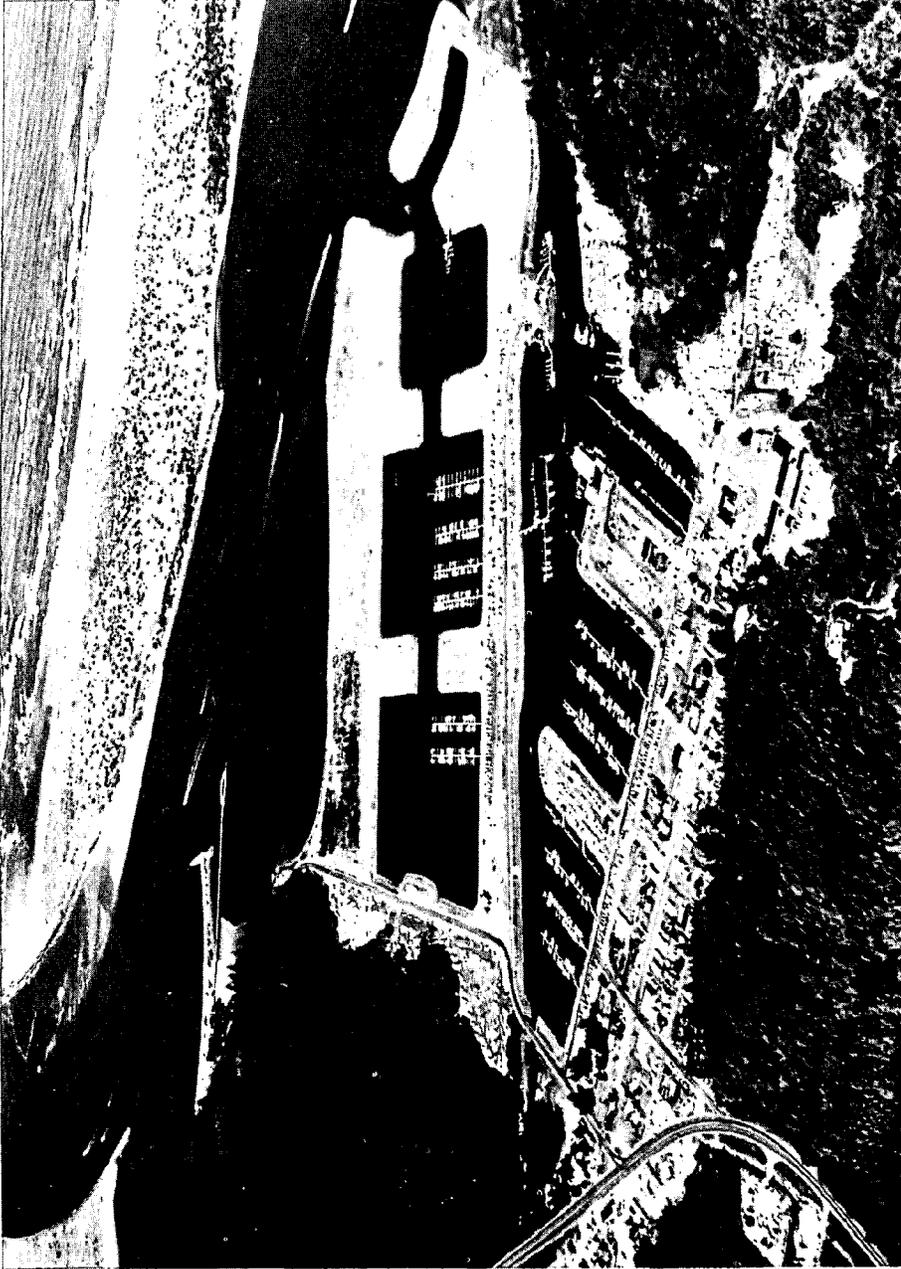
Figure 47. Winchester Bay, Oregon. Photograph courtesy of CH₂M Hill, Inc.

There is no exact definition as to how many of the above features are implied by "small craft harbor." But, many of the structures considered in this report are common components of small craft harbors (Figures 46, 47, and 48).

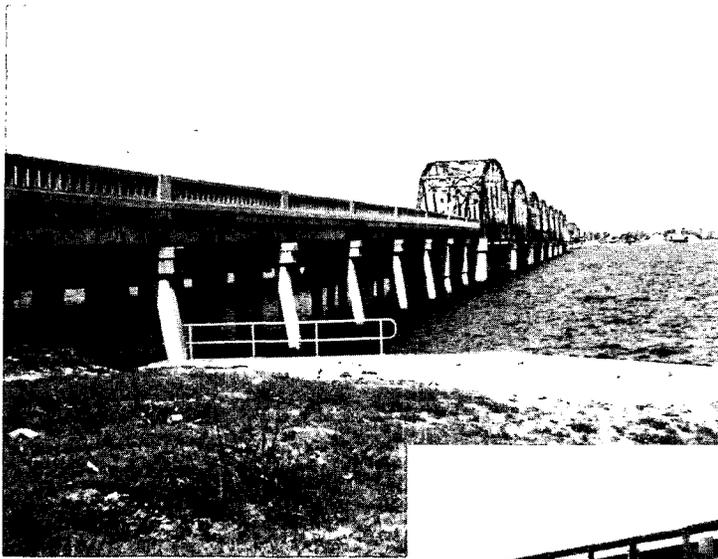
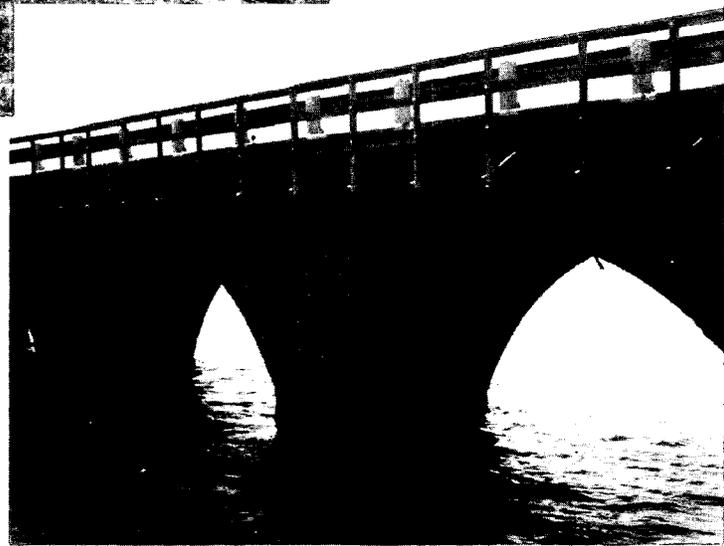
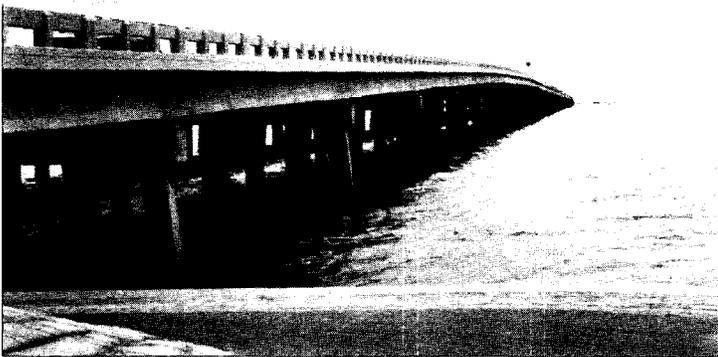
Figure 49. Many of the older bridges (top, center) along the Overseas Highway to Key West, Florida, are being replaced by new structures (bottom). Photographs by E. L. Mulvihill.

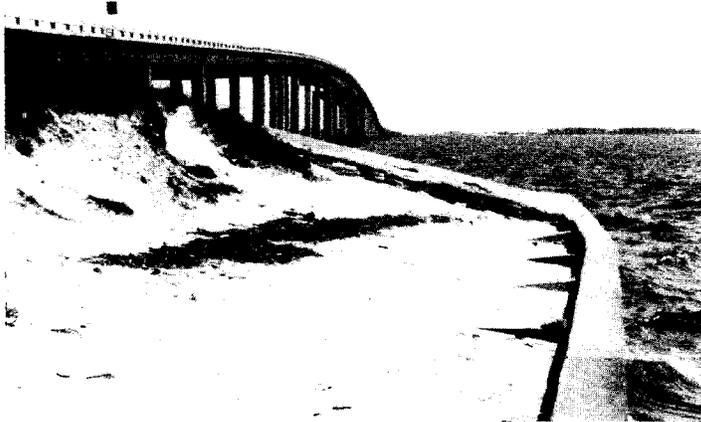
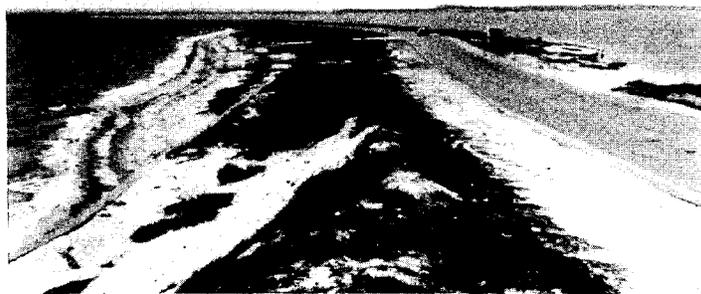
Figure 50. A bridge and causeway system crosses Apalachicola Bay on the Gulf coast of Florida. Photographs by E. L. Mulvihill.

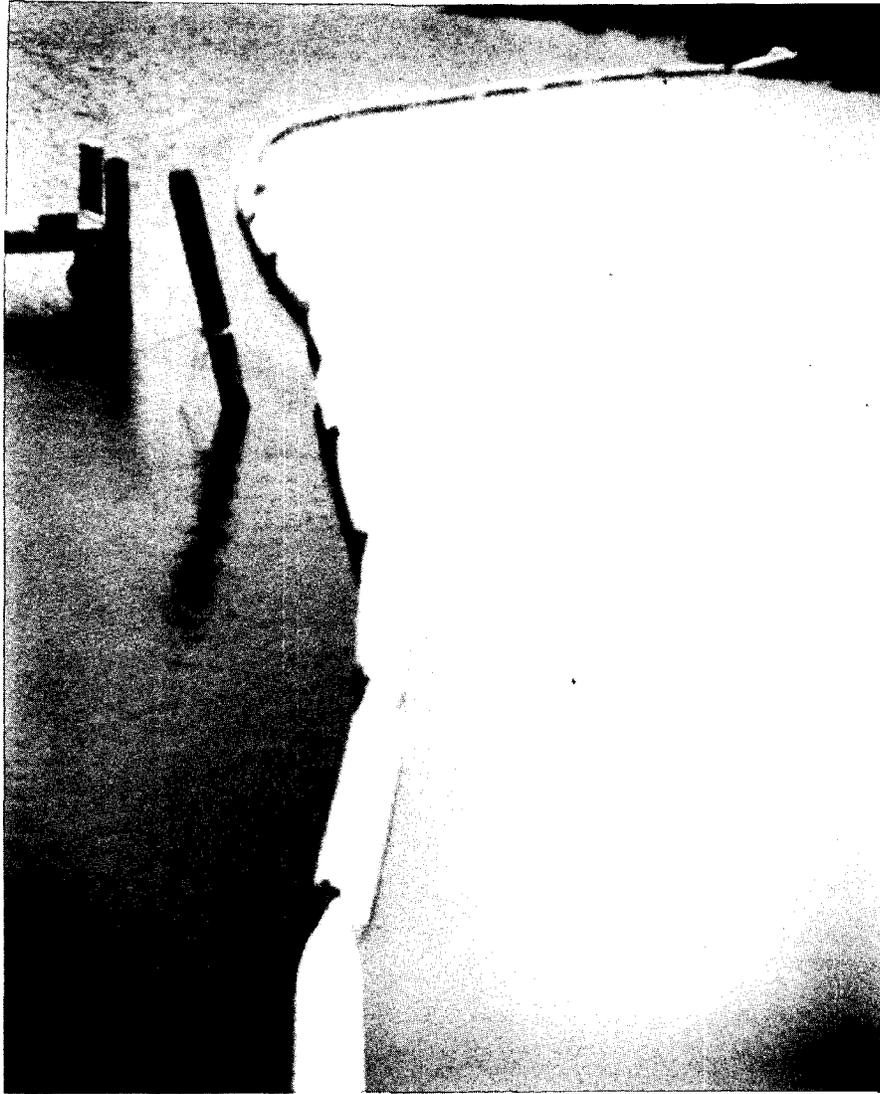
Figure 51. A silt curtain is used to contain sediment produced by causeway work on the Overseas Highway in Florida. Note the difference in water clarity on both sides of the curtain. Photograph by E. L. Mulvihill.

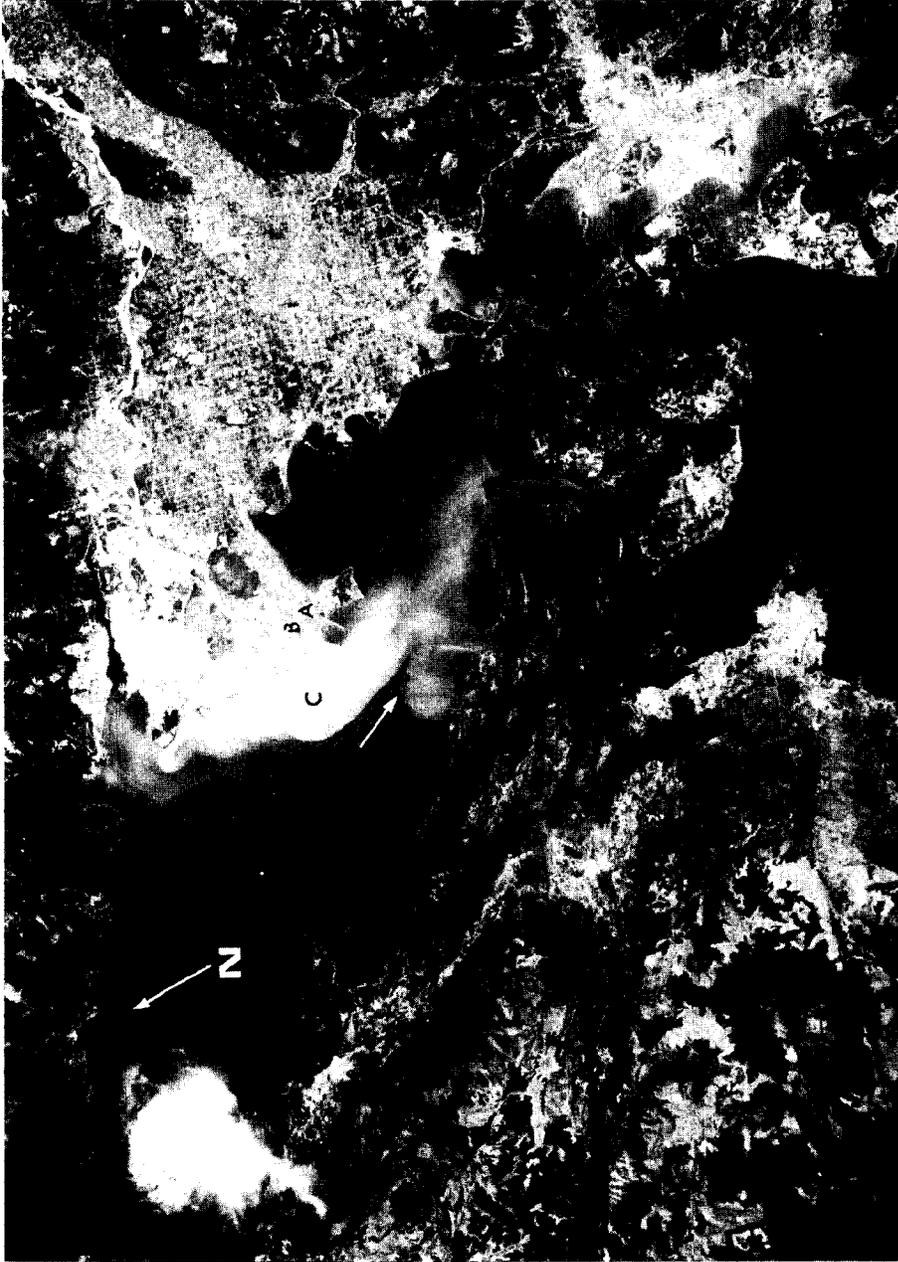
Figure 52. The Roberts Bank Causeway in British Columbia effectively diverts Fraser River silt laden water away from the shoreline. The causeway is about 2 mi (3.2 km) long. An environment atypical of the rest of the delta has developed down current of the causeway. The letter A marks the Roberts Bank Causeway, and B marks the Tsawwassen Causeway. The letter C indicates the Fraser River silt plume. The arrow denotes direction of flow. Photograph by the United States Geological Survey.

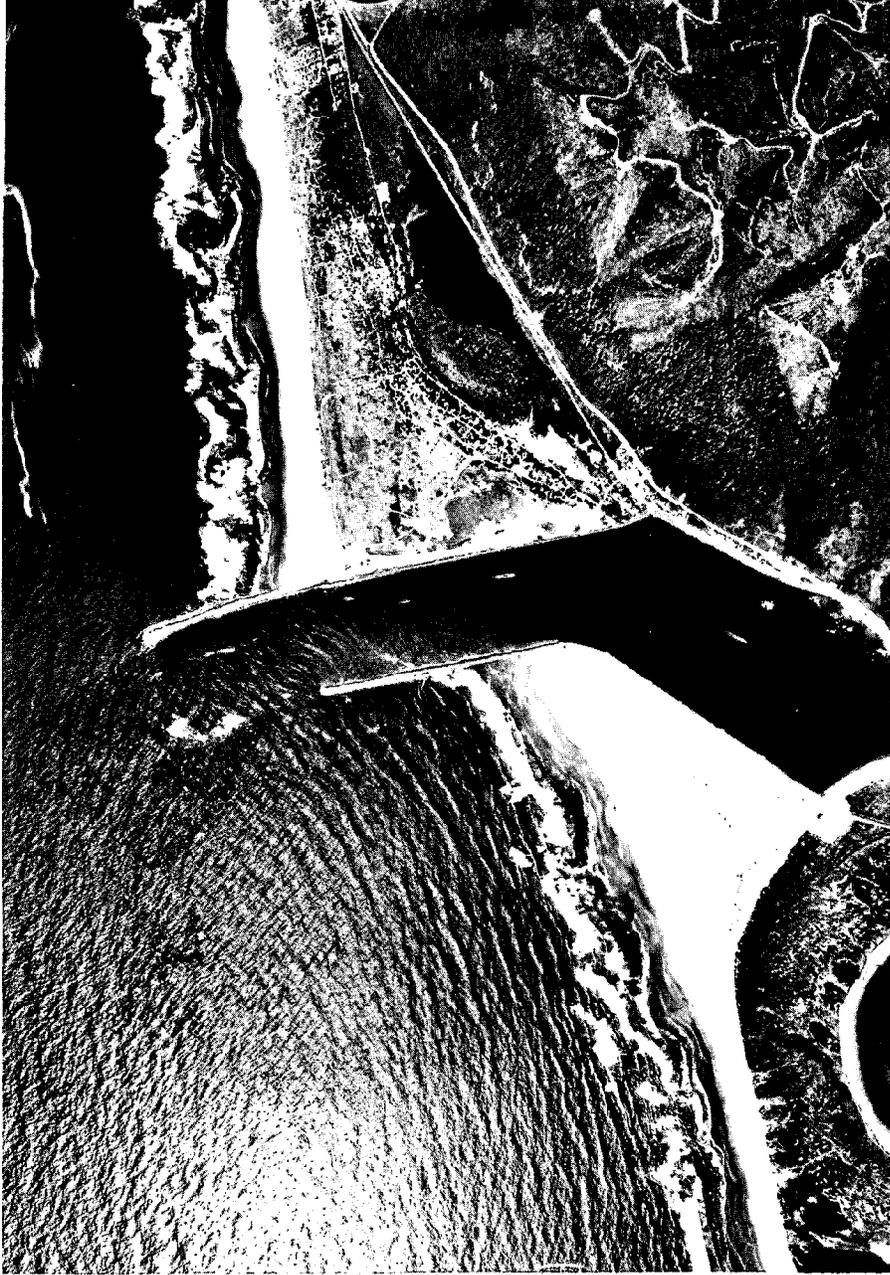
Figure 54. Tillamook jetties, Tillamook Bay, Oregon. Bayocean Spit extends south from the south jetty at center of the picture. Photograph courtesy U.S. Army Engineer District, Portland, Oregon.

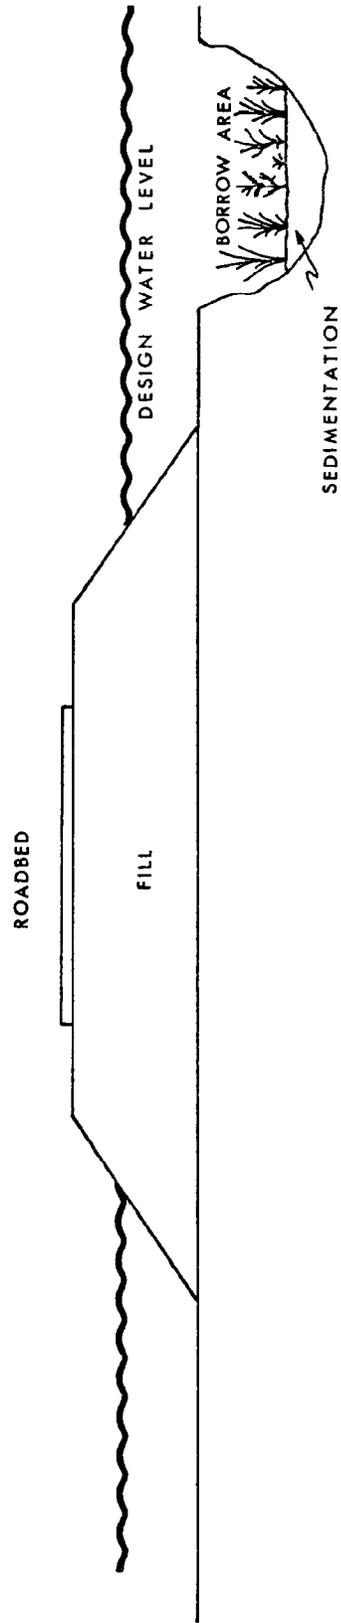
Figure 55. Cross-sectional view of a causeway constructed with fill material from a nearby borrow area. The sedimentation in the borrow area can foster seagrass growth in some situations in the Florida Keys.

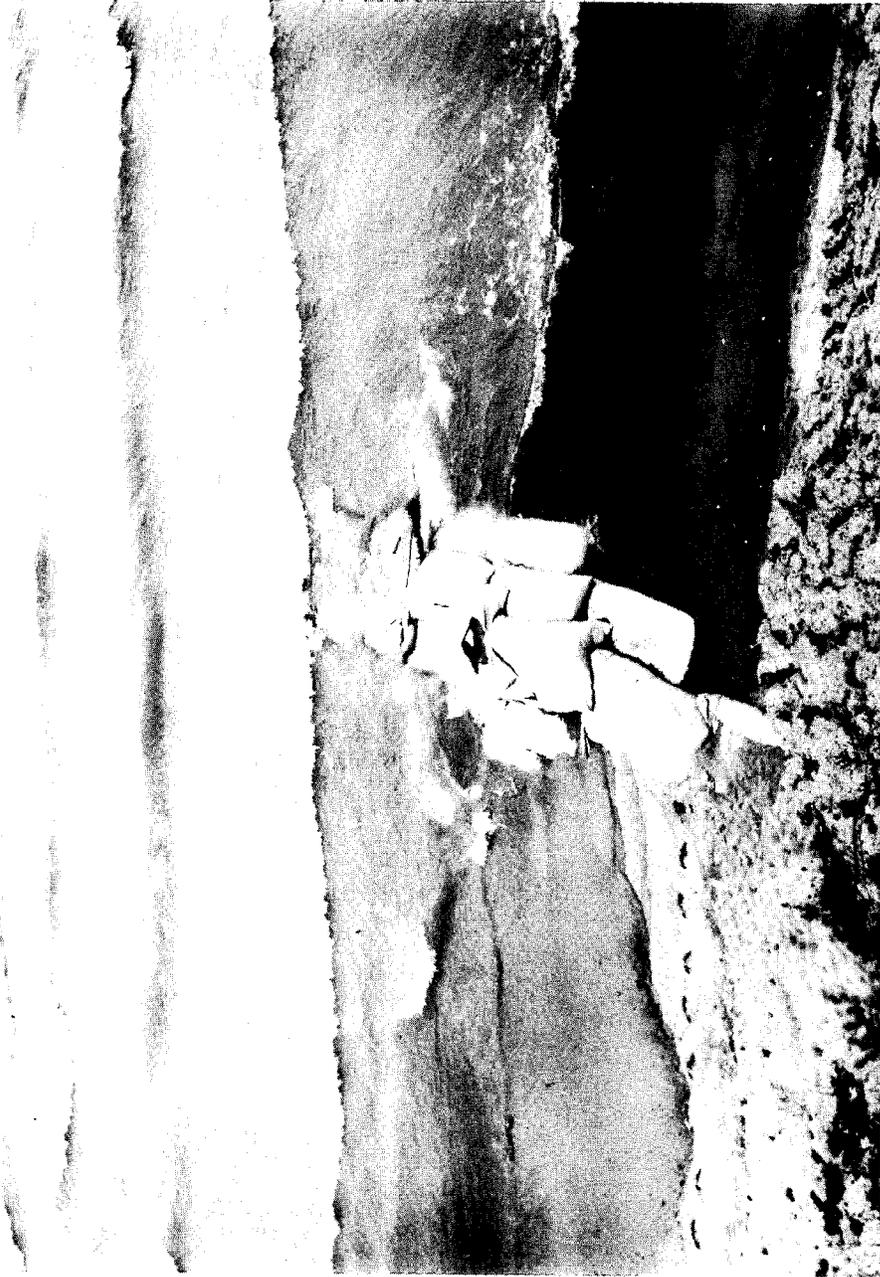
Figure 57 . Sandbag groin at Sanilac site, showing loss of sandbags at Take end. Photography courtesy of Michigan Department of Natural Resources.
